AR879 2018-2019 SOI-F Frame Outrigger Reinforcement

Complaint: Structural stress crack of chassis frame at outrigger supports

Vehicles Affected: 2018/2019 Spirit of Independence - Ford (SOI-F)

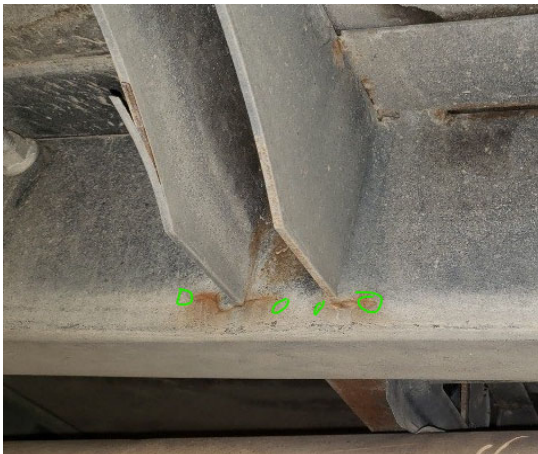
Cause : Concentrated stress loads

Step 4) If unit has cracks in frame (see photo below) - drill 1/8 inch holes at the ends of the cracks, grind surface clean and weld cracks and holes closed-If no cracks proceed to Step 5

Correction: Drill stop holes into frame, weld cracks and weld provided reinforcement plate to affected area
