Technical Service Bulletin

40 Rumbling/knocking noises from front suspension - bolted connection of strut brace

40 25 94 2059996/5 January 16, 2025. Supersedes Technical Service Bulletin Group 40 number 24-85 dated November 15, 2024 for reasons listed below.

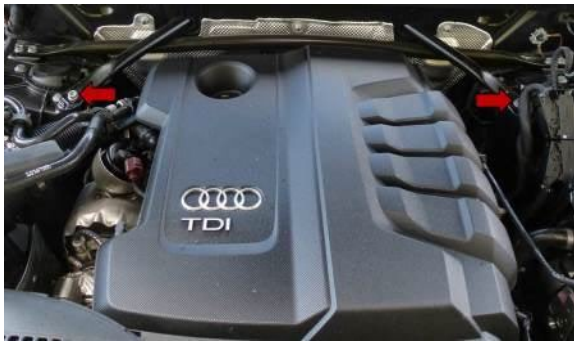
- The customer complains about rumbling or knocking noises from the front of the vehicle when driving on uneven surfaces.

The noise can be caused by tension in the vehicle body.

Figure 1. Example of tower brace for an Audi Q7.

For noise analysis, we suggest checking the bolted connection for the two strut braces. If necessary, tighten the bolt to the correct torque according to the Workshop Manual and reassess the complaint. (Figure 1)
