Technical Service Bulletin

97 Rear parking aid, lane change assist or rear lid power opening does not work

97 25 12 2070488/2 January 27, 2025. Supersedes Technical Service Bulletin Group 97 number 23-96 dated June 5, 2023 for reasons listed below.

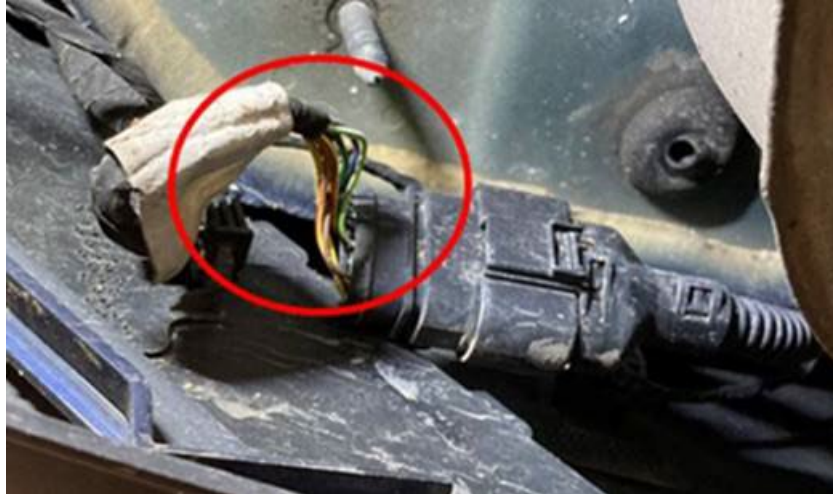
Environmental influences can cause damage to the wiring at the coupling point on the rear left bumper TSFHL.

Figure 1: Inspection point of TSFHL.

Inspect connection point TSFHL at the rear bumper for damage (Figure 1).

If damage is found, repair the harness using the following steps.

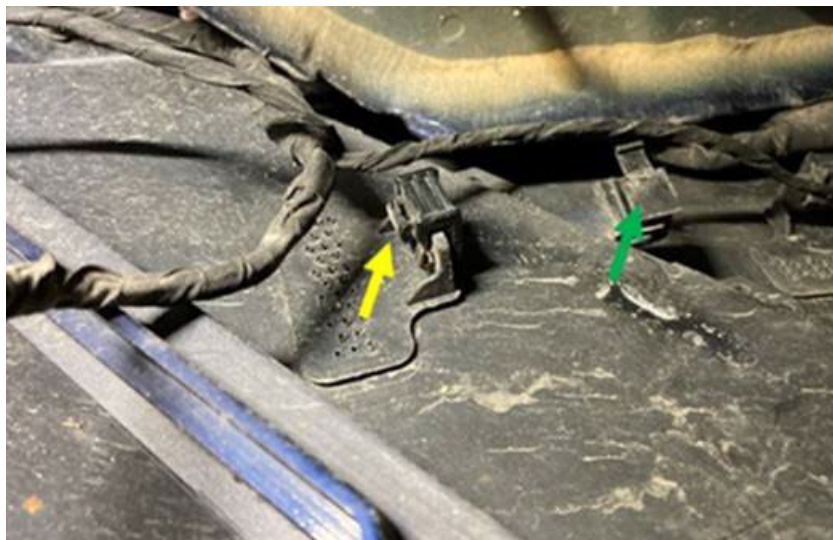
Figure 2: Cable ties to be removed.

Remove the cable tie (yellow arrow in Figure 2).

Release T14mx connector from its mounting (green arrow in Figure 2).

Repair damaged wires using wiring harness repair set **VAS 1978 B/C**.

Re-wrap the repaired wiring harness with adhesive tape **N 10729002**.

Wrap tape so that it overlaps by 50% and stops 40 mm before T14mx connector housing (see original wrapping in Figure 1).

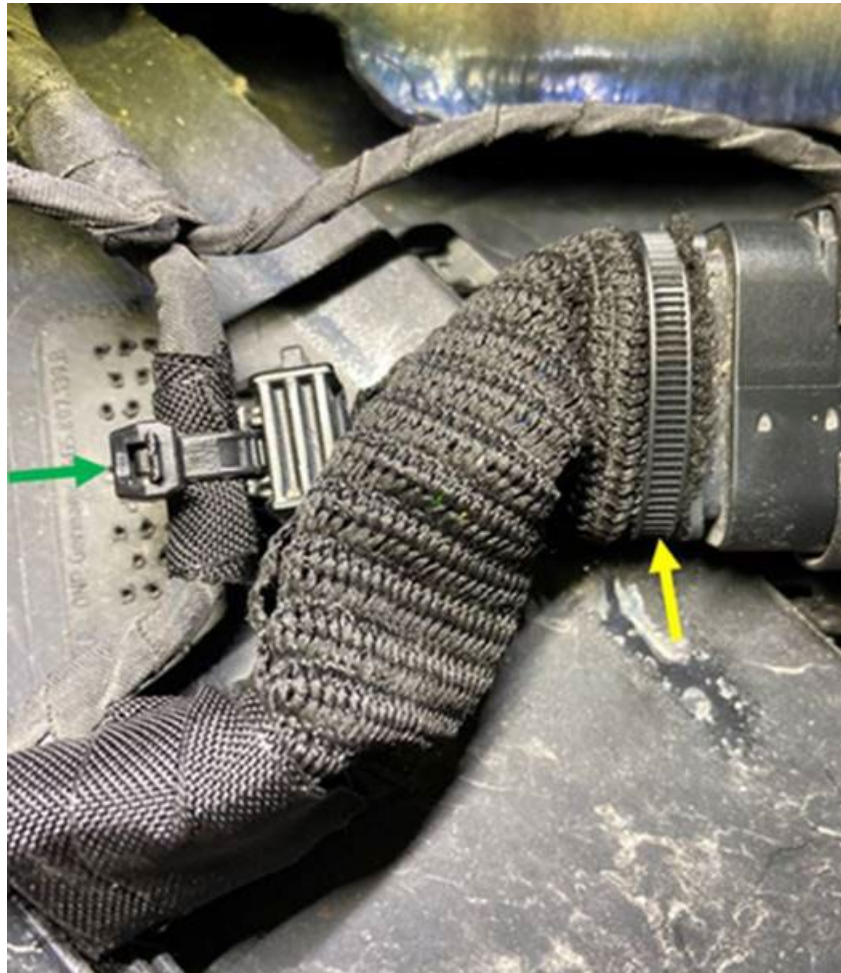
Figure 3: Completed repair of harness connection T14mx

Secure protective sleeve **N 10892001** to T14mx connector using cable tie **N 10623101** (yellow arrow in Figure 3).

Wrap adhesive tape **N 10729002** around other end of protective sleeve several times. Protective sleeve must not be attached to wiring harness with adhesive tape.

Wrap three layers of adhesive tape **N 10729002** underneath cable tie **N 90937701** (green arrow in Figure 3).
