# Technical Service Bulletin

## 93 Q4 power transmission: clacking noises during load changes/when changing direction (e.g. maneuvering/driving away)

93 25 53 2074899/2 January 23, 2025. Supersedes Technical Service Bulletin Group 93 number 24-08 dated August 28, 2024 for reasons listed below.

Model(s)	Year	VIN Range	Vehicle-Specific Equipment
Q4 e-tron, and Q4 Sportback e-tron	2022 – 2025	All	Not Applicable

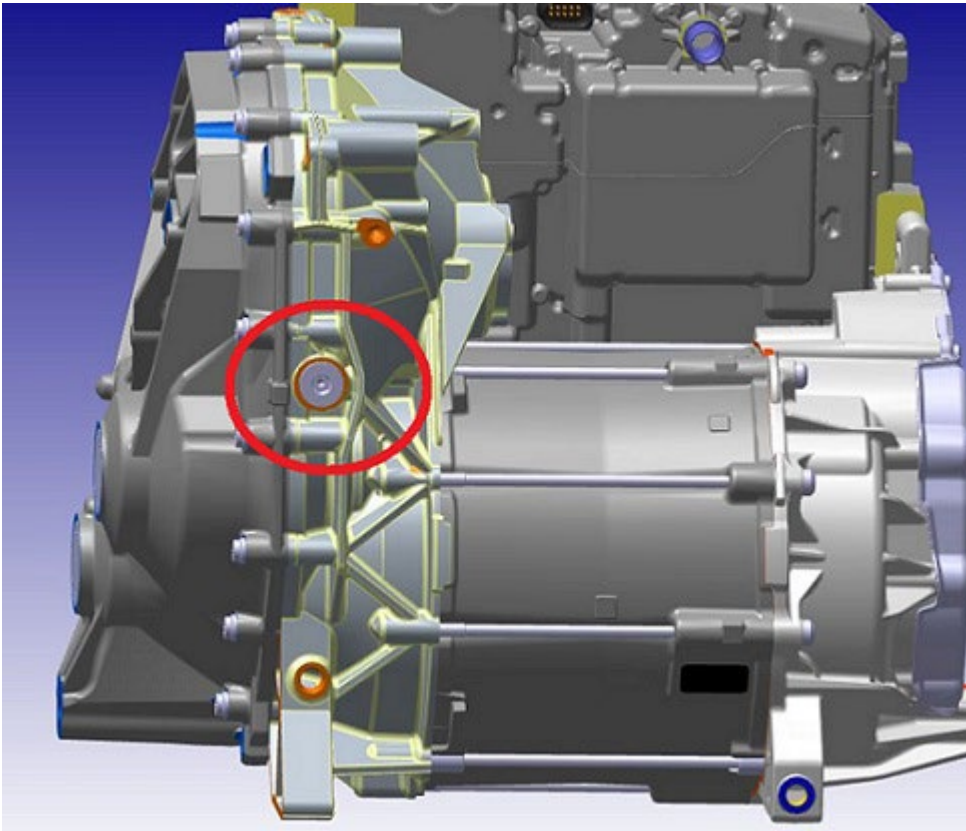
**Figure 1.** Filler cap for gear oil.

- Remove gearbox as described in ELSA Repair manual.
- Attach gearbox to engine and gearbox support -VAS6095A- as described in ELSA Repair manual.
- Drain gear oil via filler cap (refer to Figure 1, red oval).

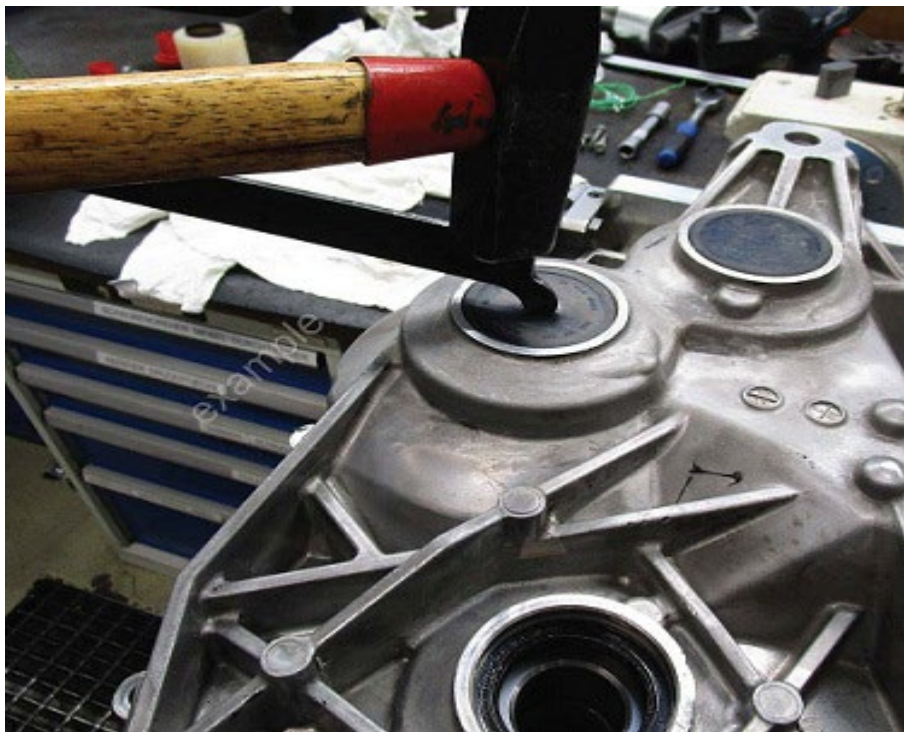
*Figure 2. Removing filler cap with extractor lever -VW681- (example).*

- Remove center filler cap using extractor lever -VW681- (refer to Figure 2).

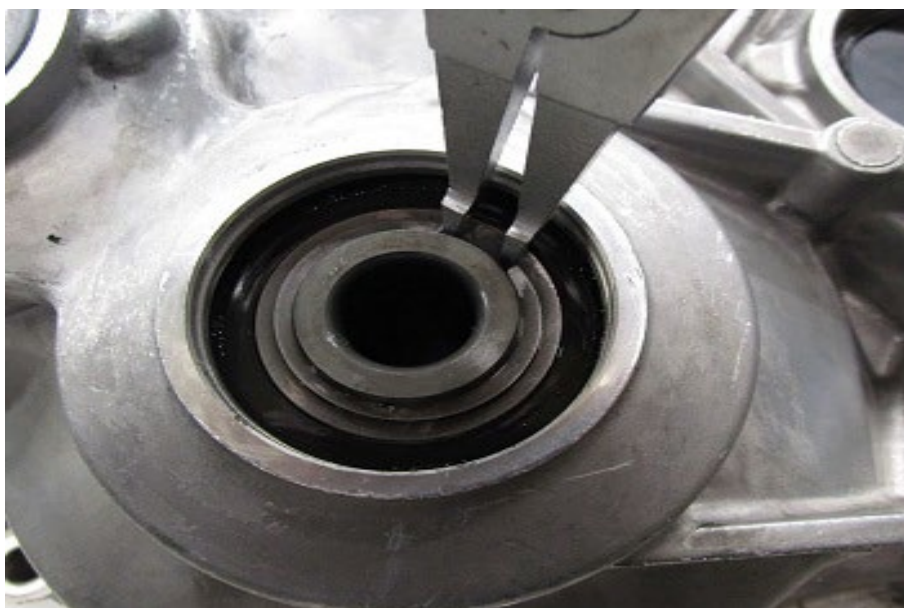
*Figure 3. Removing retaining ring for inner ring of intermediate shaft (example).*

- Remove retaining ring for inner ring of intermediate shaft (refer to Figure 3). The retaining ring must not be damaged and will need to be used again during the repair procedure.

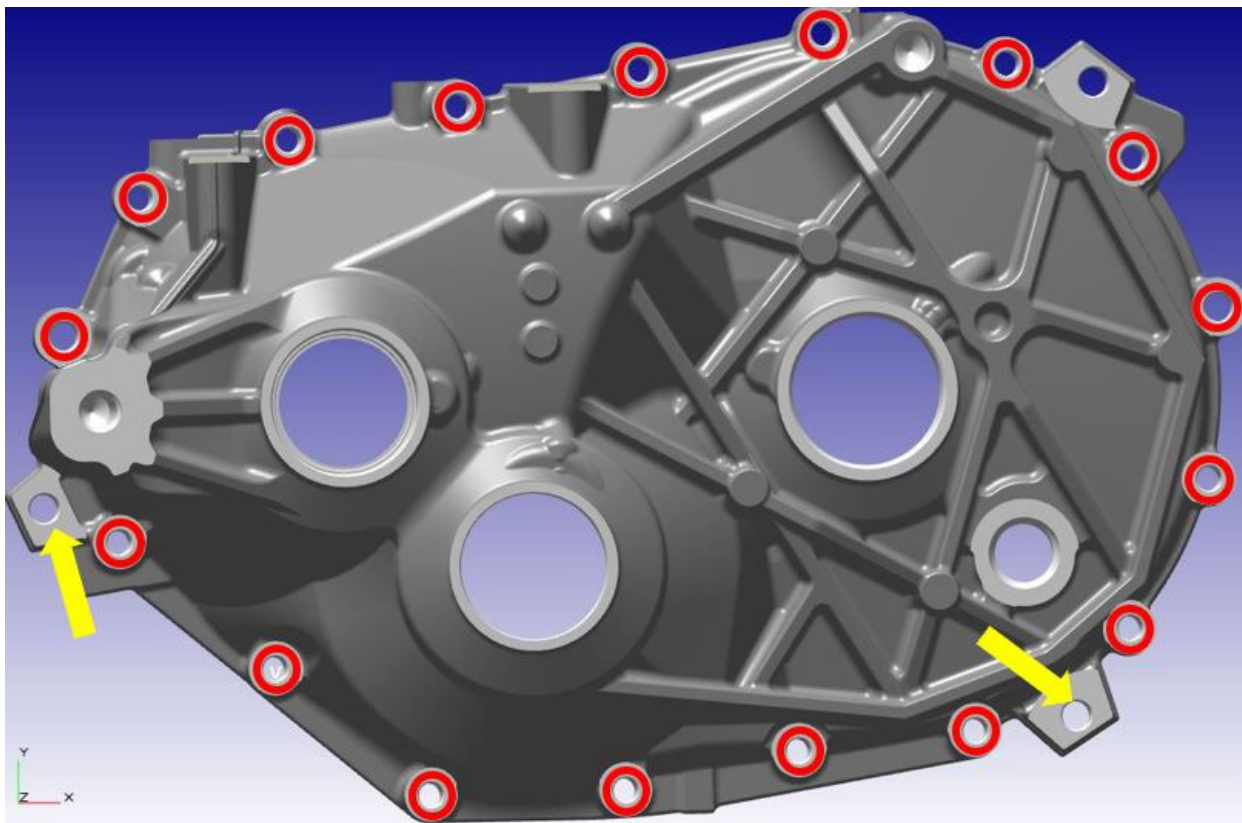
**Figure 4.** Positions of housing bolts (red circles), position of contact points (yellow arrows).

- Remove 17 housing bolts (refer to Figure 4, red circles).

- Apply a commercially available assembly lever under the contact points (refer to Figure 4 (yellow arrows), Figure 5 and Figure 6), carefully separate the two sections of the gearbox housing from each other and detach the gearbox housing.

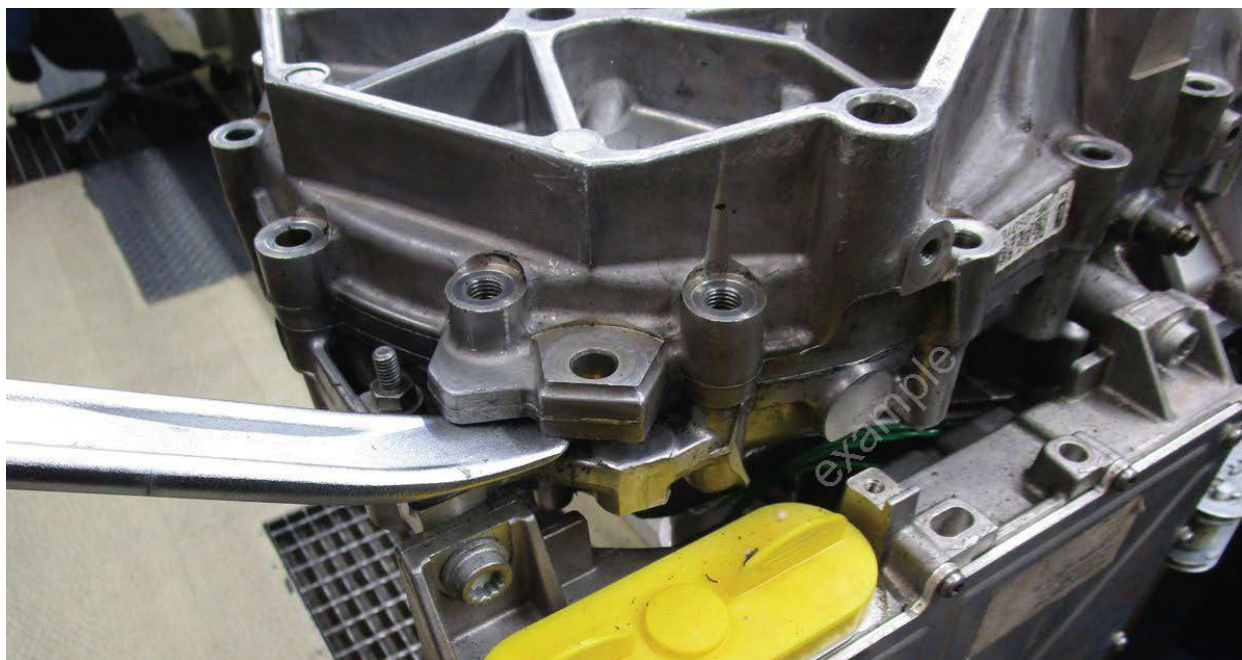
**Figure 5.** Separating sections of gearbox housing from each other using assembly lever.

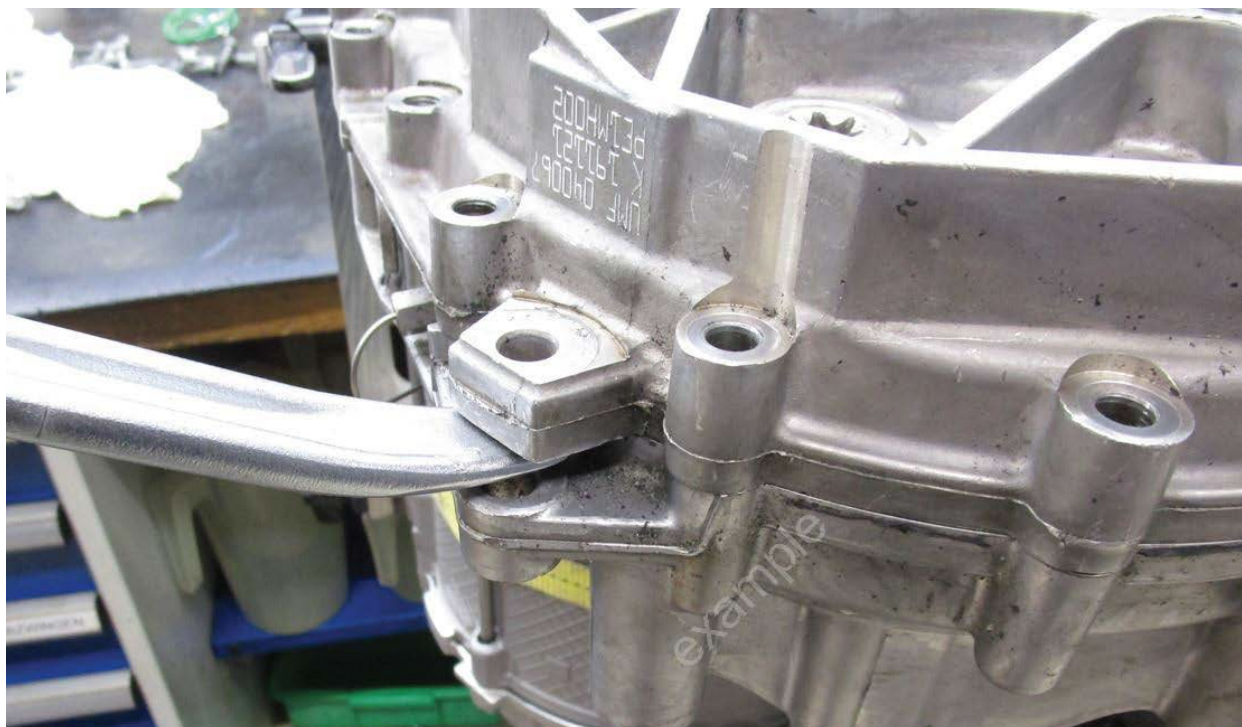
**Figure 6.** Separating sections of gearbox housing from each other using assembly lever.

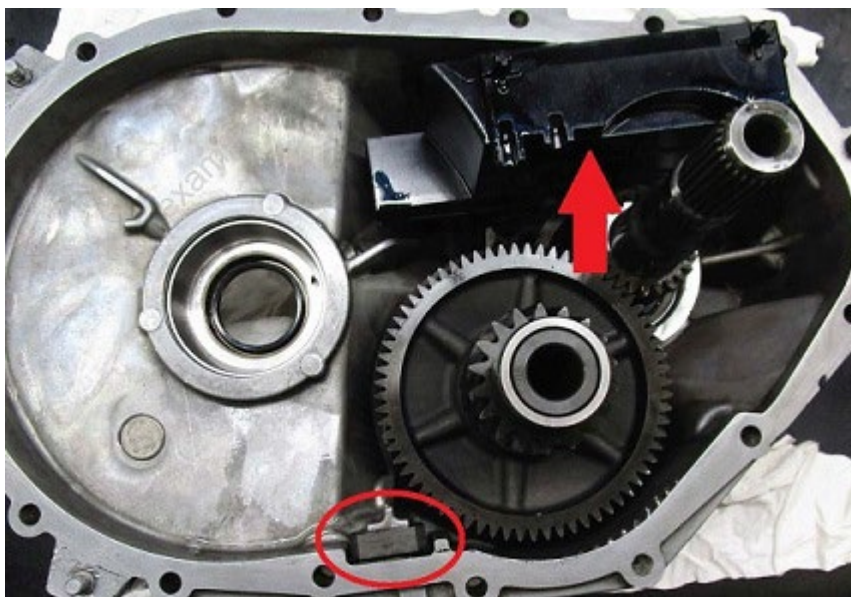
**Figure 7.** Positions of oil reservoir and magnet in gearbox housing.

- Remove oil reservoir (refer to Figure 7, red arrow) from gearbox housing.
- Remove magnet (refer to Figure 7, red oval) from gearbox housing.

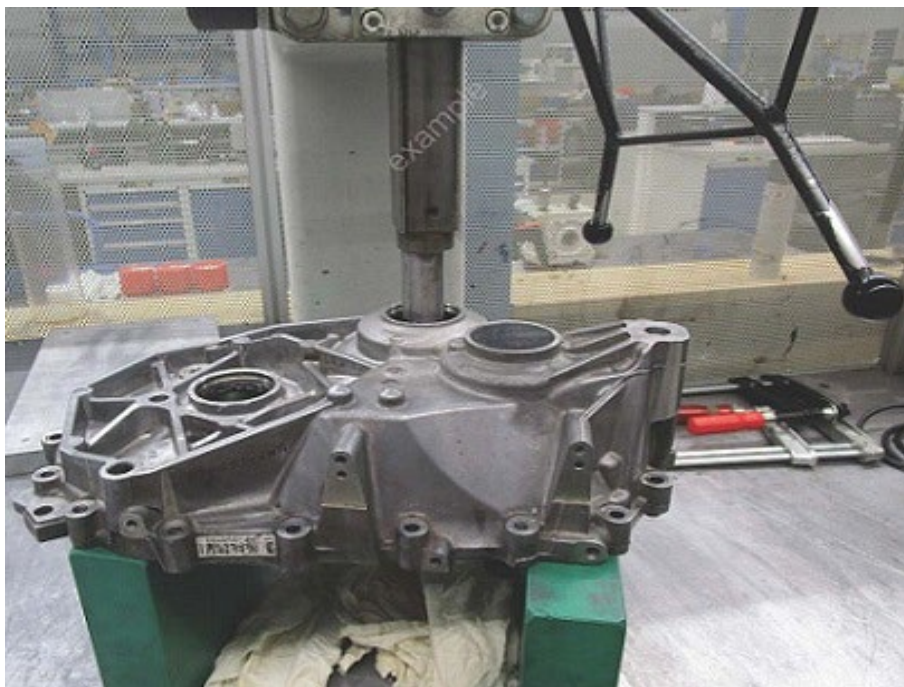
**Figure 8.** Pressing out intermediate shaft (example).

- Press intermediate shaft out using removing and installing tool -VW459/2- (refer to Figure 8).

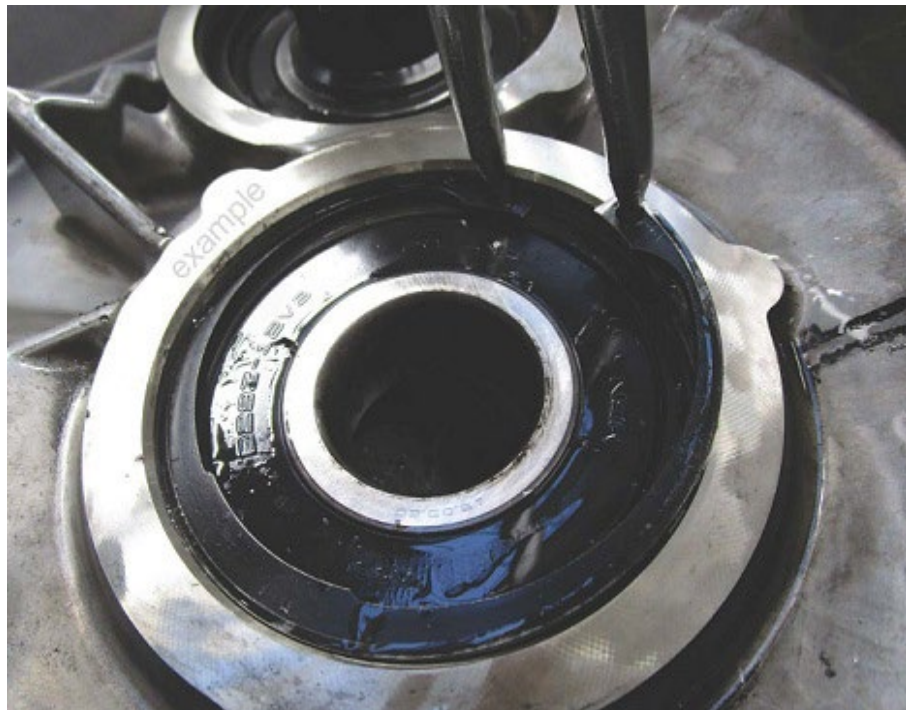
**Figure 9.** Removing retaining ring (example).

- Remove retaining ring for outer ring (refer to Figure 9) of bearing for intermediate shaft. The retaining ring must not be damaged and will need to be used again during the repair procedure.

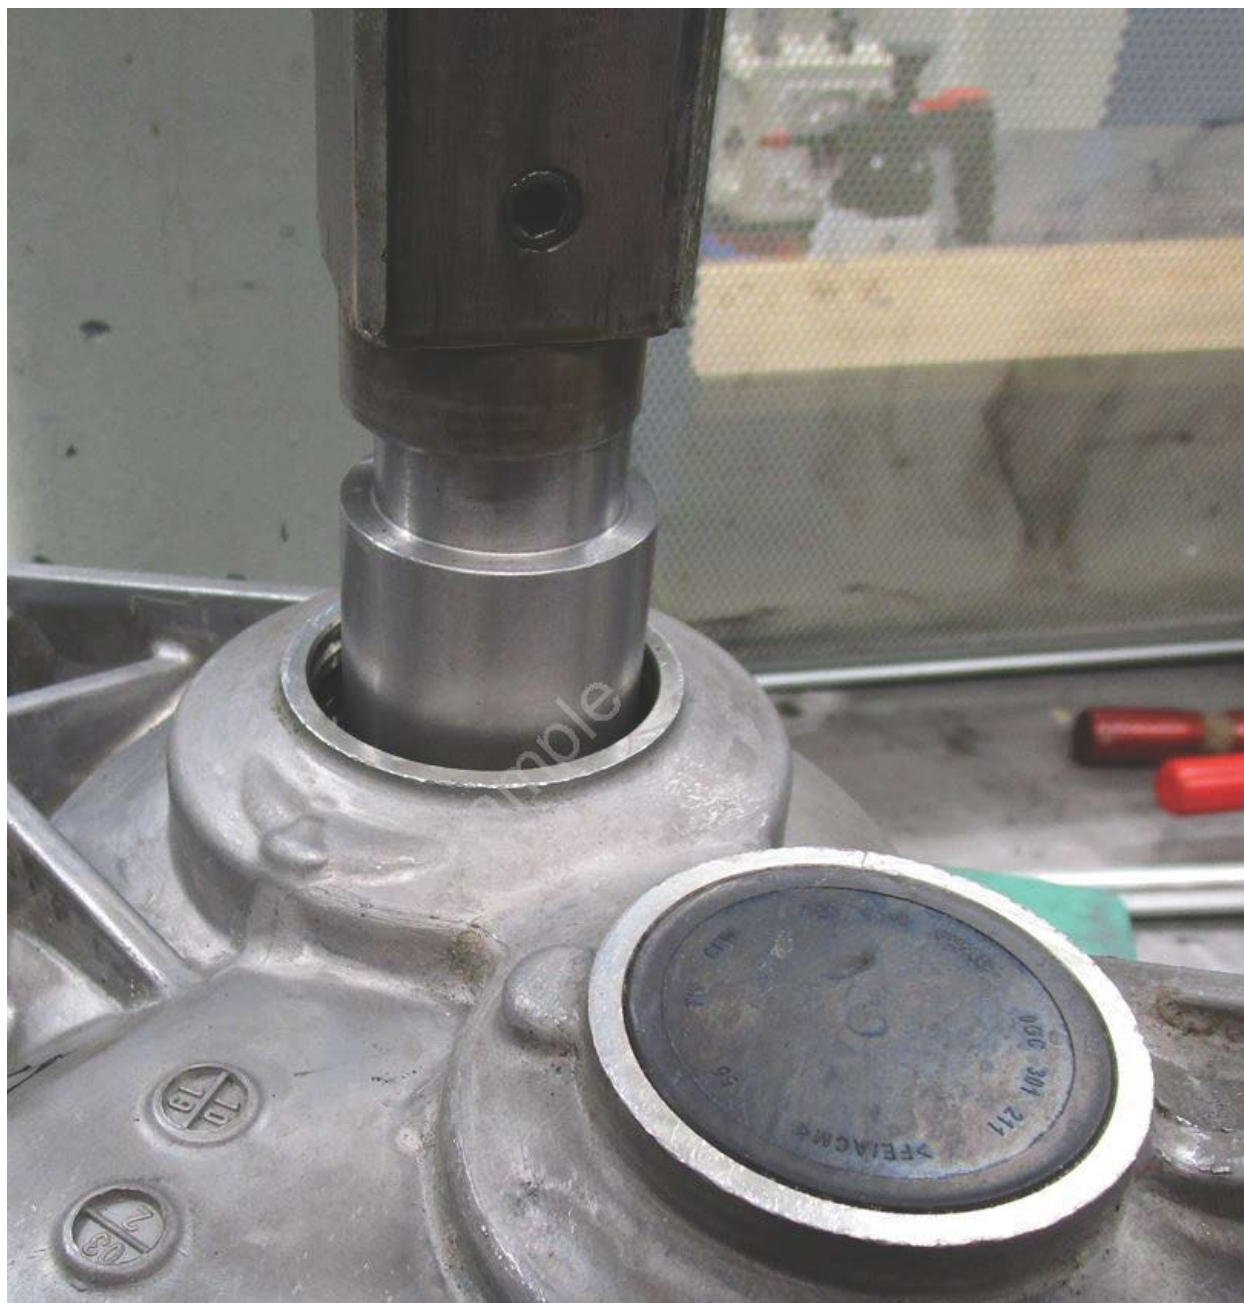
**Figure 10.** Pressing out bearing for intermediate shaft (example).

- Press bearing for intermediate shaft out using removing and installing tool -VW459/2- (refer to Figure 10).

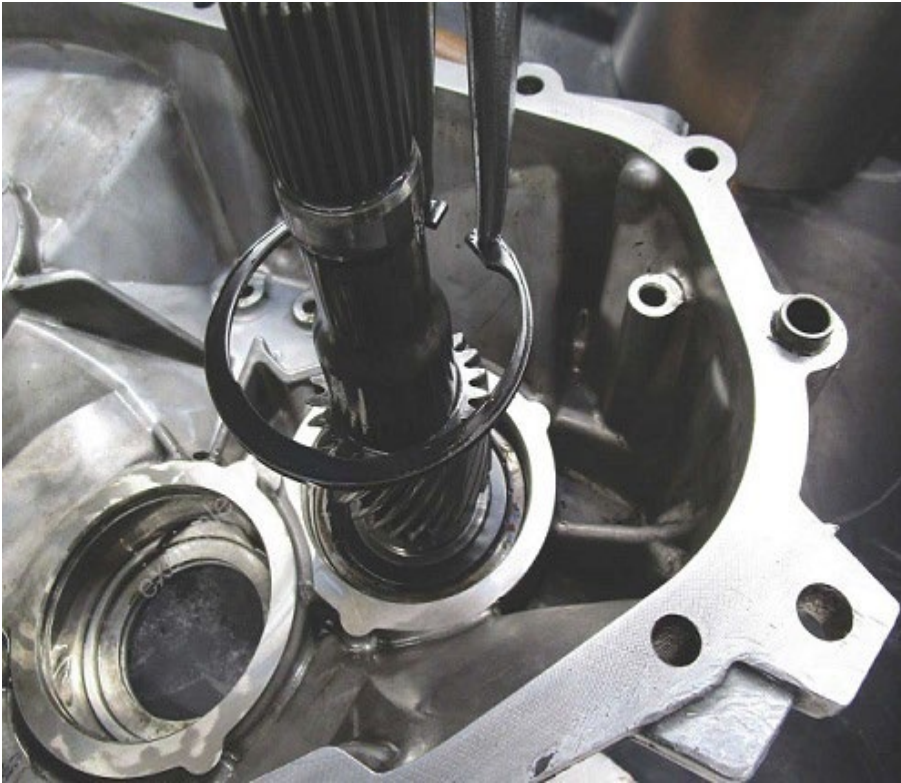
**Figure 11.** Removing outer retaining ring for drive shaft (example).

- Remove outer retaining ring for drive shaft (refer to Figure 11).

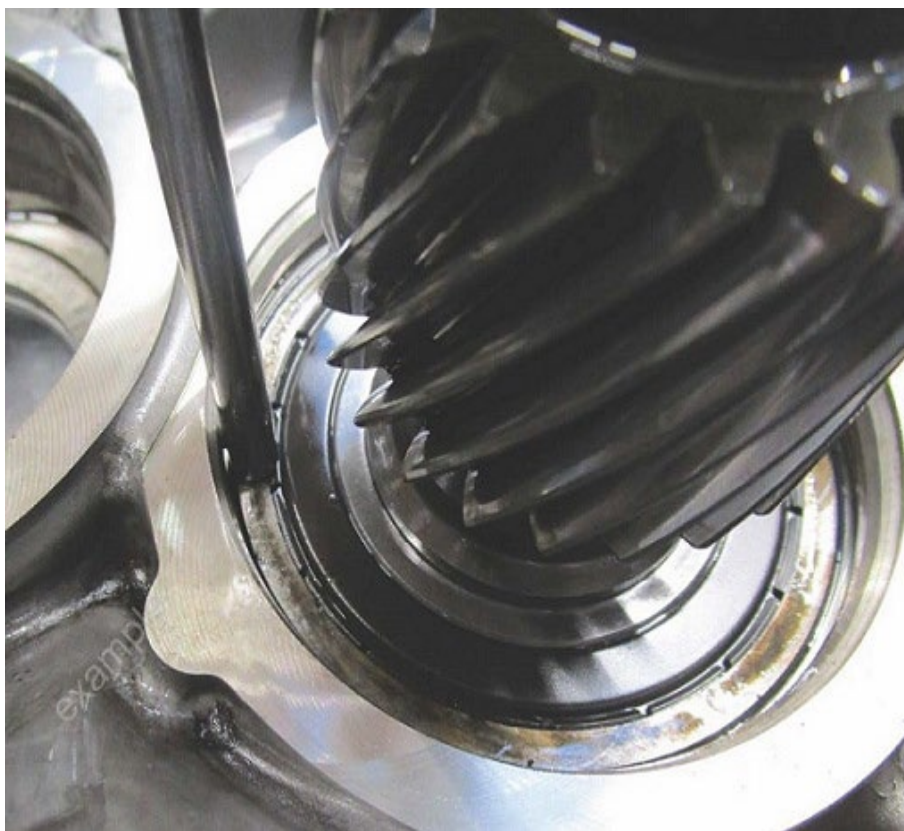
**Figure 12.** Driving bearing for drive shaft in deeper (example).

- Carefully drive bearing for drive shaft deeper into gearbox housing using a commercially available drift and hammer at outer ring of bearing (refer to Figure 12).

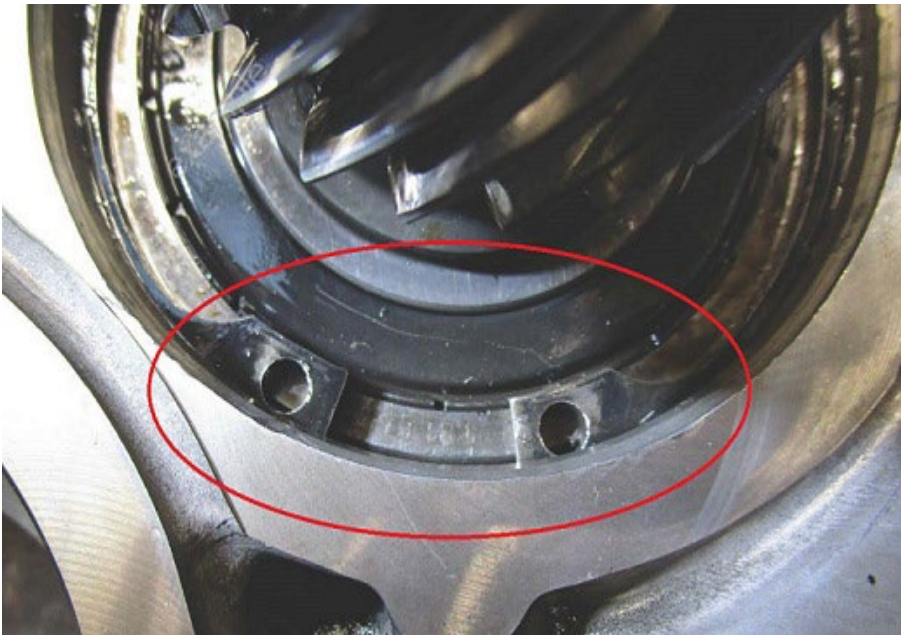
**Figure 13.** Retaining ring has snapped fully into groove (example).

- Install new retaining ring (with the maximum thickness/strength as described in parts information) as follows:
  - Install new retaining ring (starting with the maximum thickness/strength). If the retaining ring does not fit in the groove, try to insert the next thinnest retaining ring.
  - Continue in this way as necessary until a retaining ring of the correct size can be installed.

The new retaining ring must snap fully into the groove (refer to Figure 13, red oval).

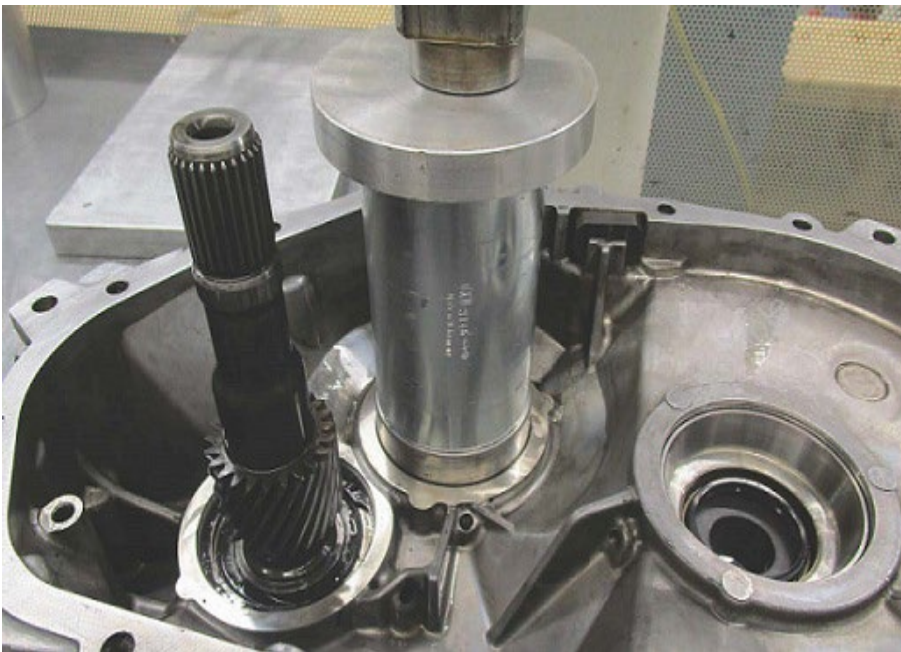
**Figure 14.** Pressing in new bearing for intermediate shaft with tube -3146-.

- Press new bearing for intermediate shaft (as described in parts information) into gearbox housing with tube - 3146- (refer to Figure 14).

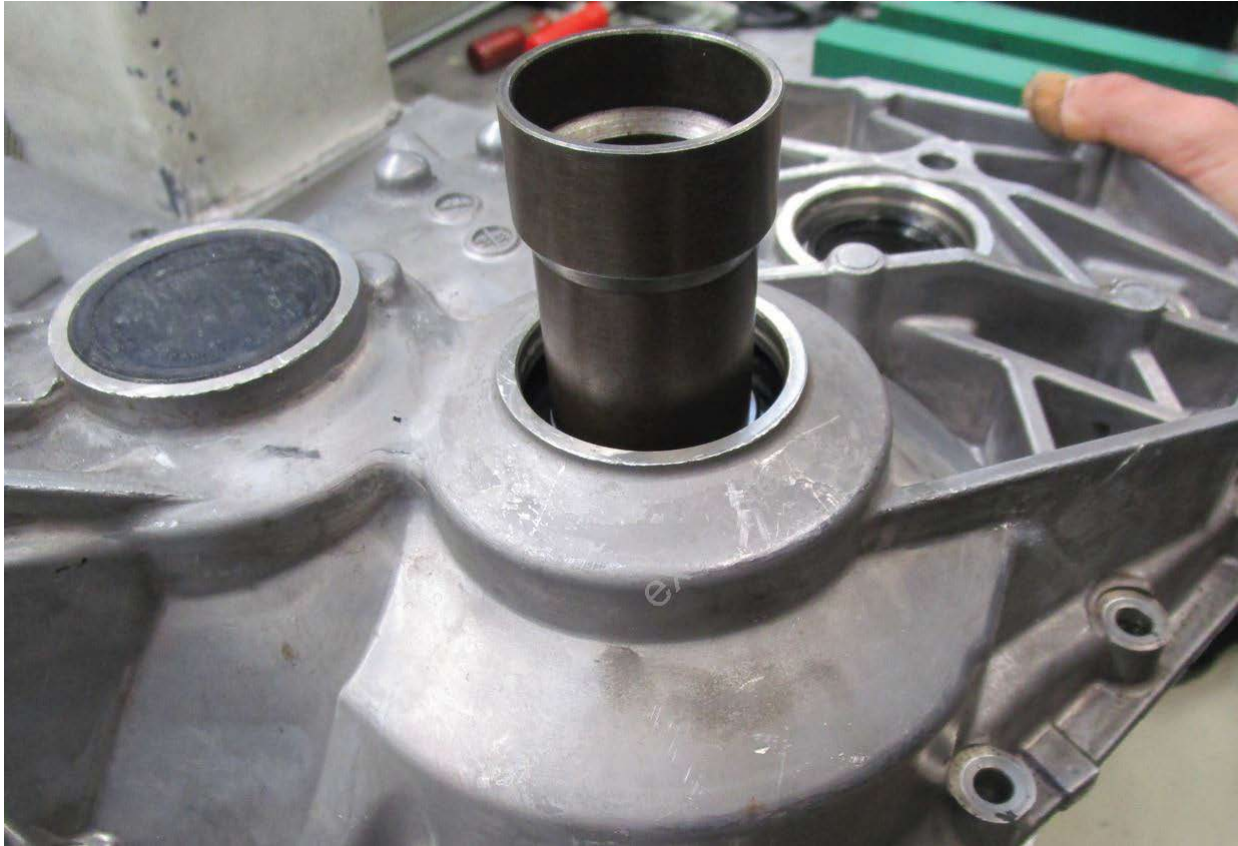
*Figure 16. Supporting inner ring with thrust piece -VW454- (example).*

- Press intermediate shaft in using removing and installing tool -VW459/2- (refer to Figure 15); at the same time, support inner ring with thrust piece -VW454- (refer to Figure 16).

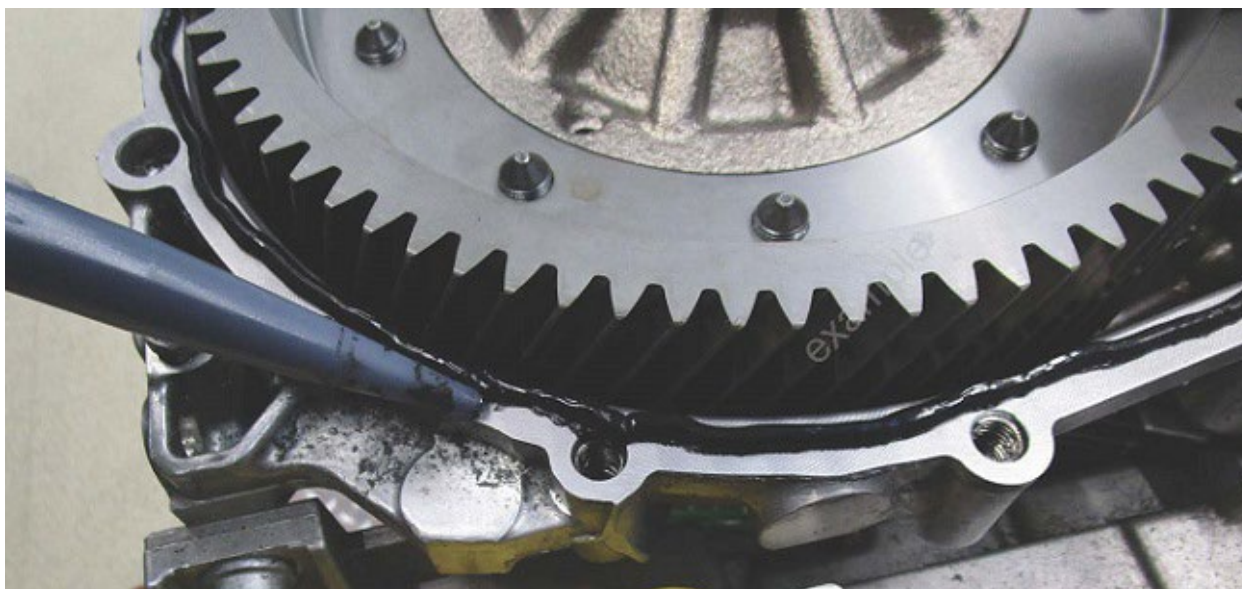
**Figure 17.** Applying silicone sealant all around sealing surface of intermediate housing (example).

- Allow flash-off time of 10 minutes for sealing surfaces.
- Apply silicone sealant (part number: D 176 501 A1) all around sealing surface of intermediate housing (refer to Figure 17).

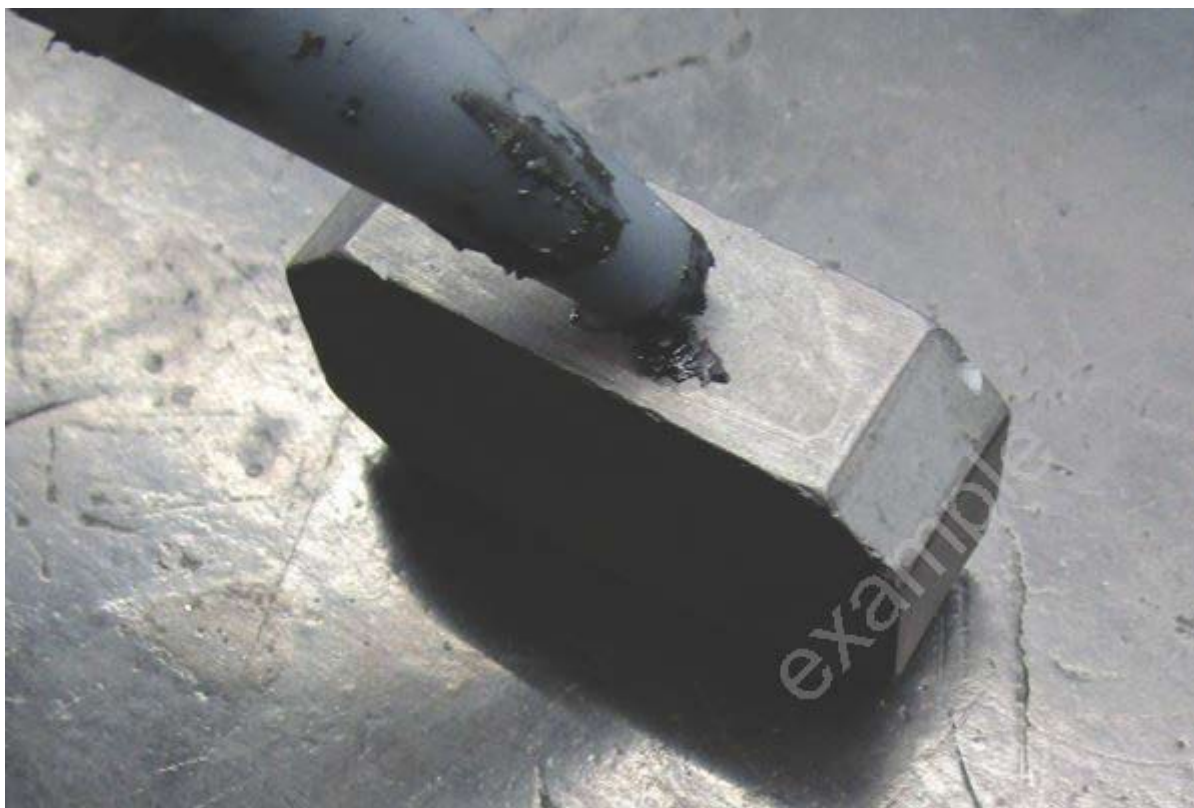
**Figure 18.** Magnet with silicone sealant (example).

- Bond previously removed magnet (refer to Figure 18) into gearbox housing using silicone sealant (part number: D 176 501 A1).

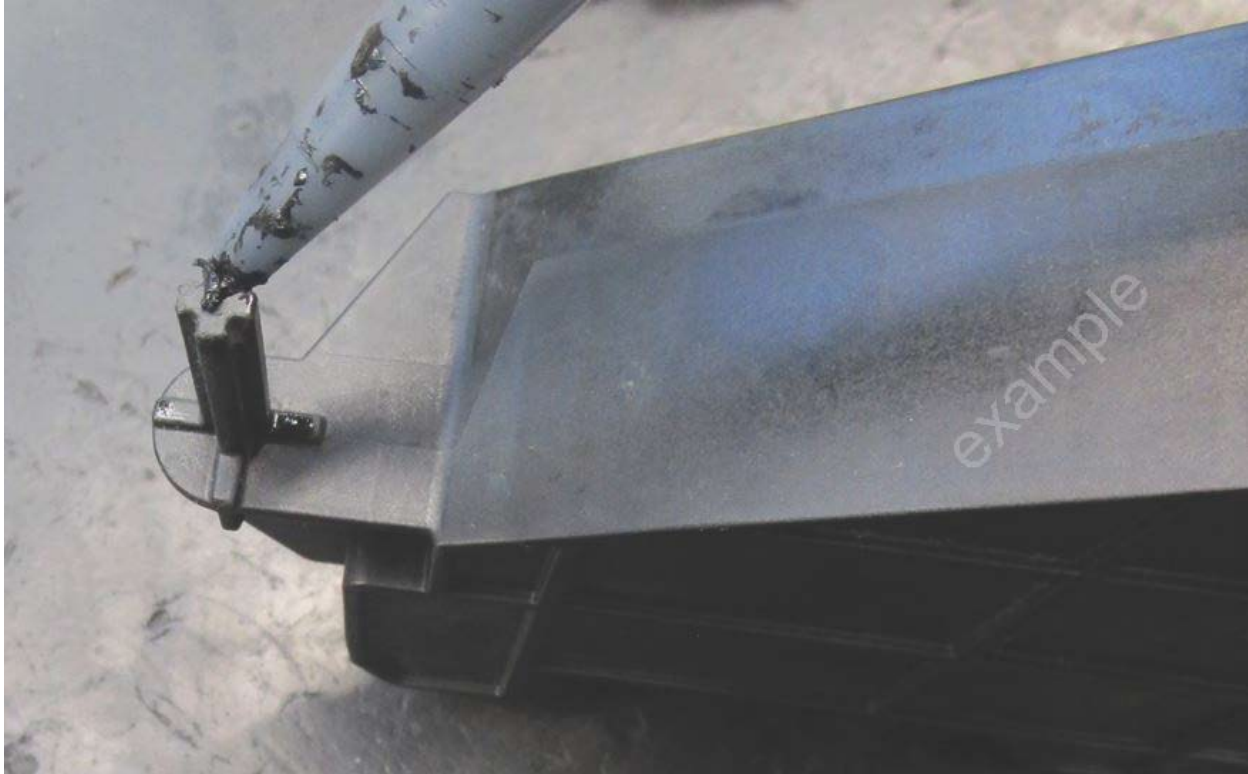
**Figure 19.** *Lightly applying silicone sealant to attachment point (example).*

- Lightly apply silicone sealant (part number: D 176 501 A1) to previously removed oil reservoir at 3 attachment points (refer to Figures 19 and 20) with.

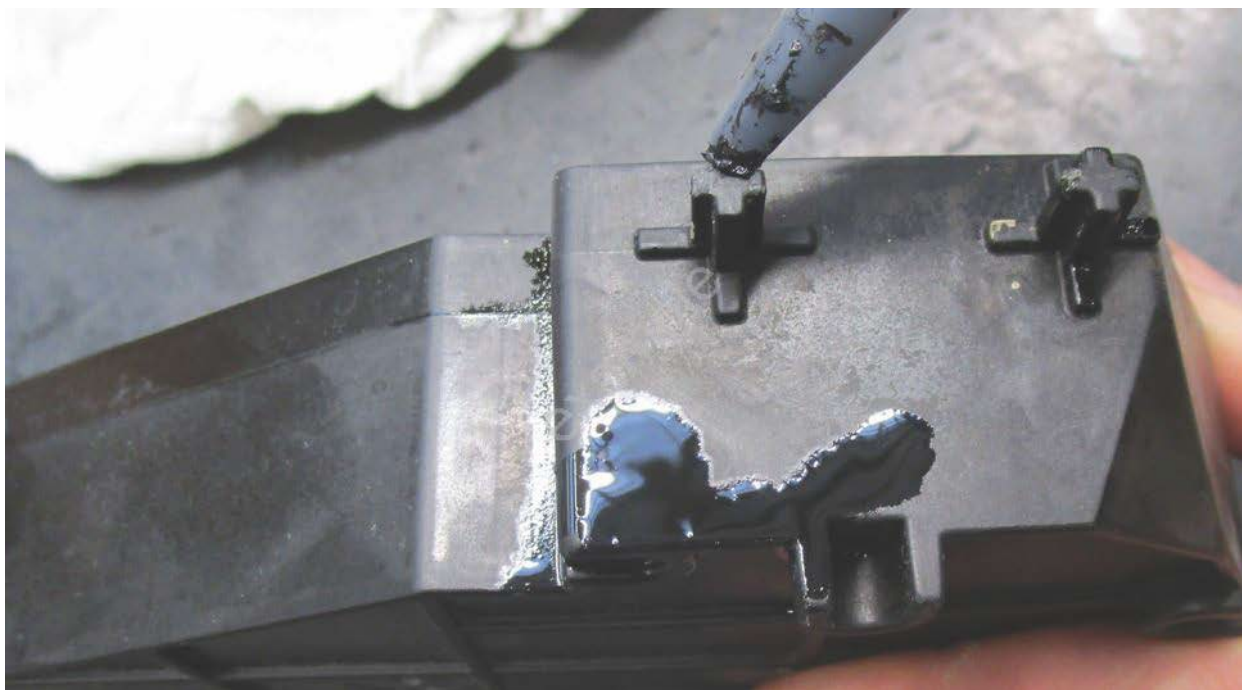
**Figure 20.** Lightly applying silicone sealant to attachment point (example).

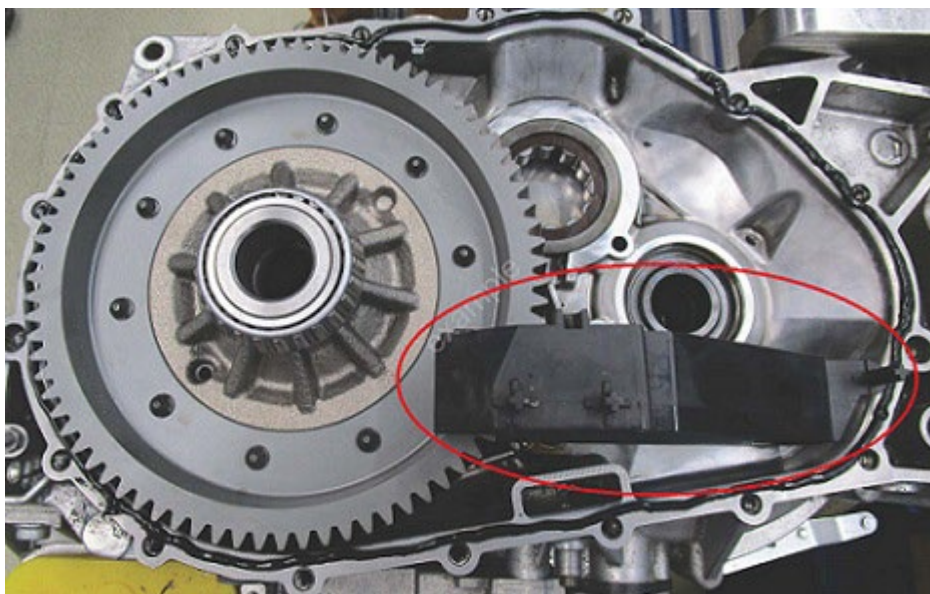
**Figure 21.** Oil reservoir fitted in intermediate housing.

- Fit oil reservoir (refer to Figure 21, red oval) in intermediate housing.

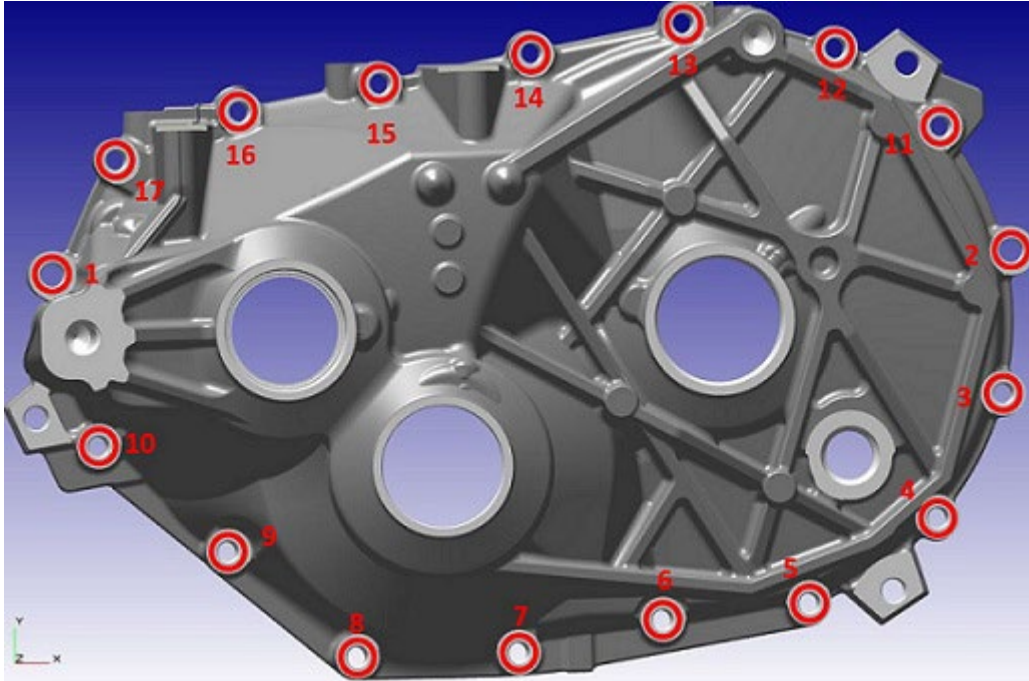
**Figure 22.** Installing multi-point socket head bolts; tightening torque 20 Nm + 90°.

- Install gearbox housing by screwing in new multi-point socket head bolts in the sequence 1 to 17 (refer to Figure 22); **tightening torque: 20 Nm + 90°**.
