# Technical Service Bulletin

## 93 e-tron GE various warning messages in the cluster, electric motor leaking P0AA600

93 25 52 2073858/6 January 23, 2025. Supersedes Technical Service Bulletin Group 93 number 24-46 dated December 19, 2024 for reasons listed below.

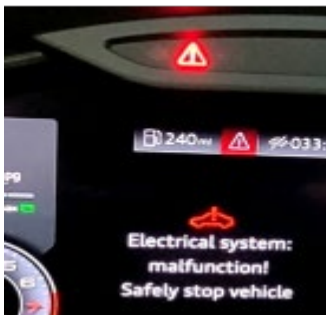
- A Drive System/Electrical System Malfunction message (Figure 1) appears in the in the instrument cluster; the warning may not be present at the time of inspection.

Figure 1. Warning lamp associated with message.

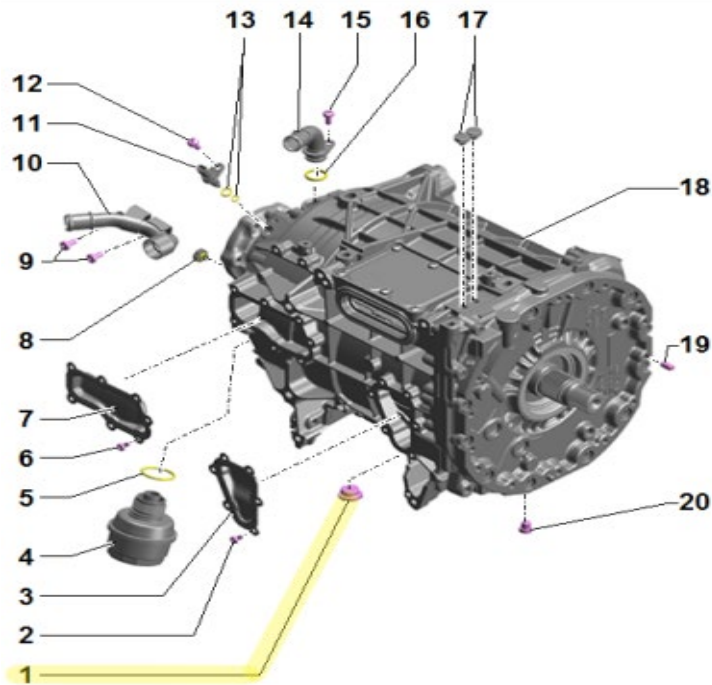
**Rear axle (Figure 2):**

Drip container is overflowing:

Coolant leaking from active chamber.

Drip container is empty:

Coolant leaking from active chamber, particularly on vehicles with low mileage.

Figure 2: (1) Drain plug.

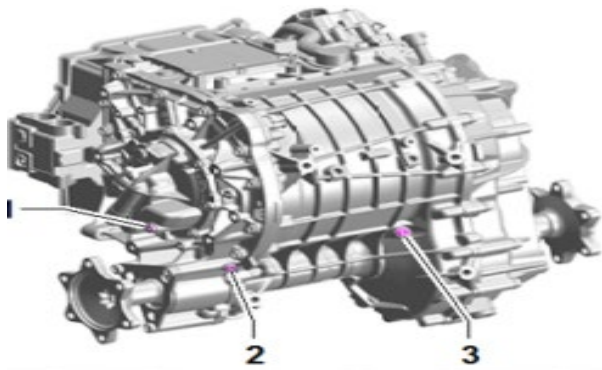
## Front axle (Figure 3):

Coolant leaking from active chamber.

Figure 3: 1) Resolver cover: A few milliliters of coolant leakage is not an issue from a technical perspective. 2) Active chamber: No coolant may escape from the bores.

**The power electronics must not be replaced if the electric drive motor is leaking.**
