Technical Service Bulletin

01 MIL on - DTC: U060B00 stored in engine control unit

01 25 53 2074392/2 January 30, 2025. Supersedes Technical Service Bulletin Group 01 number 24-29 dated July 3, 2024 for reasons listed below.

| Model(s) | Year | VIN Range | Vehicle-Specific Equipment |
|---|---|---|---|
| Q5 | 2022 – 2025 | All | Not Applicable |

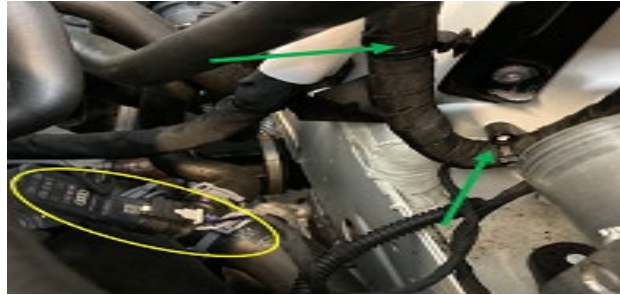
Figure 1: G31 and connector

Under certain conditions, vibrations may cause the wiring on electrical connector T3y to break.

Check wiring on electrical connector T3y for charge pressure sender -G31- for damage (see yellow circle on figure 1).

Disconnect electrical connector T91 on the engine control unit and loosen the wiring harness at the two mounting points (green arrows in Figure 1) to gain better access.

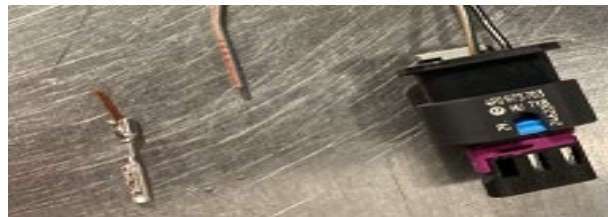
Figure 2: Wire damaged inside G31 connector

The damage may only be noticeable after de-pinning the connector or removing the harness tape.

If damage is found at the G31 connection, repair as follows:
