Service Alert

Mazda North American Operations
Irvine, CA 92618-2922

**360° VIEW MONITOR SYSTEM AIMING PROCEDURE IS
UNSUCCESSFUL**

Service Alert No.: SA-003/25

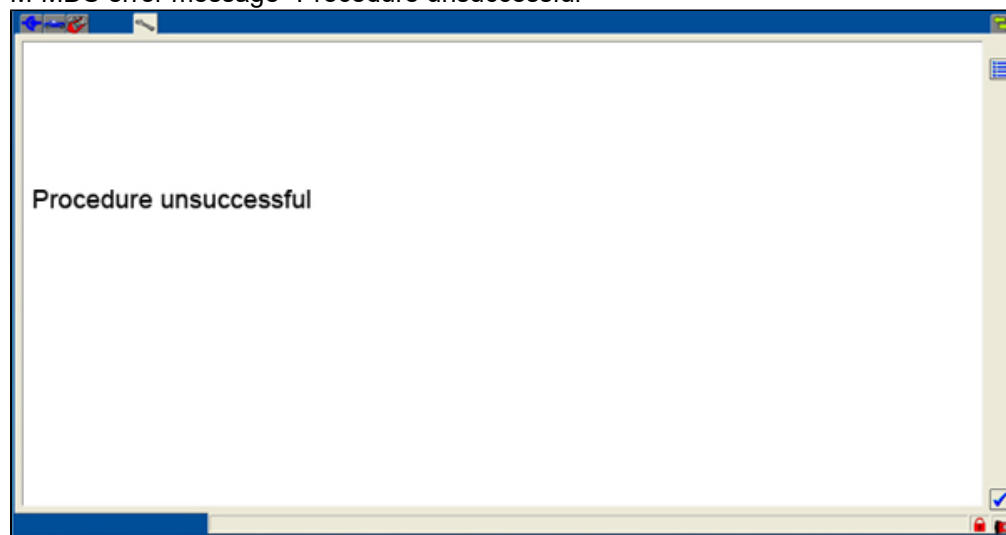
When performing the MGSS Workshop Manual [360° View Monitor System Aiming Procedure](#), M-MDS may show error message "Procedure unsuccessful". This may be caused by light glare on the SST.

M-MDS error message "Procedure unsuccessful"

This error message may be caused by light glare.
Light glare can be identified by using the center display as shown below:

If light glare is found using the center display, remove the light glare.
After light glare is removed, perform the aiming procedure again. M-MDS should now show "Procedure successful".
