01-22-03 - Late Production - Update Programming Engine/Motor Control Module -J623-

Release date: 1/9/2025

Applicable Vehicles					
Model(s)	Year	Eng. Code	Trans. Code	VIN Range From	VIN Range To
Jetta	2020 - 2021	1.4T DGXA	All	All	All

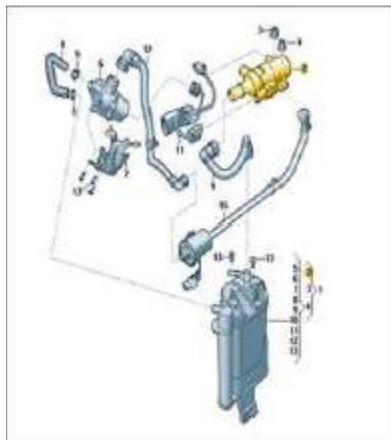
Figure 1.

In addition to the software improvement, there is also an improvement to the FTIV (fuel tank isolation valve/tank switch-off valve -N288-) (Figure 1.), which is necessary in preventing erroneous occurrences of the P2421 fault code.

The FTIV / Tank switch-off valve -N288- currently installed on the vehicle must be inspected, to verify whether an improved part has already been installed. The FTIV / Tank switch-off valve -N288 is mounted to the EVAP canister assembly, as shown below.

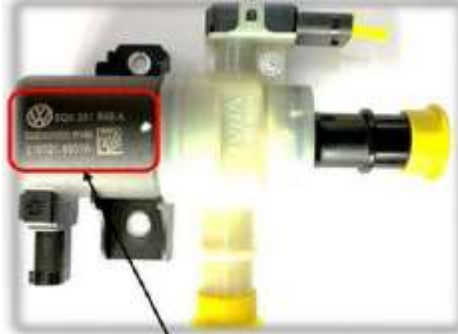
Figure 2.

Remove the EVAP canister assembly and inspect the face of the FTIV / Tank switch-off valve -N288. If the part is already updated, it will have a white paint marking or "02S" printed after the part number, as shown in Figure 2 and Figure 3.

If the part has a white paint mark or "02S", the FTIV / Tank switch-off valve -N288- is already the updated component. In this case DO NOT replace it, and instead reinstall the EVAP canister assembly. Only the software update will be required.

If there is no white paint mark or "02S" are visible on the FTIV / Tank switch-off valve -N288, the component must also be replaced in addition to the software update. Always refer to ETKA for the most up to date part number information.
