91-25-01 - MIB Display Image Distorted

Release date: 1/9/2025

Applicable Vehicles					
Model(s)	Year	Eng. Code	Trans. Code	VIN Range From	VIN Range To
Atlas, Atlas Cross Sport	2024 - 2025	All	All	All	All

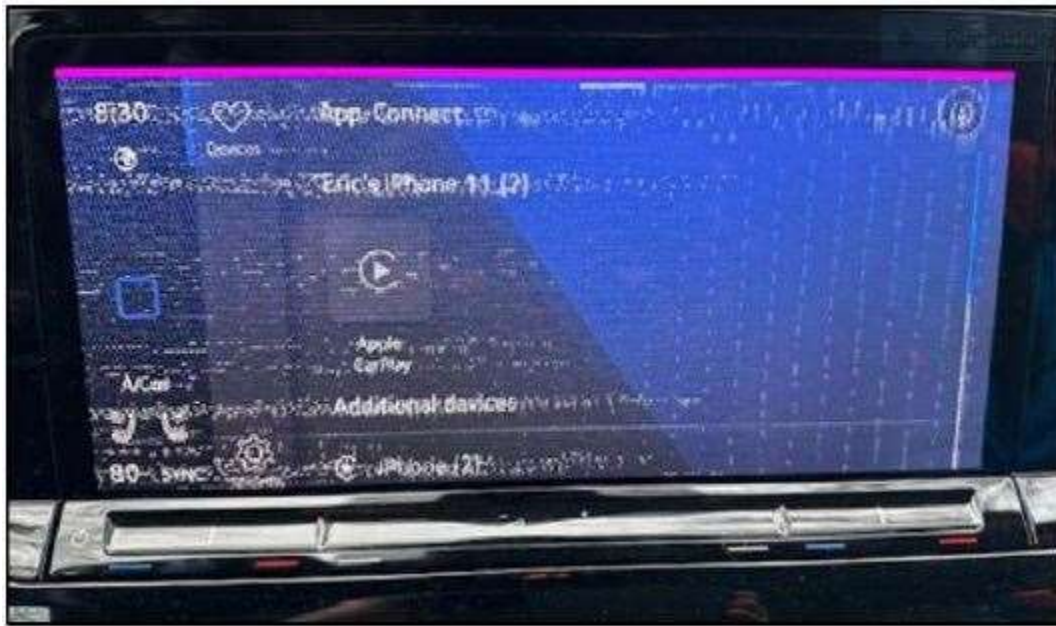
Fig. 1

The customer may complain that the image on the MIB display may appear distorted (see Figures 1 & 2).

This procedure resolves the concern specified above by updating the MIB Display -**J685**- to the latest software level **6098**.
