**26-19-01 - AdBlue® Warning and or MIL ON - Ad Blue® Leakage at Reductant Injector**

Release date: 01/30/2025

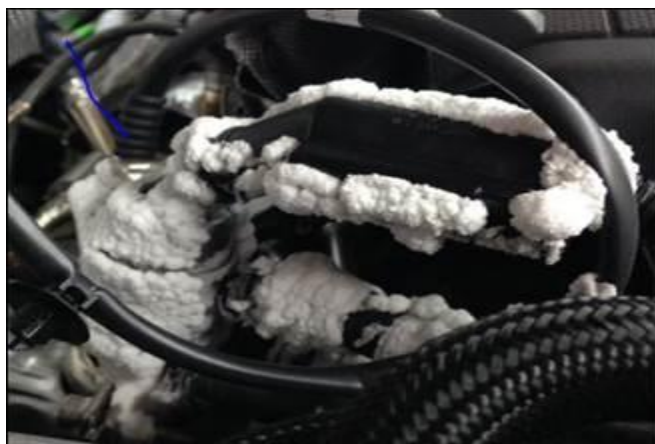
Welding process issues of the reductant line connector to the supply line may cause AdBlue® leakage at the reductant injector.

Inspect the connection of the reductant supply line connector at the reductant injector in the engine compartment. If white crystalized (dried) AdBlue® is found at the reductant injector (see Figure 1 & 2), it will be necessary to replace the reductant supply line.

Thoroughly clean the area of the reductant supply line connection with water to remove the crystallized AdBlue®.

Replace the reductant supply line.

Refill reductant agent as required per part table quantity.
