STAR ONLINE PUBLICATION

Case Number: S2508000002 Rev. A

Symptom/Vehicle Issue: Mapping Interface Module (MIM) Erroneously Sets Diagnostic Trouble Codes (DTCs) B023C-49 and or U115C-00

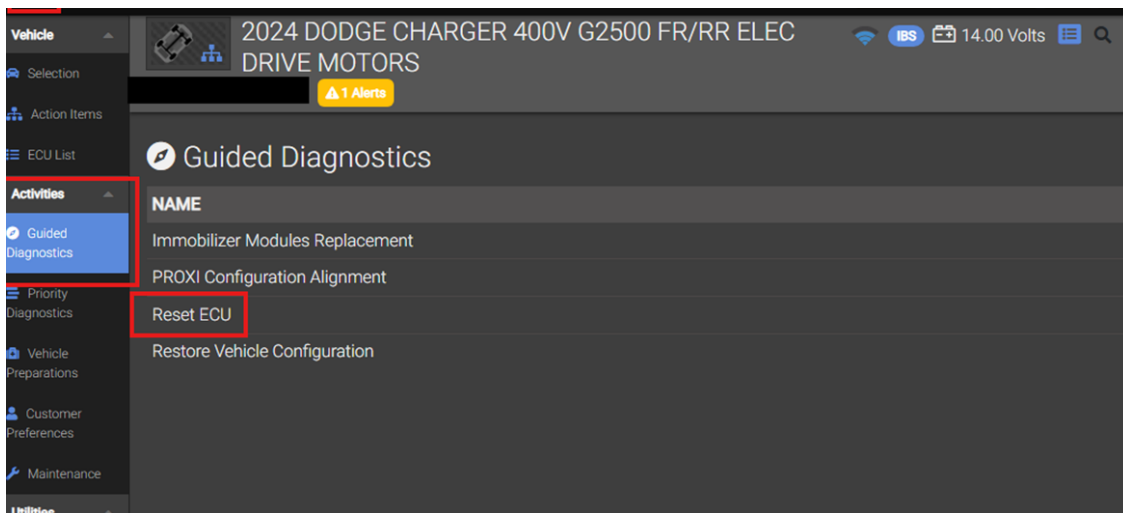
Technician Observation: Technician observed the MIM module setting DTCs B0239C-49 DASHCAM Module 1 Internal Electronic Failure and/or U115C-00 Lost Communication With ETM.

Repair Procedure: If these DTCs are observed, clear the DTCs, perform a reset ECU as listed in the Guided Diagnostics for the MIM module, then allow a sleep cycle. Re-connect the scan tool and verify that the DTCs do not return, if the DTCs do return, then continue with the Service Library (SL) diagnostic procedure(s) as needed. Engineering is investigating the concern relating to the DTCs setting erroneously and they will notify the field when updates are available.
