# Subject: Transmission Fluid Leak Near Torque Converter Housing Area

***This bulletin only applies to 8T65/45 or 9T45/50/60/65 transmissions.***

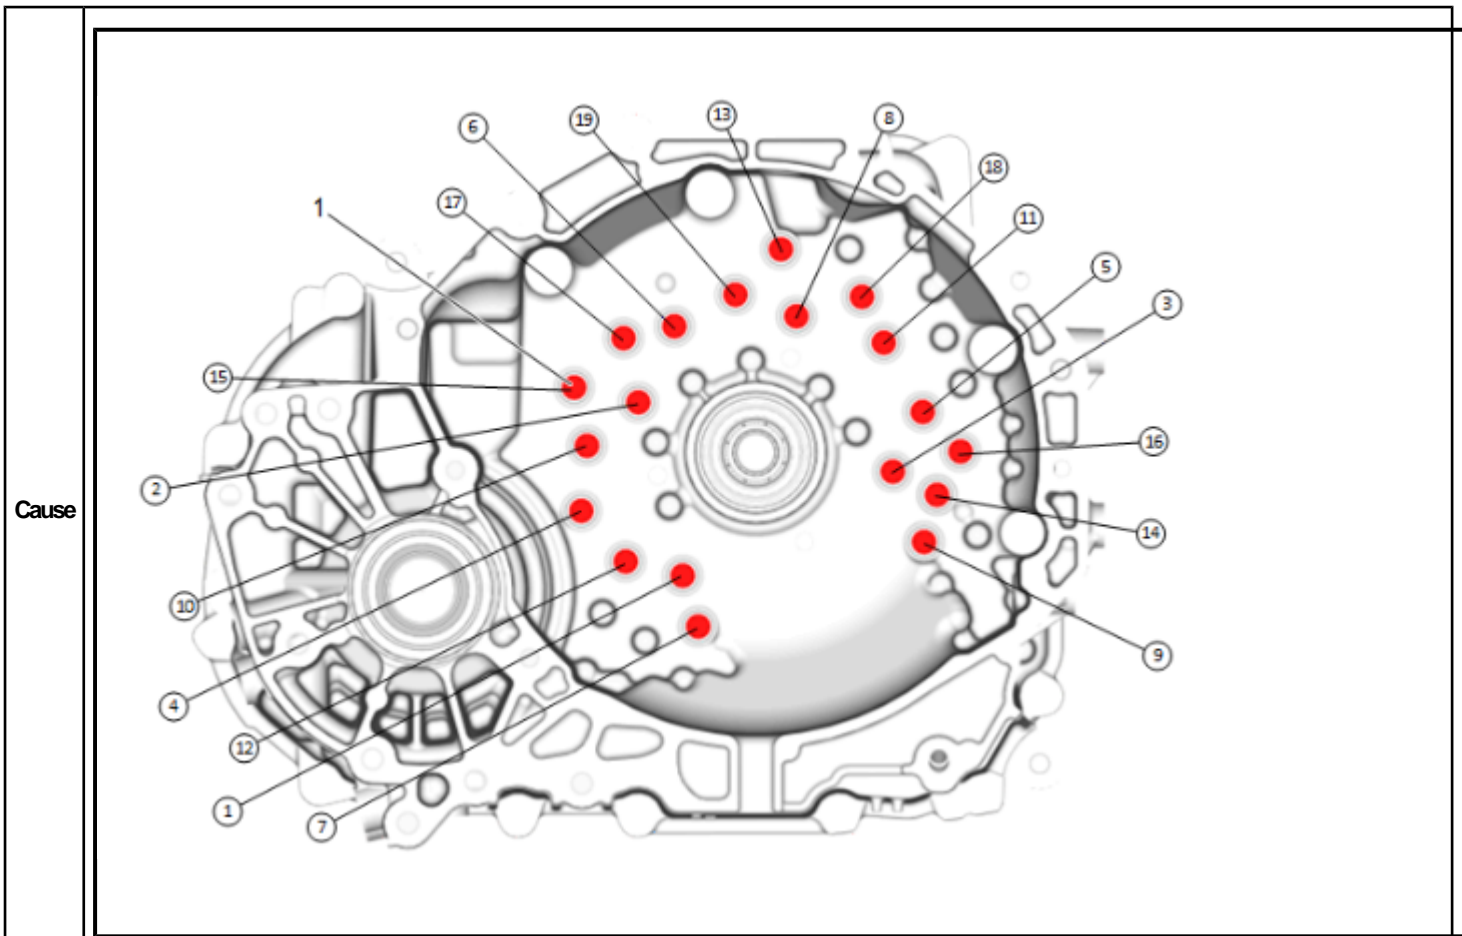
6419117

This condition may be caused by the transmission pump bolts were not fully torqued.

- If the transmission Julian date is between 24 171 and 24 292 and the vehicle comes in with a transmission leak in the torque converter housing area, order the bolts required.

- Once the bolts have arrived, remove the transmission, and verify that the bolts are loose.
- If loose, replace all the bolts and reinstall the transmission.
