TECHNICAL SERVICE BULLETIN- "THIS IS NOT A RECALL"

DOC #	PROCESS NAME	PAGES	BY	DATE
TSB 2307	VDRIVE Re-Torquing / Verifying V-Drive Flange Bolts PLATE BOLT	1	BFisher	07/05/2023

Vehicles Affected: 2021-2023 Spirit of Equess. If you have questions, contact ARBOC Specialty Vehicles @ 1-866-953-5555.

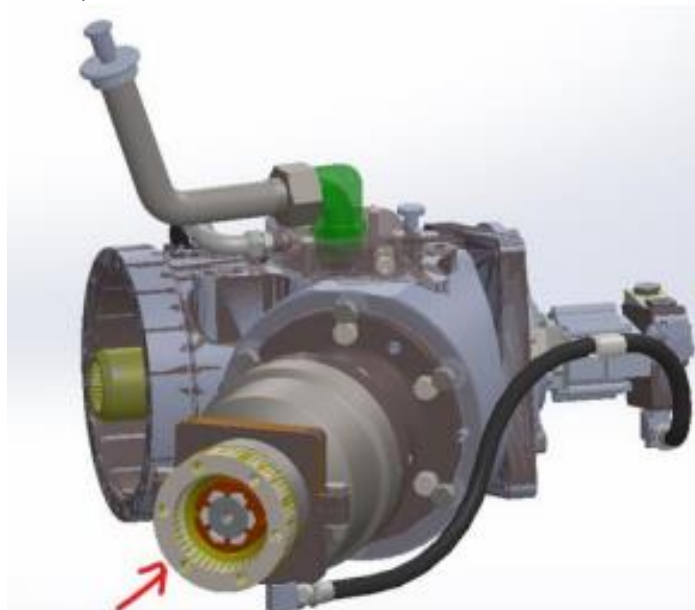
The purpose of TSB 2307 is to alert Dealer/Owner of the potential issue. **THIS IS NOT A RECALL**

1. Remove driveshaft to Vdrive adapter bolts (QTY 4).
2. Support driveshaft and disconnect from Vdrive adapter plate.
3. Install 2 driveshaft bolts into driveshaft plate to hold adapter while torquing the adapter plate bolts to the Vdrive. See photo below.
4. Torque bolts to 90 ft/lbs
5. Remove 2 driveshaft bolts from adapter plate and reconnect driveshaft to adapter plate.
6. Install driveshaft bolts and torque to 90 ft/lbs.
