Service Bulletin

Bulletin No.: 25-NA-015

Subject: Information on Accessory Rocker Panel Molding Ground Lamp Package Incorrect Terminal

Brand:	Model:	Model Year:		Build Date:		Engine:	Transmission:
		from	to	from	to		
Cadillac	Escalade IQ	2025	2025

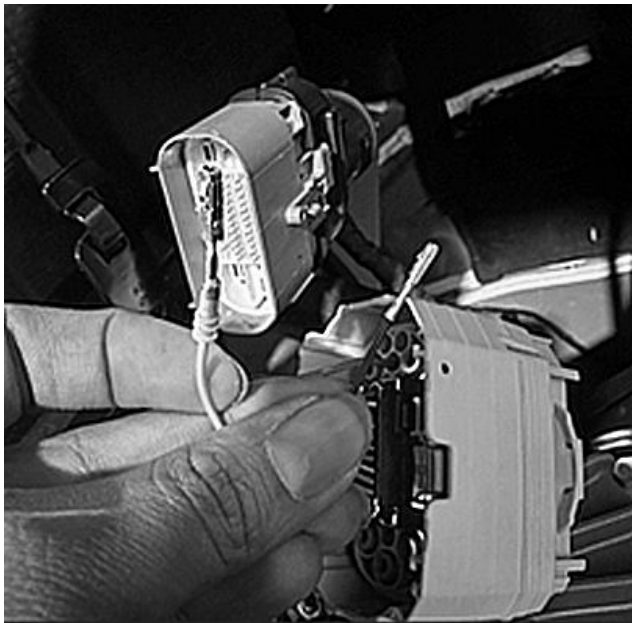
<p data-bbox="1420 1444 1492 1467">6819489</p> <p data-bbox="526 1467 1189 1489">Note: Black wire removed from electrical connector for clarity.</p> <p data-bbox="526 1496 1476 1568">During installation of the accessory rocker panel molding ground lamp package, the included accessory harness for the passenger side may have a terminal that is double in size vs. the terminal taken out of cavity 12 of engine harness connector X111.</p> <ul data-bbox="526 1579 1476 1624" style="list-style-type: none"> - Gray wire with larger incorrect terminal included in accessory wire harness. Black wire from vehicle X111, cavity 12.

Cause	Incorrect oversized terminal installed on the passenger side accessory wire harness on the gray wire.
Correction	<ol style="list-style-type: none"> 1. Cut off the larger terminal from the gray wire on accessory harness. 2. Leave the black wire and terminal in cavity 12 of the X111 electrical connector. 3. Cut the black wire approximately 1 inch from the electrical connector and apply Woven Polyester Electrical Tape (PET) to cover over end of the terminal side wire. 4. Using an appropriate gauge dura-seal butt splice, connect the gray accessory side and black harness side wire together. 5. Secure the wire with PET tape. 6. Verify the operation of the rocker molding lamps.
