Service Bulletin

Bulletin No.: 25-NA-003

Subject: Rattle Type Noise Heard from Brake Pedal Area

Brand:	Model:	Model Year:		VIN Breakpoint:		Engine:	Transmission:
		from	to	from	to		
GMC	HUMMER EV	2025	2025	—	—	—	—

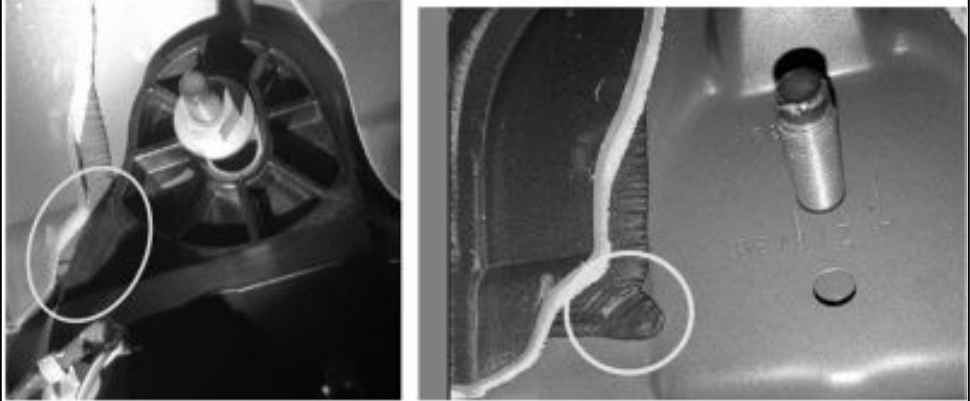
6805453

<p>This condition may be caused by excess body seam sealer was found extending under the brake pedal housing near the sky bolt (single bolt on top of the housing), as shown in the picture above.</p>
<p>Correction</p>	<p>Trim back the excess body seam sealer following the procedure below.</p>

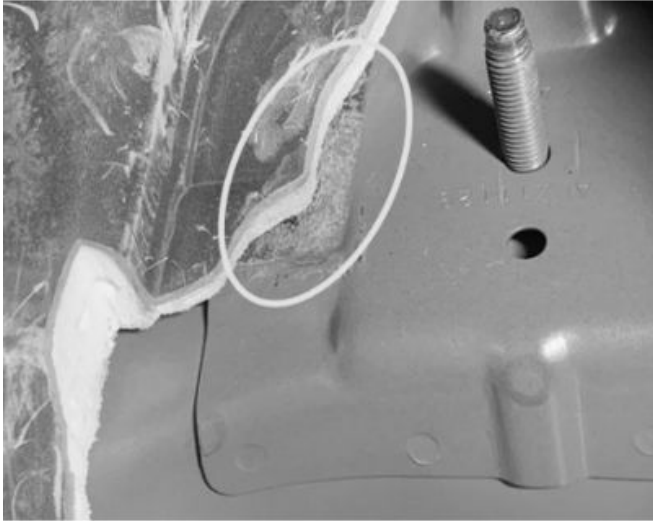
6805499

1. Verify brake pedal does rattle and/or produces a noise
2. Remove the brake pedal assembly. Refer to *Brake Pedal Assembly Replacement* in SI.
3. Locate the excess body seam sealer.

4. Remove the section of sealer that is making contact to the brake pedal, as shown in the picture above, using an appropriate scraping tool.
