SERVICE ACTION

Global Service Action
Number: N961

Blanking Connector - Install	Publication No.: N961
	Model: Defender (LE)
	Model Year: 2025
	Date of Issue: 23 January 2025
	Expiry Date: 31 January 2027

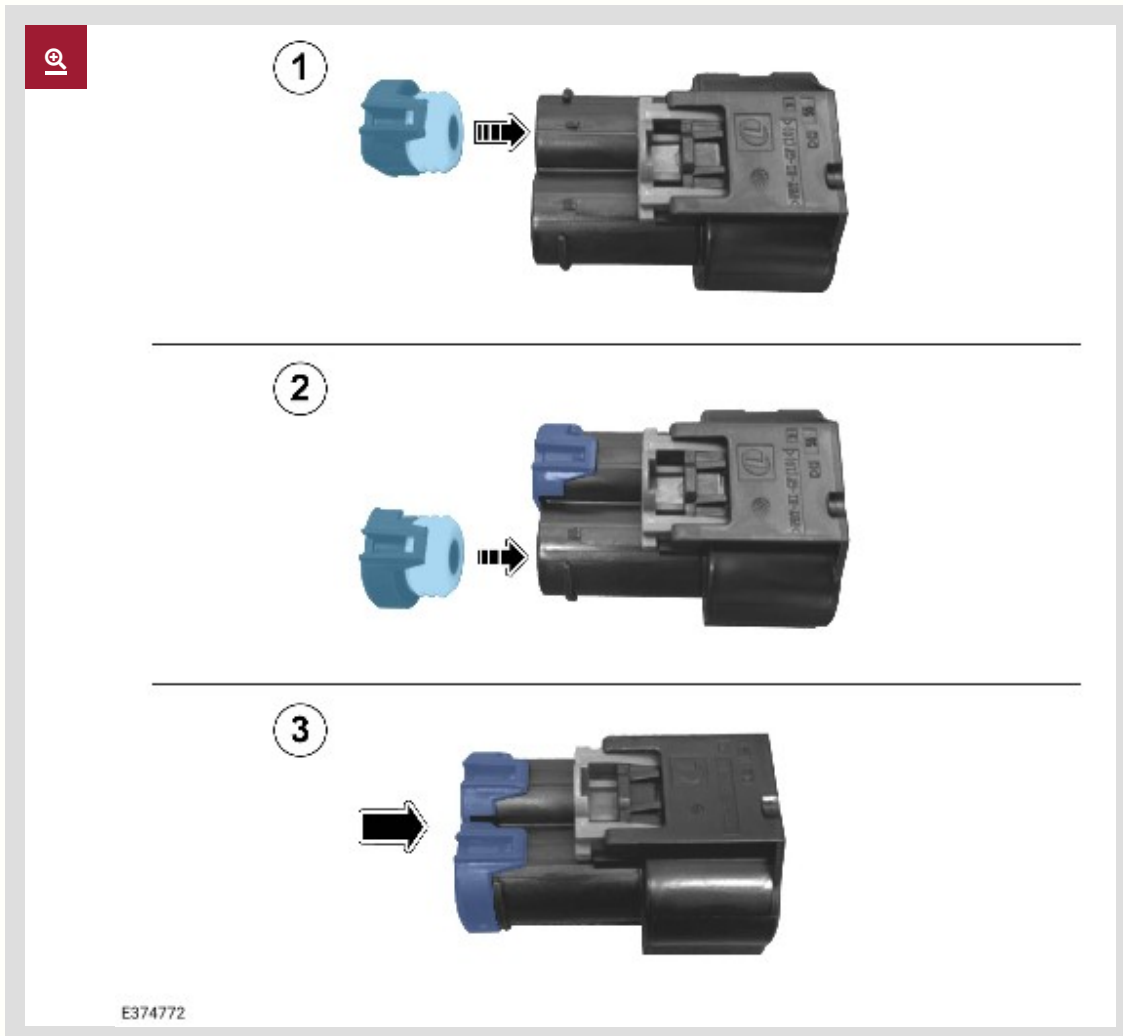
On certain 2025 model year Defender vehicles, a junction box blanking connector is missing.

2. Install the 2 new sealing caps into the new connector housing as shown in the illustration.
