TECHNICAL SERVICE BULLETIN

ISSUE DATE:	6/29/2020
REVISION DATE:	7-13-2022
SERVICE BULLETIN SUBJECT:	Side Window Seal Retrofit
VINs or MODELS AFFECTED:	Service Specified Buses
COMPLETE BY:	Next Service Opportunity
SERVICE BULLETIN #:	SB-20-85

SIDE WINDOW SEAL RETROFIT

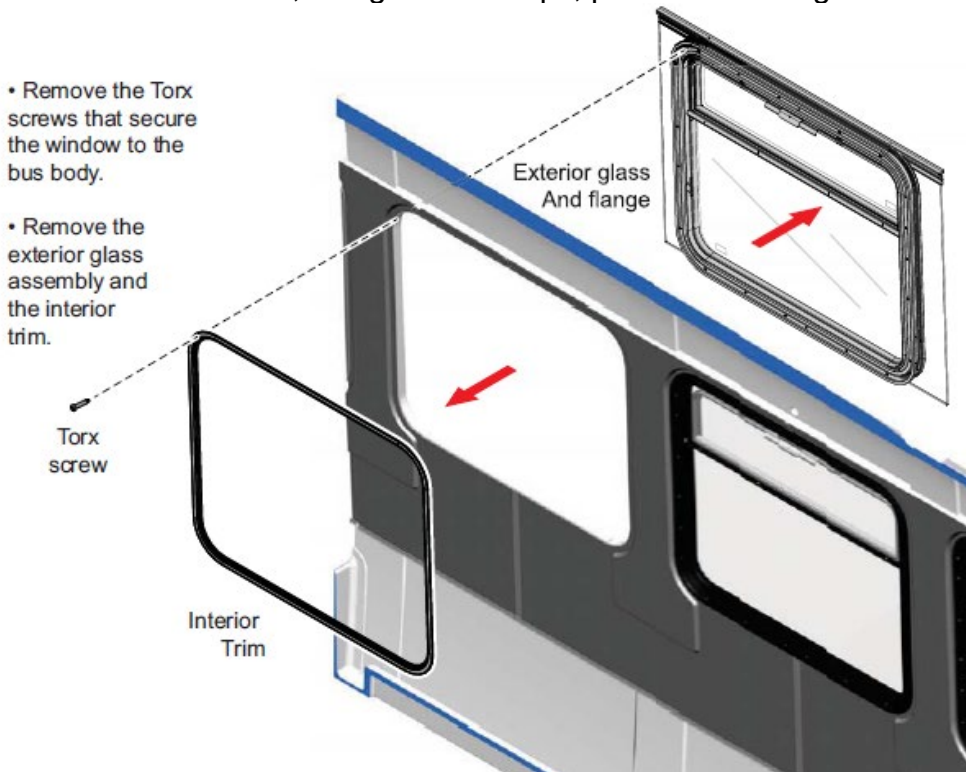
1. Complete the Proterra approved Lockout/Tagout procedure to make the bus safe for work.
2. On the interior of the bus, remove the side window trim (**031241**) that covers the fasteners securing the side window in place and mark the trim location using tape and a marker.
3. On the interior of the bus and working one window at a time, using a T-20 Torx Bit and Drill Driver, remove all Torx screws securing the side window.
IMPORTANT! Ensure the exterior window glass and frame are properly supported on the exterior of the vehicle, using suction cups, prior to removing all the Torx screws.
