Service Bulletin

Bulletin No.: PIE0811A

Subject: Engineering Information - Service Engine Soon, Service Emission System, and/or Service Exhaust Fluid System Message on Driver Information Center (DIC), DTCs P249C, P20E8 Set

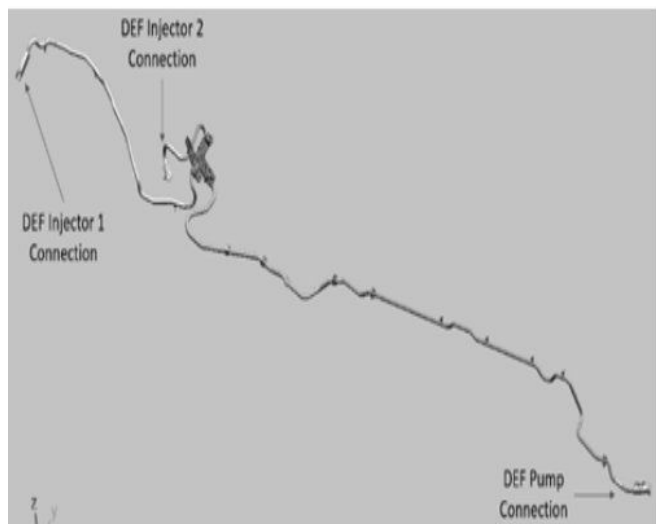
6793855

- 1.2. If no, is there a leak at the Emission Reduction Fluid Exhaust Front Pipe Injector Supply Pipe, or at one of the two connections to the Reductant Fluid Injector, or the Emission Reduction Fluid Pump Outlet Port, as shown in the picture above.

- 1.3. If no, refer to SI for the diagnostic procedure for DTC P249C and/or P20E8.
- 1.4. If yes, is the Emission Reduction Fluid Exhaust Front Pipe Injector Supply Pipe or the connector damaged in any way?
- 1.5. If yes, replace the Emission Reduction Fluid Exhaust Front Pipe Injector Supply Pipe, perform a Reductant System Tamper Warning Service Bay Test, and release the vehicle back to the customer.
- 1.6. If no, contact the engineer listed below first, **then** follow the Cleaning Procedure outlined below, perform a Reductant System Tamper Warning Service Bay Test, and release the vehicle back to the customer.

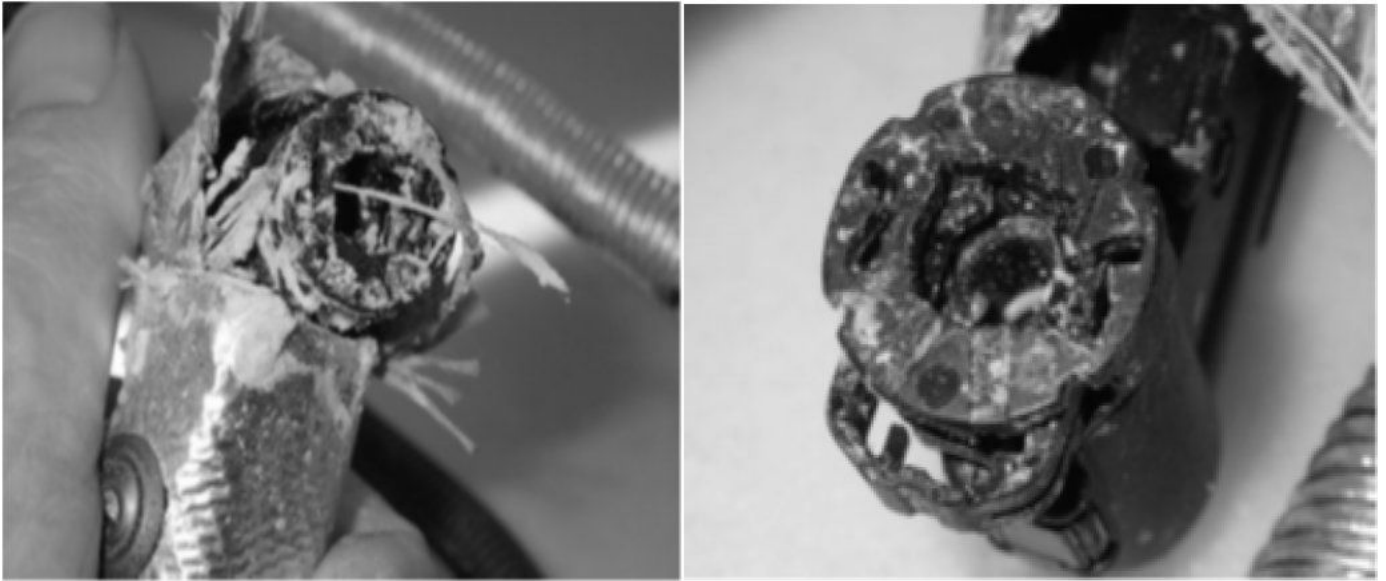
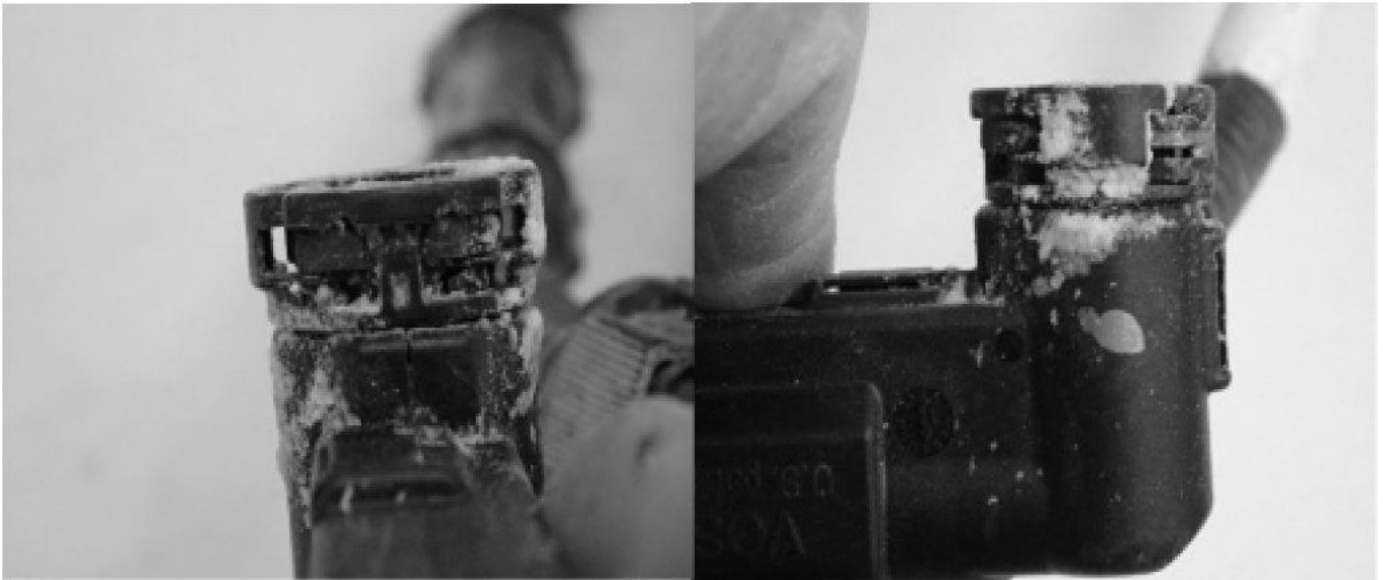
The Emission Reduction Fluid Exhaust Front Pipe Injector Supply Pipe may be contaminated with crystallized DEF in or around the connector, as shown in the pictures above. This procedure outlines the correct cleaning procedure before attempting to re-connect the Emission Reduction Fluid Exhaust Front Pipe Injector Supply Pipe to the Reductant Fluid Injector or the Emission Reduction Fluid Pump Outlet Port.

1. Fill a clean container with fresh DEF.
2. Remove or pull back the heat protecting hood from the Emission Reduction Fluid Exhaust Front Pipe Injector Supply Pipe connector end if present.
3. Fully disconnect the Emission Reduction Fluid Exhaust Front Pipe Injector Supply Pipe connector from the Reductant Fluid Injector or the Emission Reduction Fluid Pump Outlet Port by following the Removal Procedure outlined below (detach any clips or liners as needed for access). Wipe off any dust or dirt present on the outside of the connector.

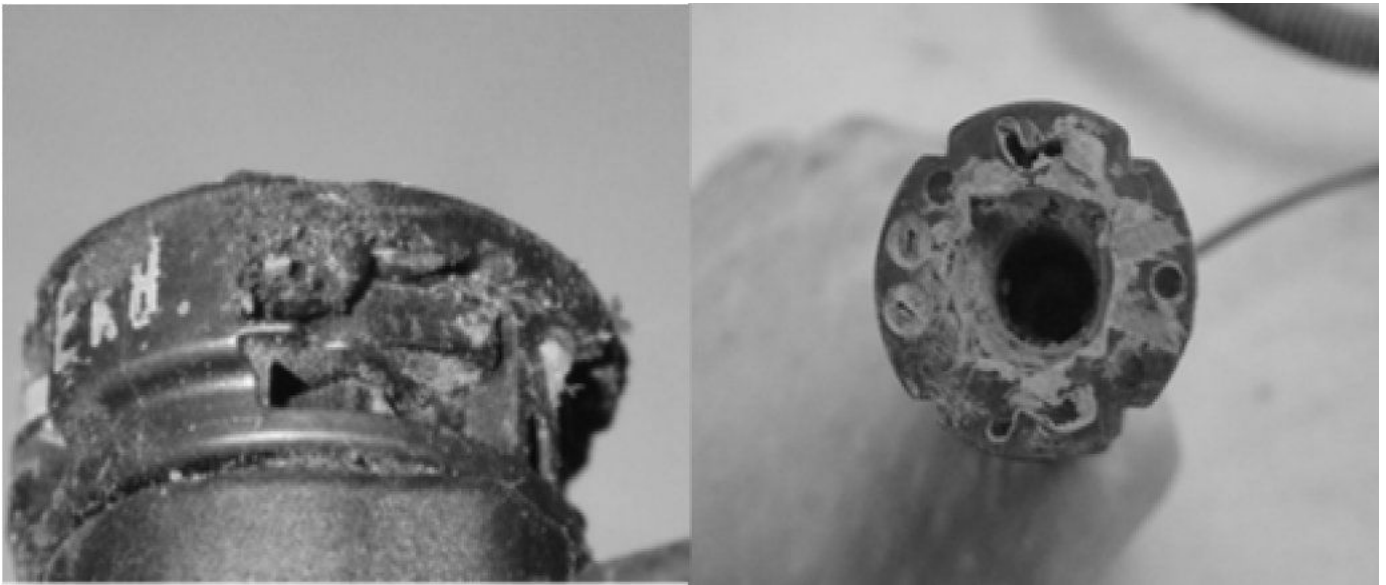
6793865

Note: This procedure cannot be performed if the Emission Reduction Fluid Exhaust Front Pipe Injector Supply Pipe connector is contaminated with other forms of contaminants such as frame wax or dirt inside the connector, as shown in the picture above. If this is the case, DO NOT perform the cleaning procedure as the Emission Reduction Fluid Exhaust Front Pipe Injector Supply Pipe will need to be replaced.
