# Service Bulletin

Bulletin No.: 20-NA-175

**Subject: Vertical Misalignment Between Cab and Pickup Box on Driver Side of Vehicle**

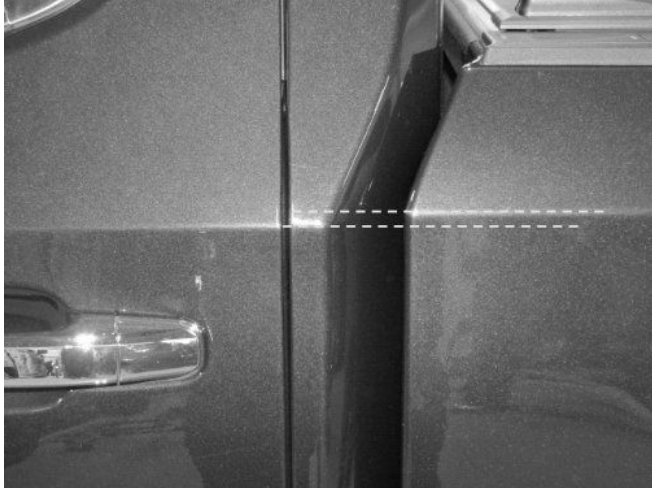
<p style="text-align: right;">5645798</p> <p>Some customers may comment on noticing anywhere from 2 –10 mm (0.08 – 0.4 in.) vertical misalignment of the body feature line between the cab and the pickup box, on the driver's side of vehicle.</p>
<p><b>Cause</b></p>	<p>The cause of the condition may be pickup box structure variation.</p>
<p><b>Correction</b></p>	<p>Realign the left side of the cab and install shim washers, following the steps in the Service Procedure below.</p>

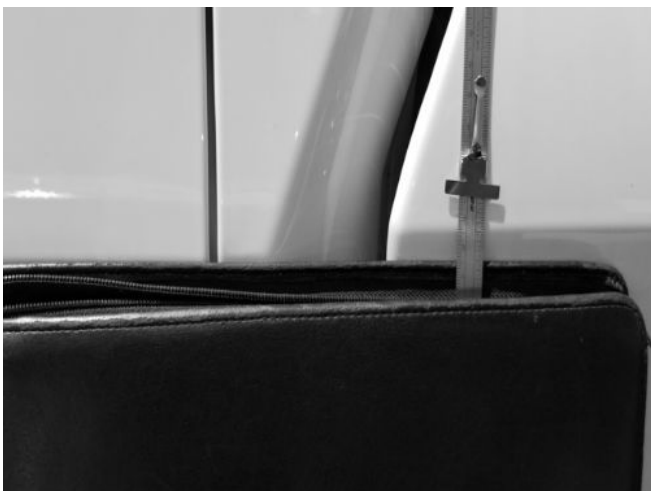
5645804

1. Verify the condition by visually checking, and measuring, the body feature line variance, on the left side of the vehicle.
