McLaren Artura Engine Oil Leak Diagnosis Guide – Oil Cooler

Location: Powertrain

Topic: McLaren Artura Engine Oil Leak Diagnosis Guide - Oil Cooler

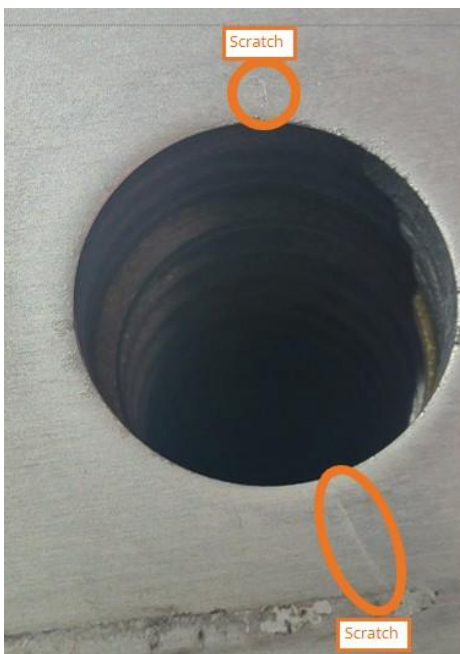
17. Inspect oil cooler face, and through holes escalate any concerns for review on TR providing images Example:

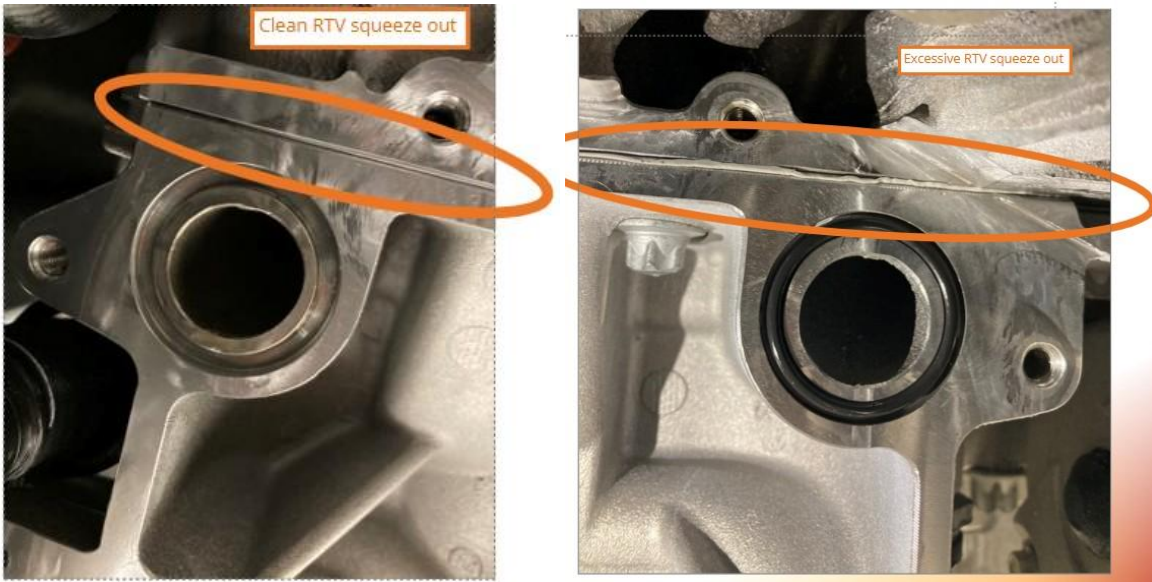
18. Inspect block interface for RTV Squeeze out, escalate if concerned with squeeze out on TR to the Technical Support team

Example of clean face vs high squeeze out:

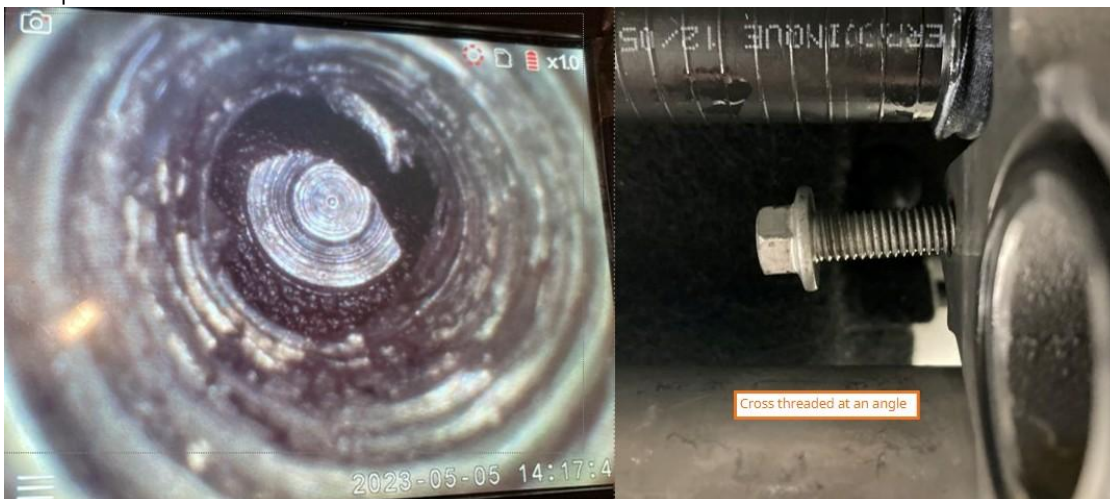
19. Check the block threads, are these clean and the bolts have not been fitted cross threaded/damaged?

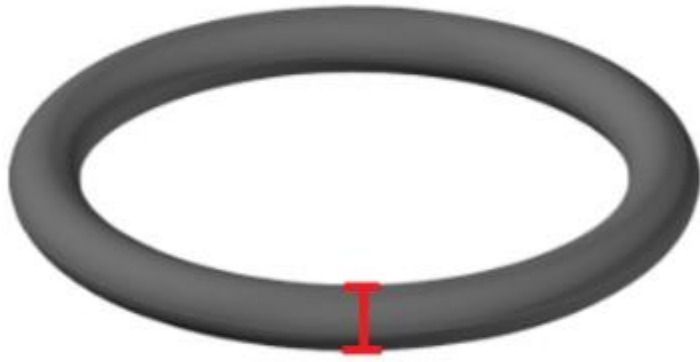
Cross section Measurement

20. Measure cylinder block o ring recess using the document attached in the link Measurement of Cylinder Block

22. Replace oil cooler seals with seals advised by Technical Support ensuring new seals and new bolts are used as per MSP instructions
