McLaren Artura Transmission Oil Leak Diagnosis Guide

Location: Powertrain / Hybrid

Topic: McLaren Artura Transmission Oil Leak Diagnosis Guide

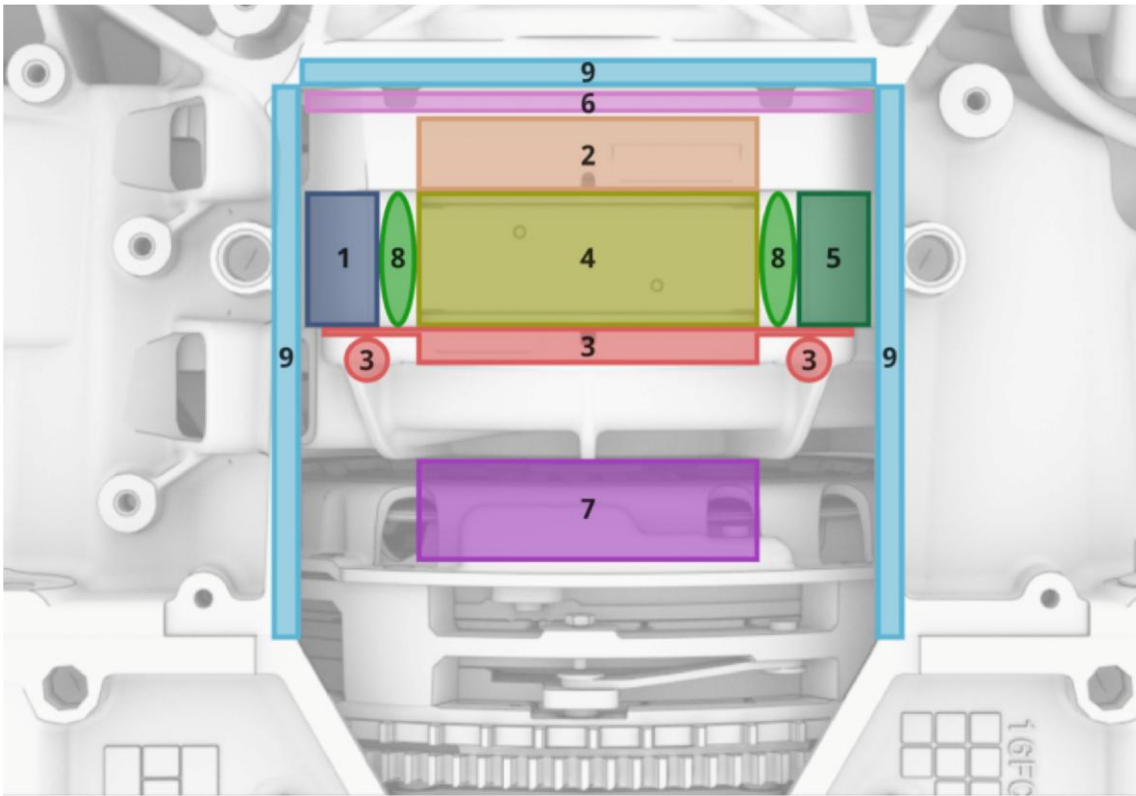
Oil Types				
Location	Clear dielectric oil, no UV reaction	Yellow tinge dielectric oil, hint of UV	New transmission oil, golden, green UV reaction	New engine oil, green UV	Red grease
1 Dark Blue					
2 Orange					
3 Red					
4 Yellow					
5 Dark Green					
6 Pink					
7 Purple					
8 Light Green					
9 Light Blue

14. If leak continues post cycle 5 please fill in table in accordance with the leak path map below. Check dielectric oil level when vehicle has cooled down and attach table, dielectric oil level and all images to a TR If no leak present after overnight dwell period, no further action required.
