E-Series	Model Description	Production Date
G45	X3 Sports Activity Vehicle	June 20, 2024 – October 15, 2024
G60	5 Series Sedan	
G70	7 Series Sedan	
G90	M5 Sedan	
U10	X2 Sports Activity Coupe	
U11	X1 Sports Activity Vehicle

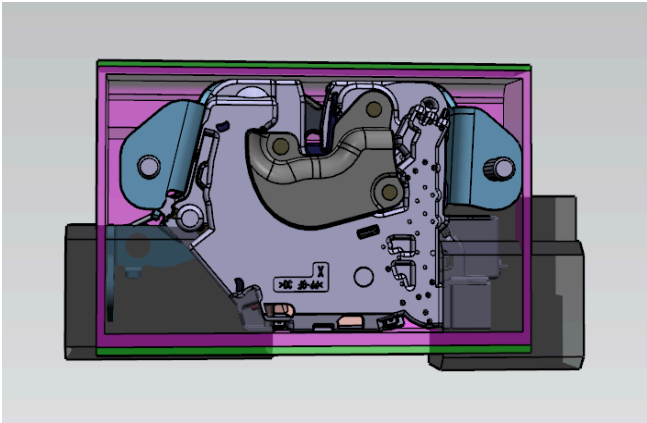
Due to changes in the opening mechanism of the trunk/tailgate latch, it is possible that the trunk/tailgate may not completely lock after closing it.

Replace the trunk/tailgate latch.

Replace the latch that secures the trunk/tailgate following the repair instructions listed in ISTA/AIR 51 24 100.
