SIB 52 01 25

## G70 FRONT DRIVER'S SEAT WIRING HARNESS IS CHAFED

E-Series	Model Description	Production Date
G70	7 Series Sedan	Vehicles produced up to June 12, 2023.

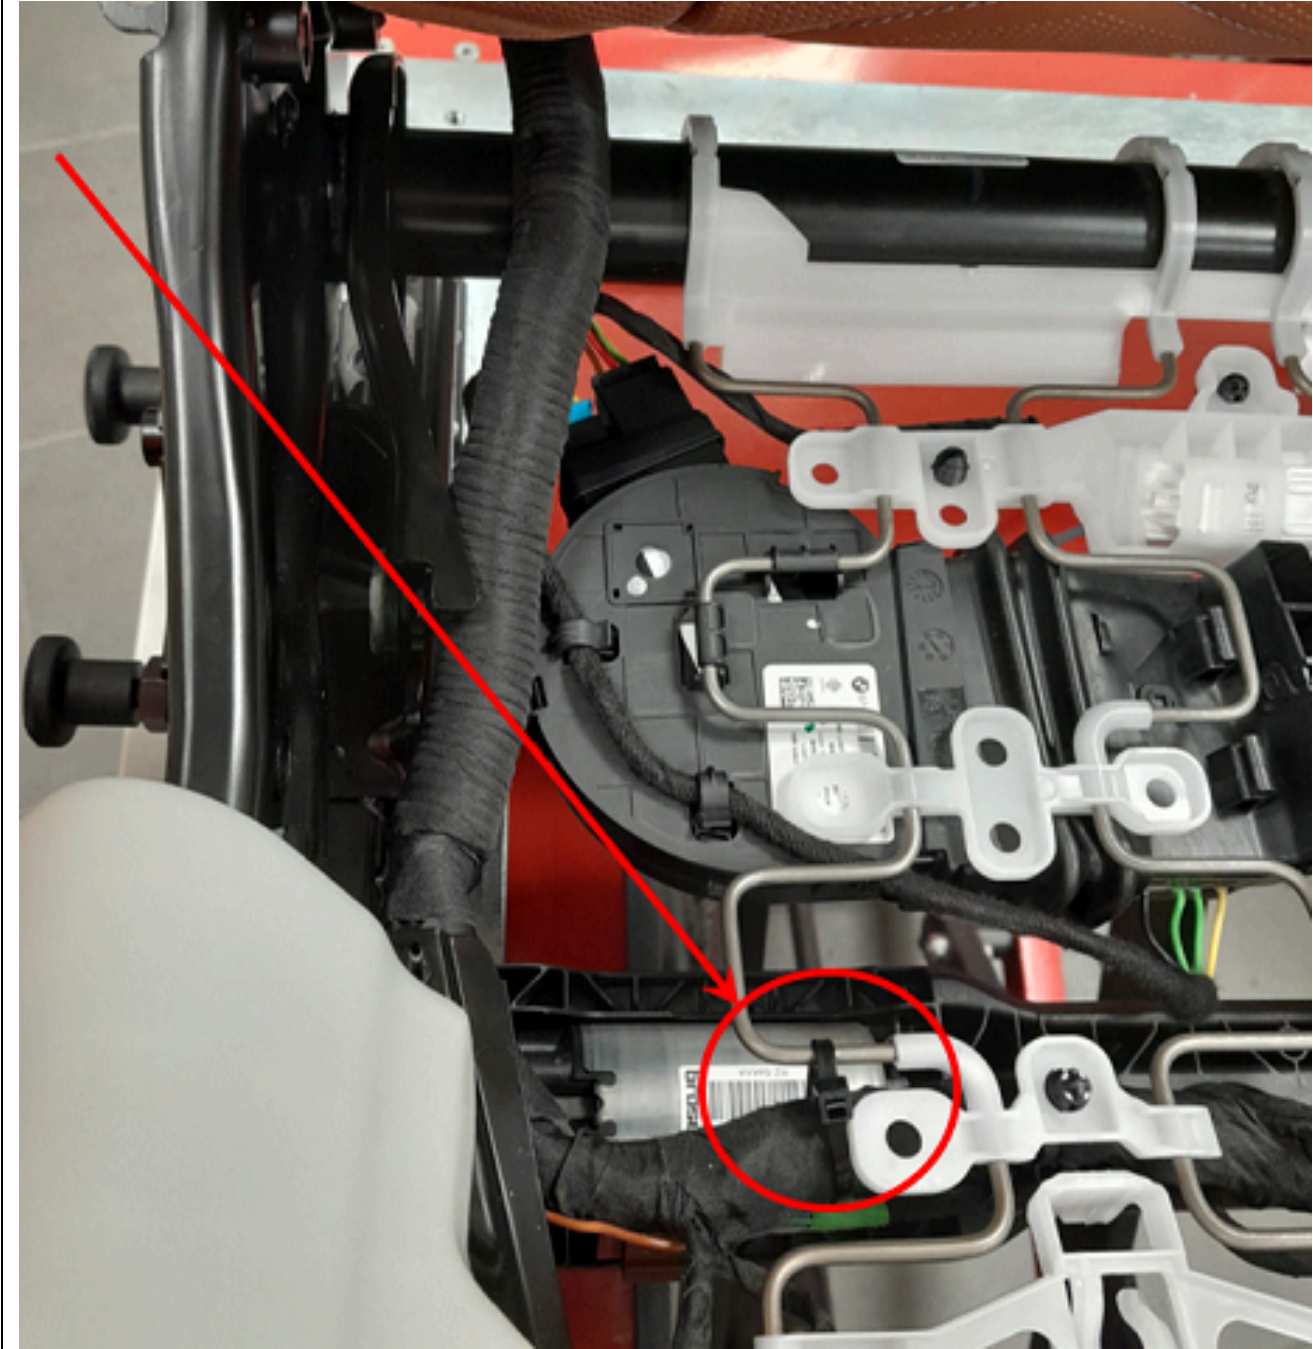
The screw-drive of the driver's front seat up/down adjustment may chafe the seat wiring harness depending upon seat height that is set.

See the following photo (image is showing seat frame assembly from above with seat covering material removed).

Install a plastic cable strap to hold the seat harness to the seat frame assembly to prevent contact.

Repair or replace the harness as needed and secure it with an additional cable strap during installation.
