Customer Satisfaction Program

N242478860 Heated Seat Icon Not Displayed on Virtual Cockpit Unit

Release Date: February 2025

Models: 2025 Chevrolet Blazer EV

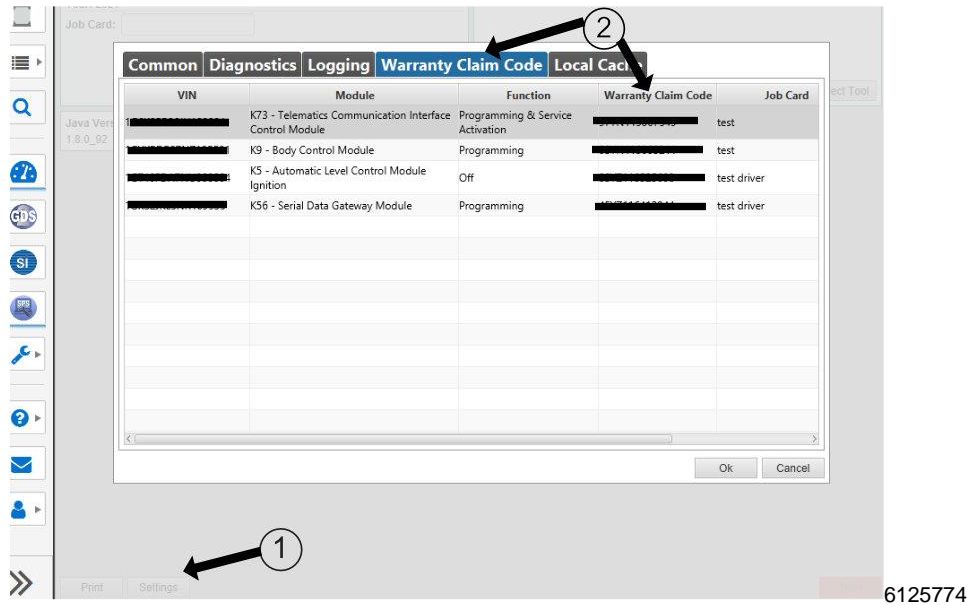
Warranty Claim Code Information Retrieval

If the Warranty Claim Code was not recorded on the Job Card, the code can be retrieved in the SPS2 system as follows:

1. Open TLC on the computer used to program the vehicle.
2. Select and start SPS2.
3. Select Settings (1).
4. Select the Warranty Claim Code tab (2).

The VIN, Warranty Claim Code and Date/Time will be listed on a roster of recent programming events. If the code is retrievable, dealers should resubmit the transaction making sure to include the code in the SPS Warranty Claim Code field.

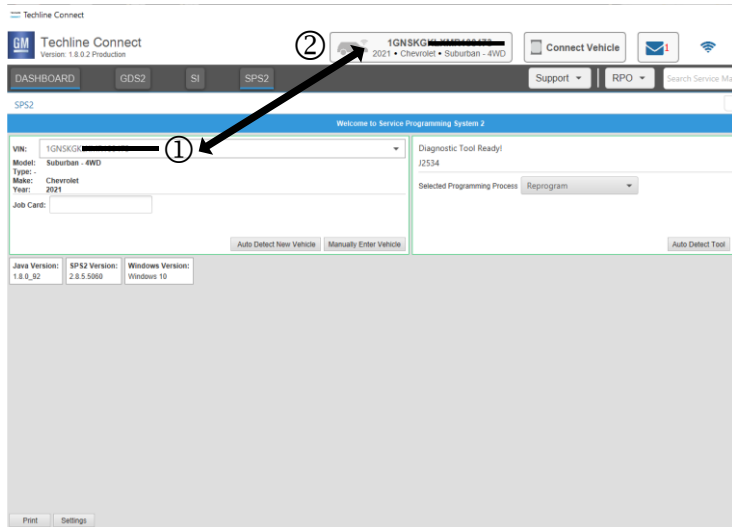
5743643

Caution: Be sure the VIN selected in the drop down menu (1) is the same as the vehicle connected (2) before beginning programming.

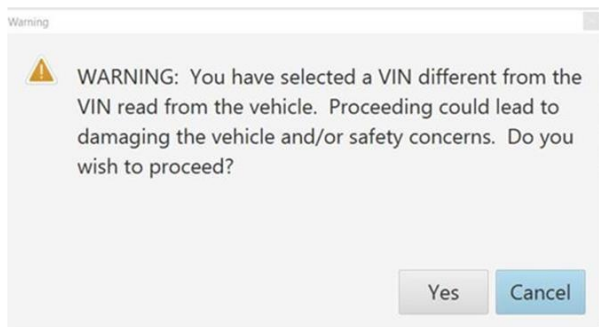
5877000

Important: If the vehicle VIN DOES NOT match, the message below will be shown.

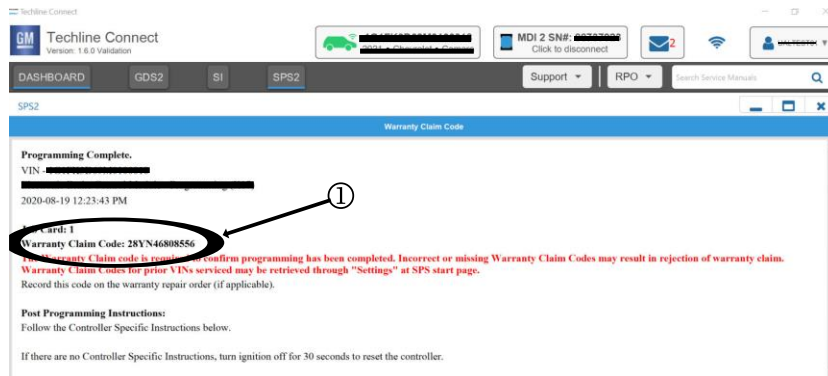
5644478

Important: To avoid warranty transaction rejections, you **MUST** record the warranty claim code provided on the Warranty Claim Code (WCC) screen shown above on the job card. Refer to callout 1 above for the location of the WCC on the screen.

- Record SPS Warranty Claim Code on job card for warranty transaction submission.
