Service Bulletin

Bulletin No.: 23-NA-020

Subject: Oil Leak from Front of Engine

Brand:	Model:	Model Year:		VIN:		Engine:	Transmission :
		from	to	from	to		
Chevrolet	Corvette	2023	2023	—	—	5.5L (RPO LT6)	—

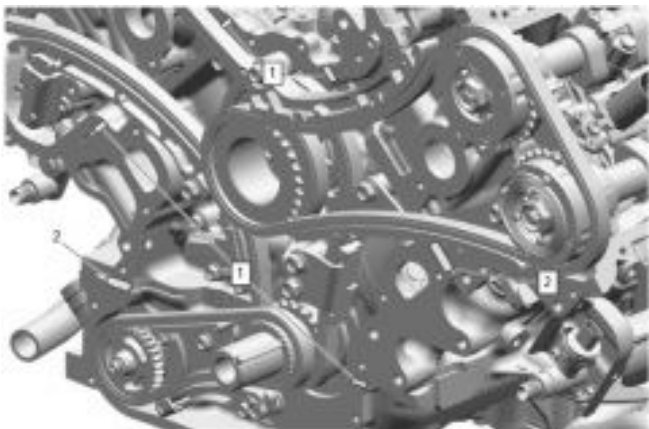
Involved Region or Country	North America, Europe, Israel, Palestine, Japan, Thailand, Australia/New Zealand
Condition	Some customers may comment that there is a visible engine oil leak coming from underneath the middle of the vehicle. During inspection, some technicians may notice that there is a small oil leak coming from the engine front cover area.
Cause

<p>This condition may be caused by improper front cover bolt torque or inadequate sealer adhesion at one of the six T-Joint locations. 6267588</p> <ul style="list-style-type: none"> - The oil leak can be found at the T-Joint location where the cylinder head meets the engine block, or at one of the other T-Joint locations (shown in yellow) in the graphic above.
Correction	To correct this condition, it will be necessary to install new front cover gaskets and follow the revised RTV sealing procedure as noted below.

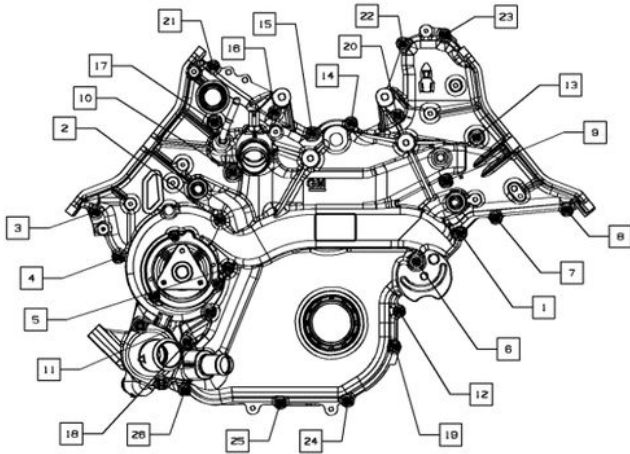
6825640

Note: Design 1: All fasteners are M5

- Positions 2, 5 and 11 are M5 X 72.65 mm
- Position 9 is M5 X 55 mm
- All other positions are M5 X 30 mm

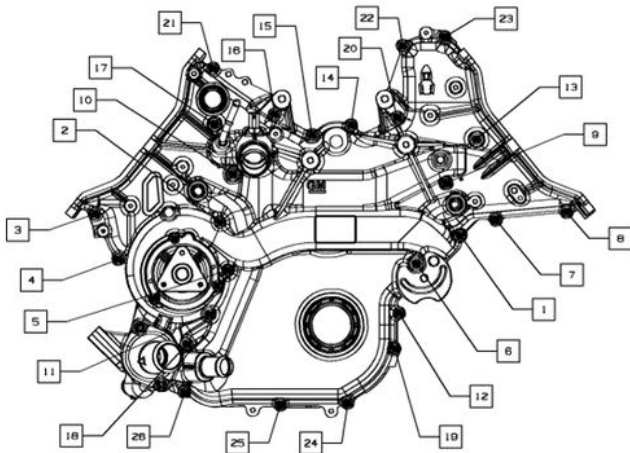
6825641

Note: Design 2: Positions 2 and 5 are M6

- Positions 2 and 5 are M6 X 73.65 mm
- Position 11 is M5 X 72.65 mm
- Position 9 is M5 X 55 mm
- All other positions are M5 X 30 mm
