Service Bulletin

Bulletin No.: 23-NA-102

Subject: Drivability Concerns, Hesitation, Transmission Shifting Rough/Harsh, Malfunction Indicator Lamp (MIL) Illuminated - Multiple DTCs Set

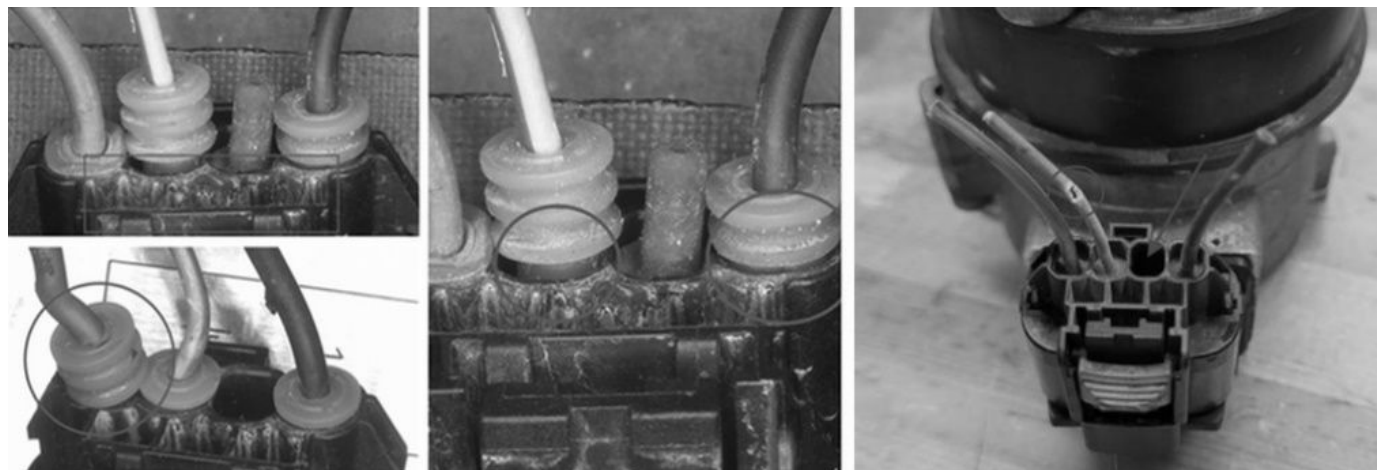
Information**Area of Concern at the CAC Pump Electrical Connector**

An open cavity or an unsealed pump connector allowing water into the (M10) charge air cooler pump electrical connector might be the root cause of the communication failure.

- Check the CAC Pump connector sealing and look for any corrosion at the pump due to water leakage.

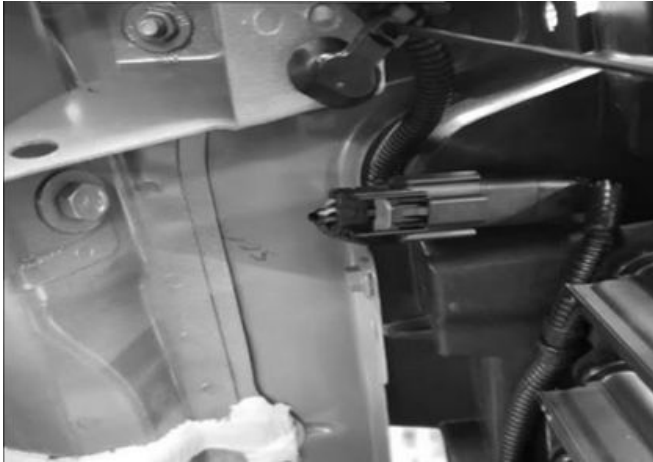
Area of Concern Active Grille Air Shutter Actuator In-line Connector

The following DTCs may be caused by the engine wiring harness to active grille air shutter actuator in-line connector (X618 on the pickup and X604A On the SUV). Please check circuit 4621 which may be:

- Not properly connected

- Not properly held by the rear clip
- Grounded on the radiator

The graphic above shows how the proper connection must be.

- Check the active grille air shutter actuator in-line connector for not being properly connected or grounded to the radiator.

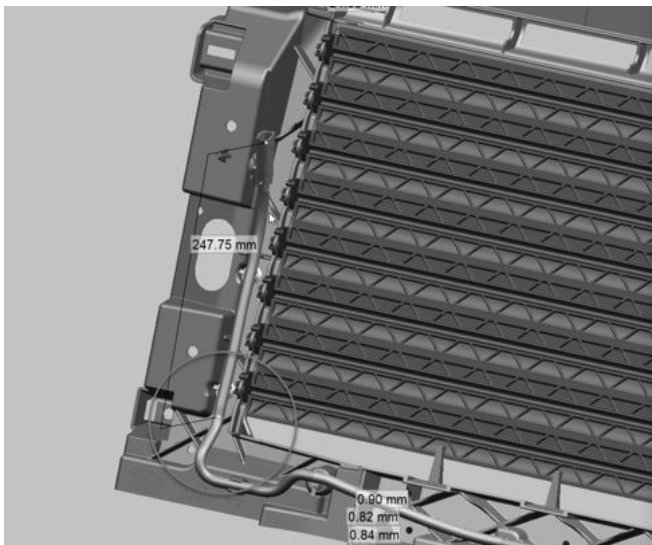
DTCs may be caused by the active grill air shutter wiring pinched at the radiator support.

The graphic above depicts where a pinching condition may be located.

- Check the active grill air shutter wiring route to identify possible damaged points in the wiring.

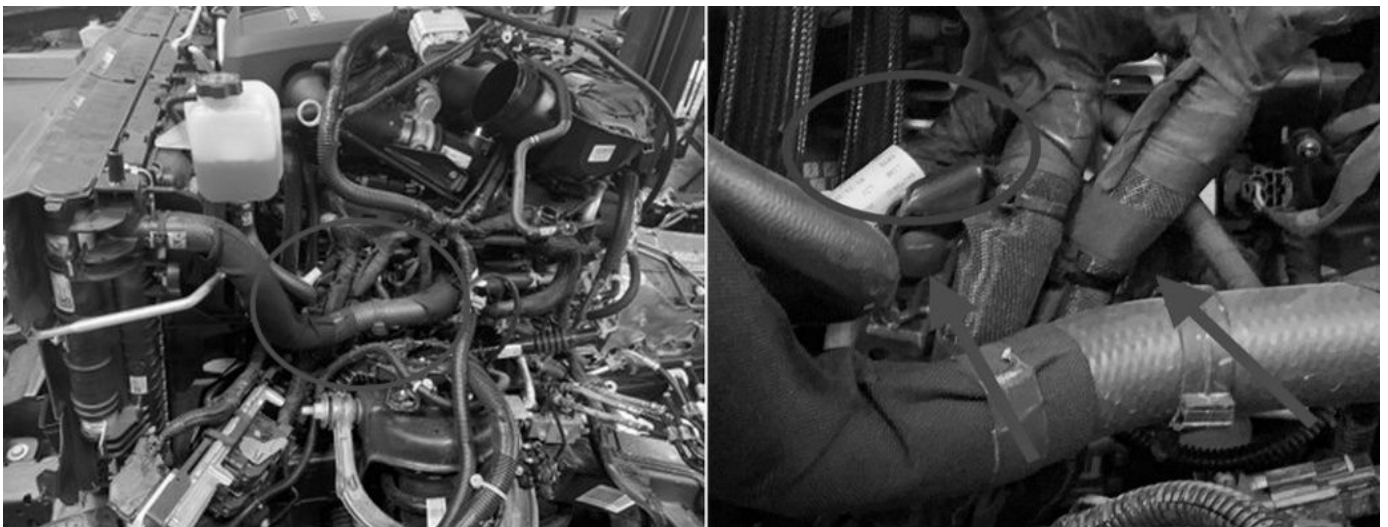
LM2 Area of Concern at Alternator Bracket

- Arrows indicate location of retainer pins that were not properly installed.
- Blue circle indicates where a chafe in the wiring has occurred. The mis-installed bracket allowed the harness to lay on the alternator.

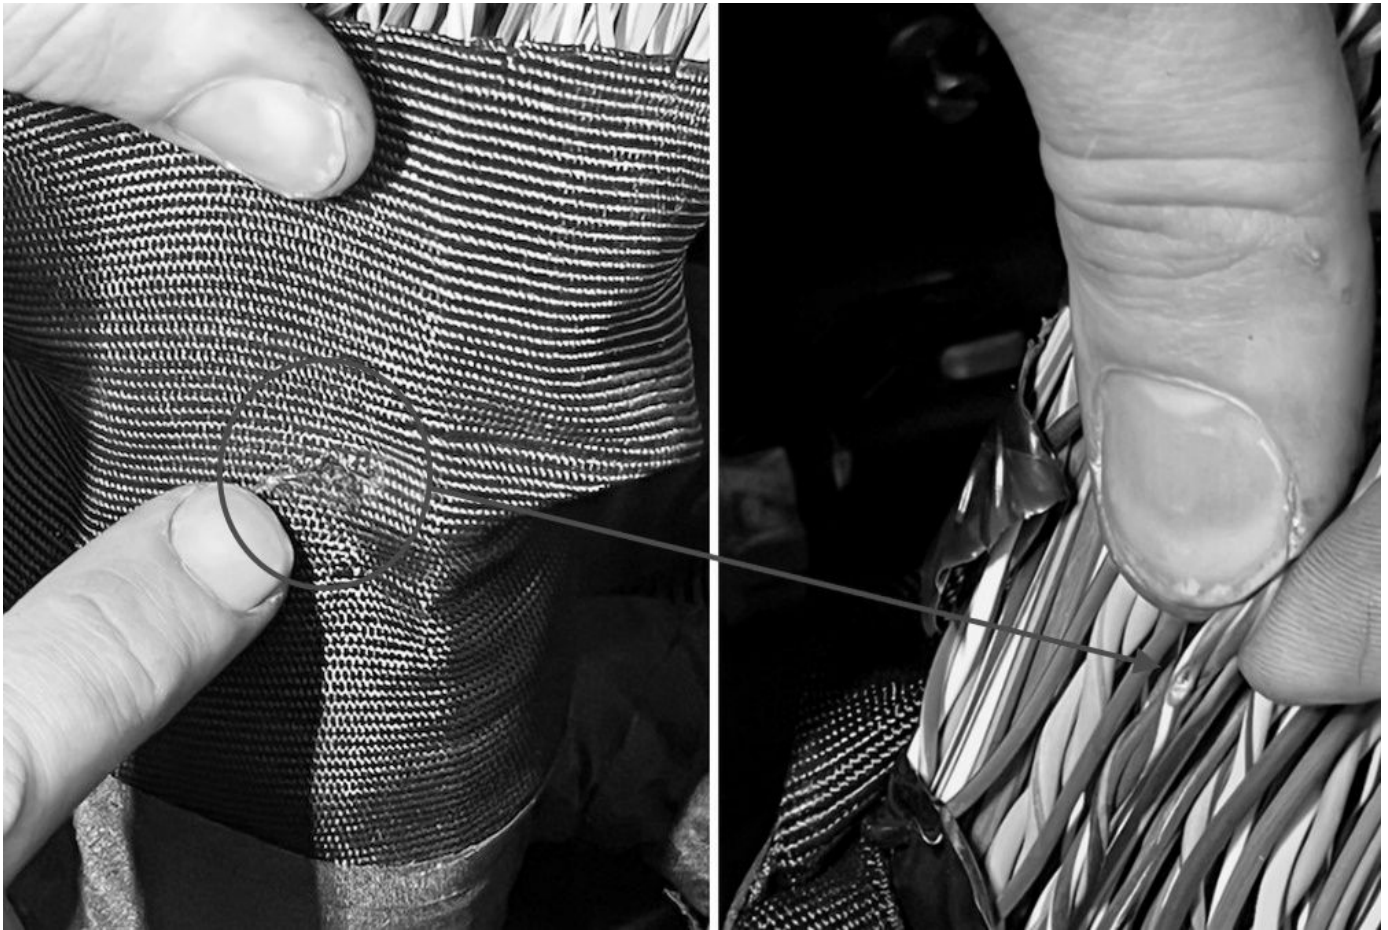
LM2 – Wiring Harness Contact at Alternator Bracket.

- The engine wire harness was chafed by a bracket next to the back of the alternator.

U0073 CAN BUS 2 off or U0074 CAN BUS 3 off

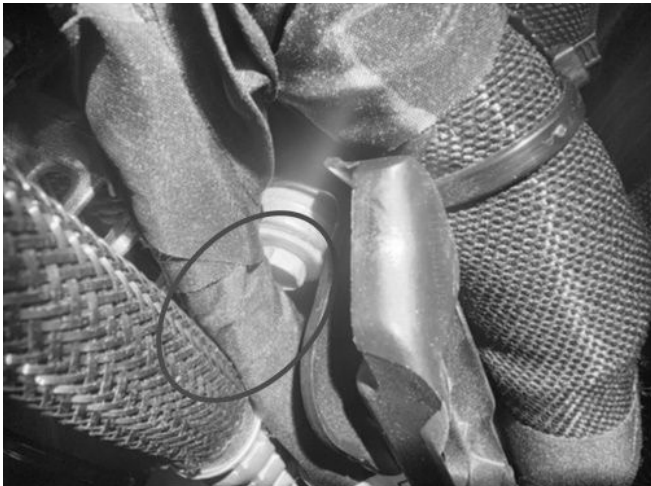
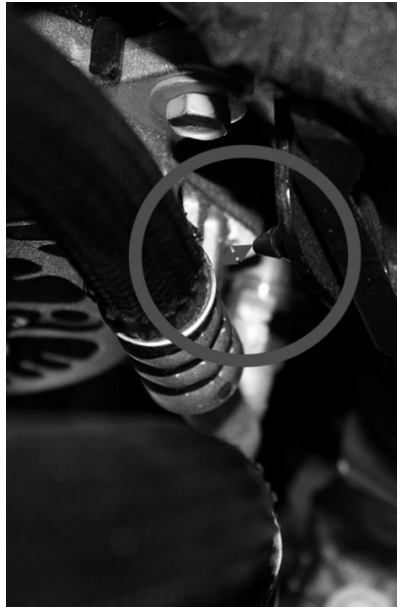
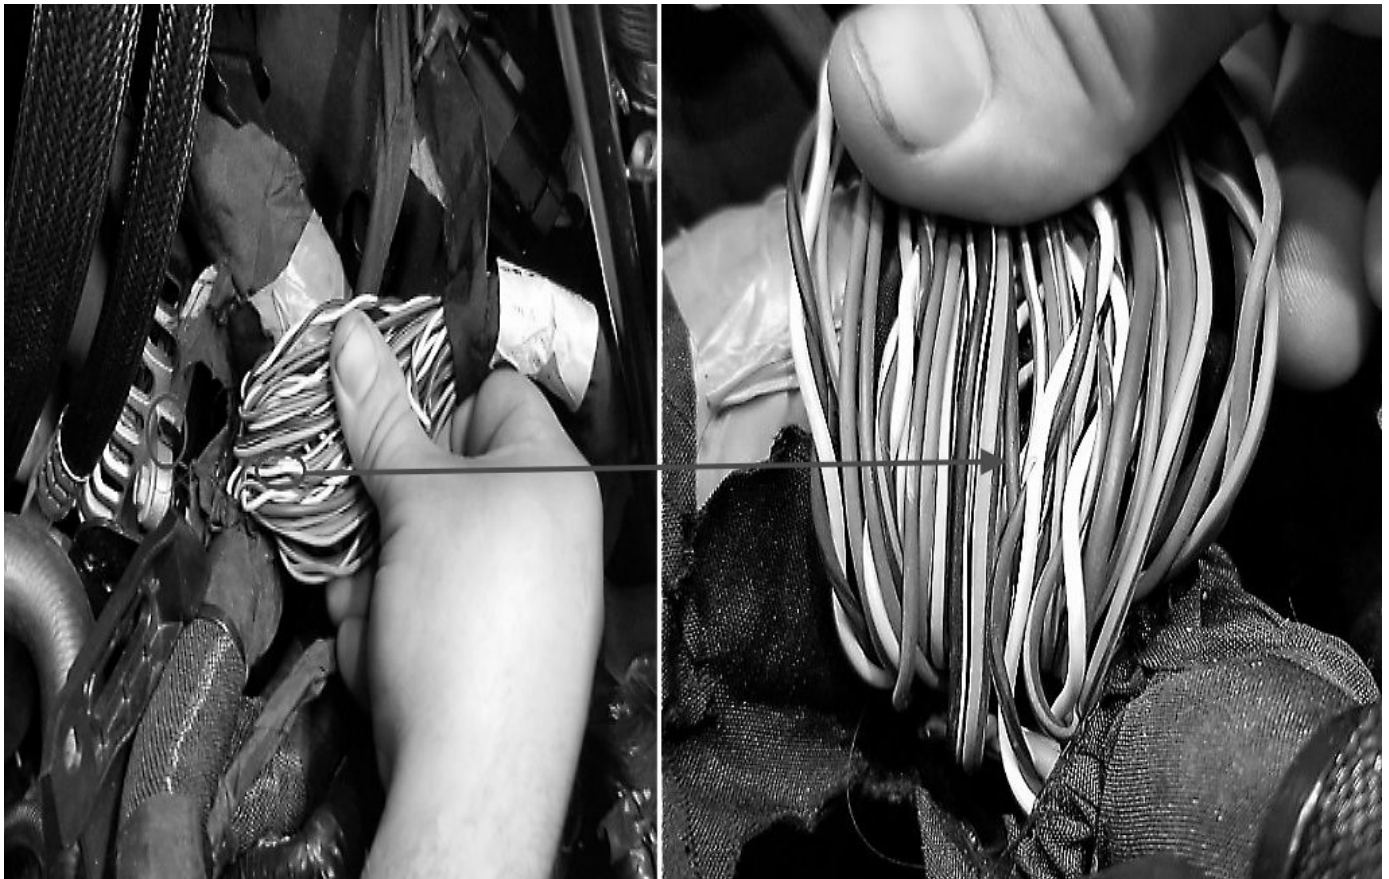
LZ0 Area of Concern at Alternator Bracket

LZ0 – The Wiring Harness Contacted the Alternator Bracket do to Routing of the Harness.

Note: During the repair. It was noted that a 5/8 ths diameter hose was used to prevent a reoccurring chafe condition.

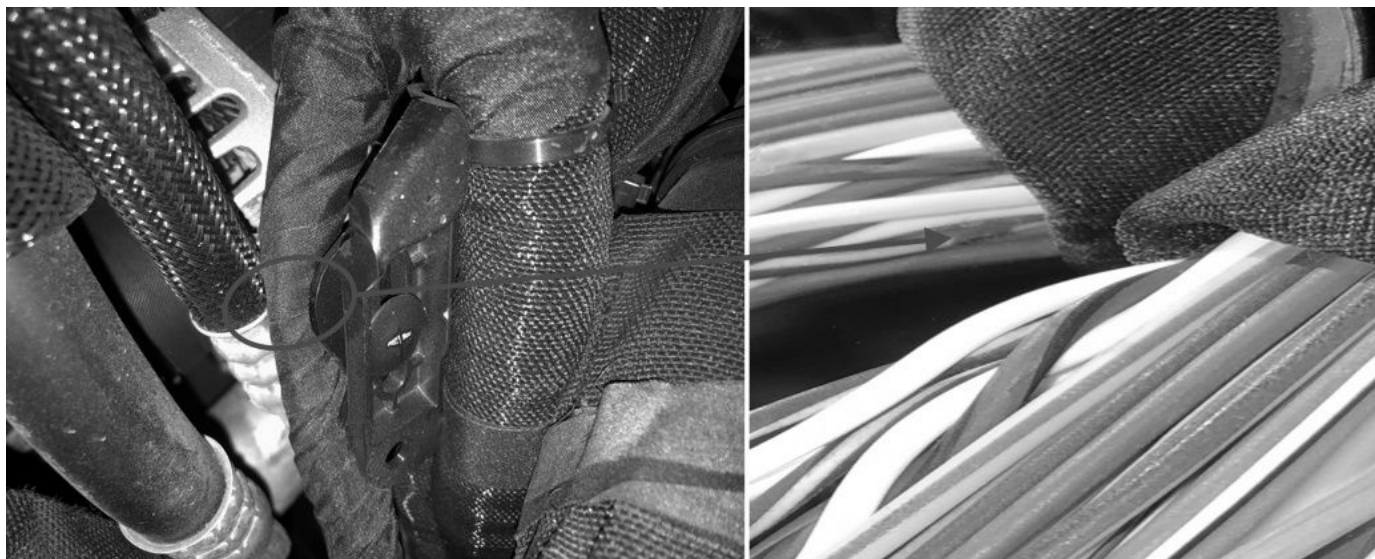
LZ0 – Wiring Harness Contacting the A/C Line and Alternator Bracket.

This is CAN 3 wire harness. Can 4 is also in this bundle only blue and yellow twisted with white.

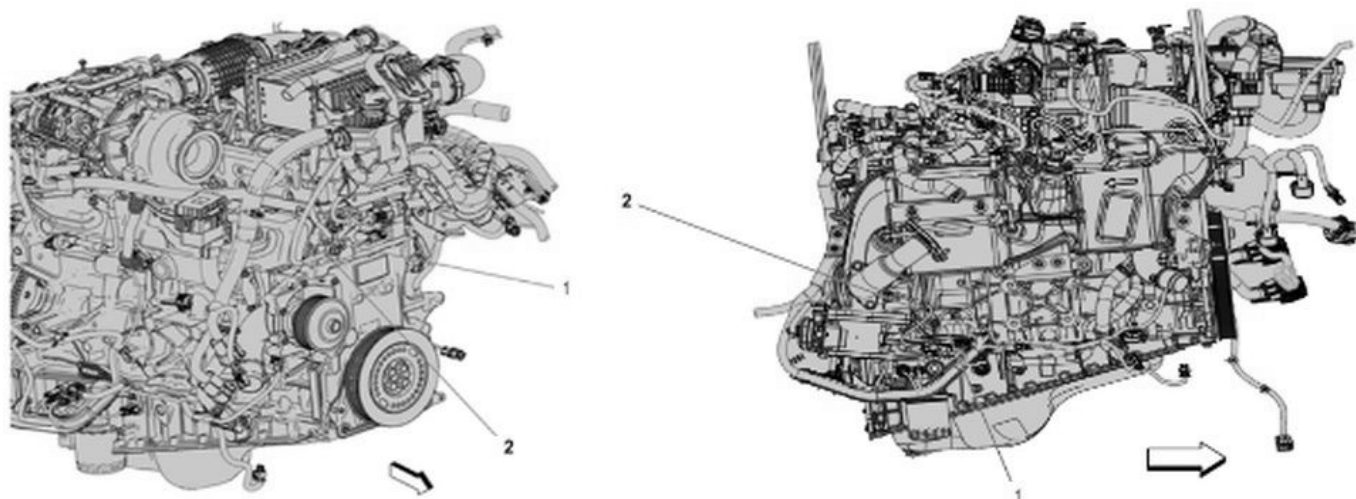
Loose Ground

Inspect ground connections G176A (1) and G177B (2) may exist. Please check for any:

- Loosen condition
- Damaged or dirty threads
