# Service Bulletin

Bulletin No.: 24-NA-261

**Subject: Radio Software Version Y175 – Multiple Updates for IOK**

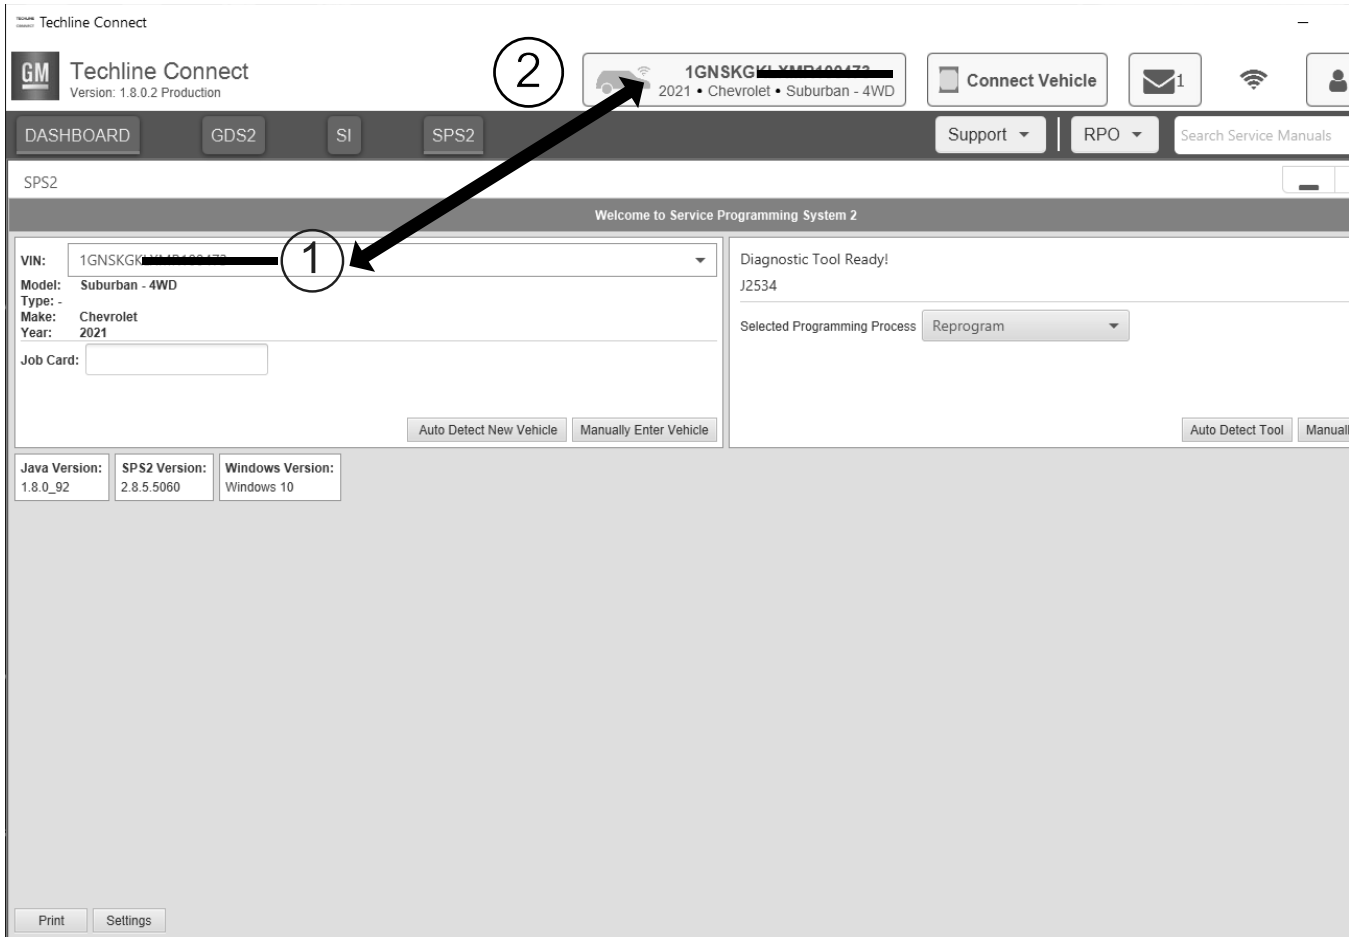
5743643

**Caution:** Be sure the VIN selected in the drop down menu (1) is the same as the vehicle connected (2) before beginning programming.

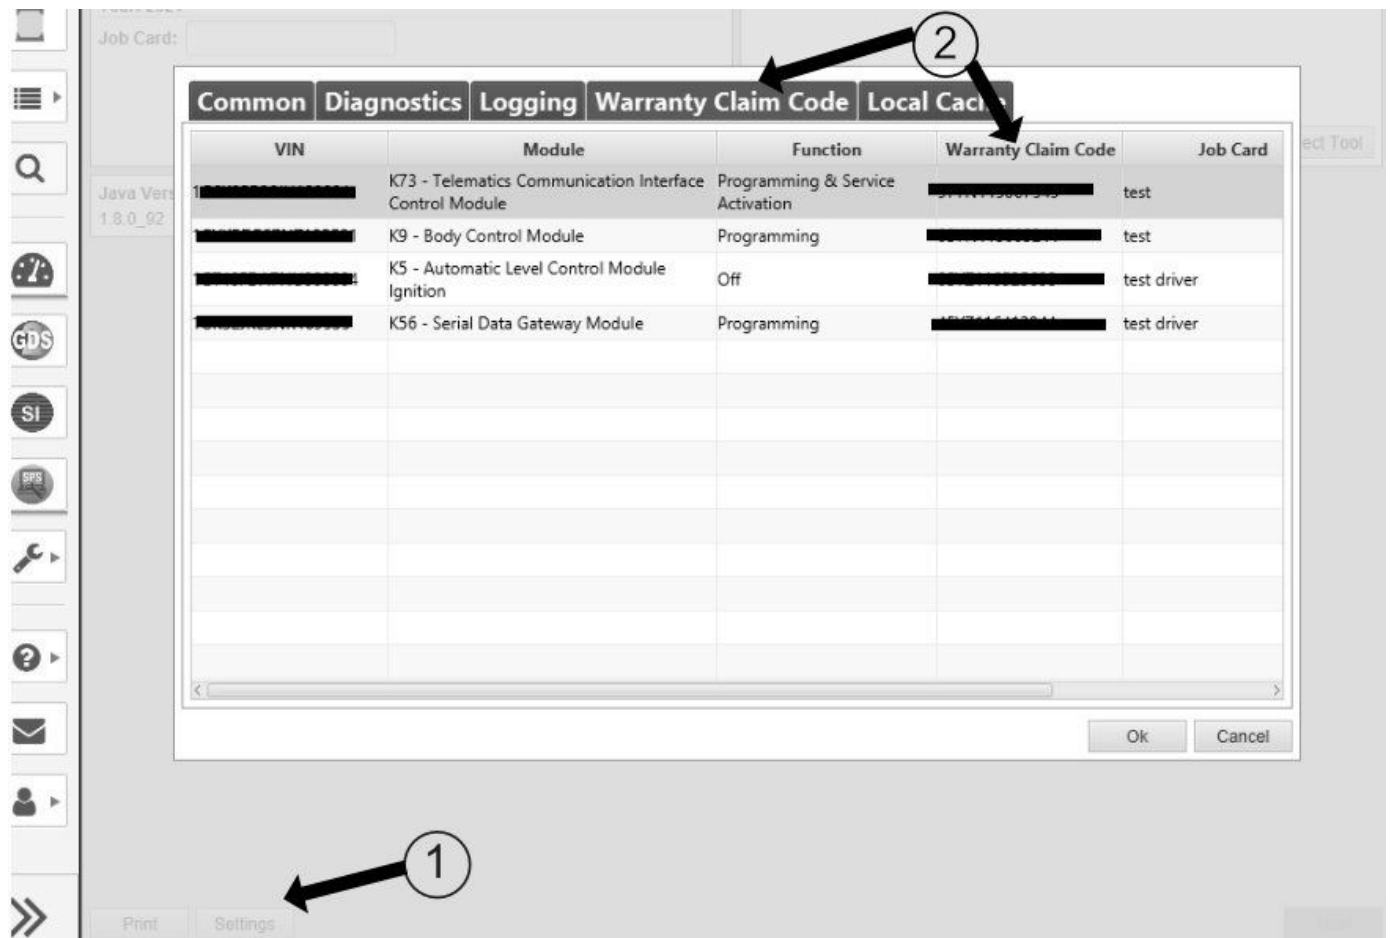
If the Warranty Claim Code was not recorded on the Job Card, the code can be retrieved in the SPS2 system as follows:

1. Open TLC on the computer used to program the vehicle.
2. Select and start SPS2.
3. Select Settings (1).
4. Select the Warranty Claim Code tab (2).
