Service Bulletin

Bulletin No.: 25-NA-003

Subject: Rattle Type Noise Heard from Brake Pedal Area

Brand:	Model:	Model Year:		VIN Breakpoint:		Engine:	Transmission:
		from	to	from	to		
GMC	HUMMER EV	2024	2025	—	—	—	—
	HUMMER EV SUV		2024

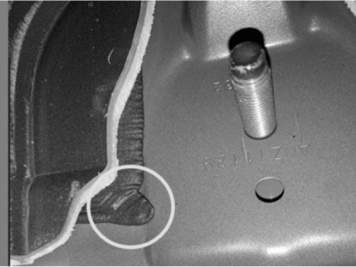
Involved Region or Country	North America, Mexico, Middle East, Israel
Condition	Some customers may comment on a rattle type noise heard from the brake pedal area.
Cause	<div style="display: flex; justify-content: space-around;">

</div> <p style="text-align: right; margin-top: 10px;">6805453</p> <p>This condition may be caused by excess body seam sealer was found extending under the brake pedal housing near the sky bolt (single bolt on top of the housing), as shown in the picture above.</p>
Correction	Trim back the excess body seam sealer following the procedure below.

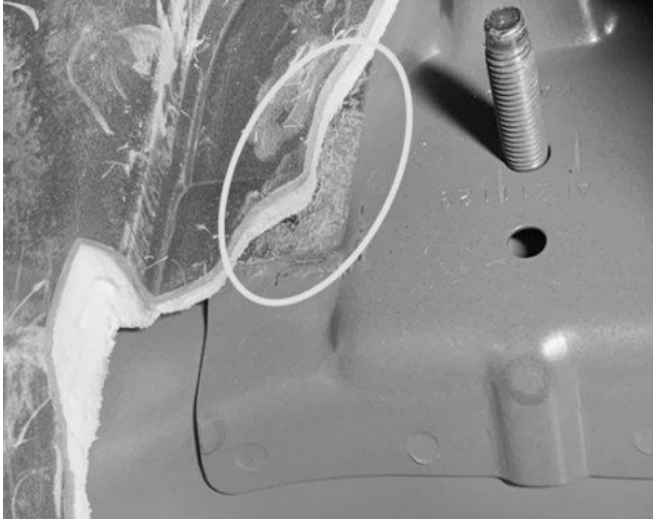
6805499

1. Verify brake pedal does rattle and/or produces a noise
2. Remove the brake pedal assembly. Refer to *Brake Pedal Assembly Replacement* in SI.
3. Locate the excess body seam sealer.

4. Remove the section of sealer that is making contact to the brake pedal, as shown in the picture above, using an appropriate scraping tool.
