# Service Bulletin

Bulletin No.: 25-NA-017

**Subject: Center Console Storage Door Difficult to Open and/or Binding or Stuck**

Brand:	Model:	Model Year:		VIN:		Engine:	Transmission:
		from	to	from	to		
Chevrolet	Blazer EV	2024	2025	-	-	All	All

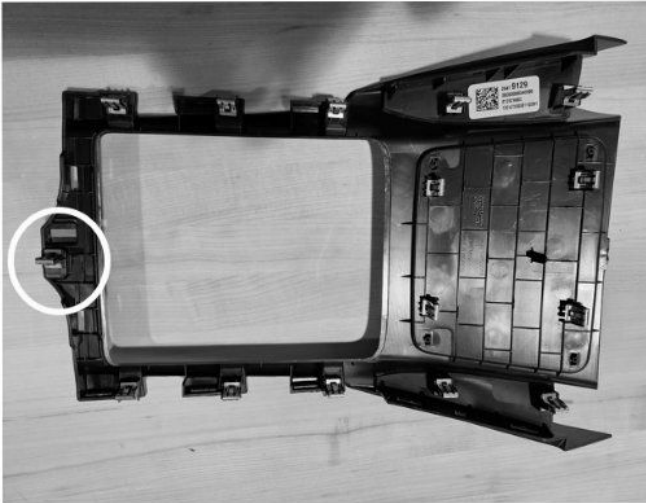
6825579

<b>Involved Region or Country</b>	United States, Canada, Mexico, Middle East, Israel, Palestine, Argentina (Mercosur), Brazil (Mercosur), Chile (West), Colombia (West), Ecuador (West), Uruguay (West)
<b>Condition</b>	Some customers my comment that the center console storage door is difficult to open, binding or stuck.
<b>Cause</b>	The floor compartment upper panel may be distorting and causing a bind condition.
<b>Correction</b>	Complete the procedure outlined below.

Remove the floor console upper panel. Refer to *Front Floor Console Upper Panel Replacement* in Si.
