Volvo Car USA LLC

Technical Journal Title Interior Door Deco Light not Functioning		Ref. No. TJ 37035.1.0	
Issuer (Dept.) Technical Service		Issue Date 1/8/25	Status Date 1/24/25
Car Market United States and Canada	Partner 3 US 7510 Volvo Car USA	Function Group 3541	
Function Description Lighting, interior, complete		Page Page 1 of 4

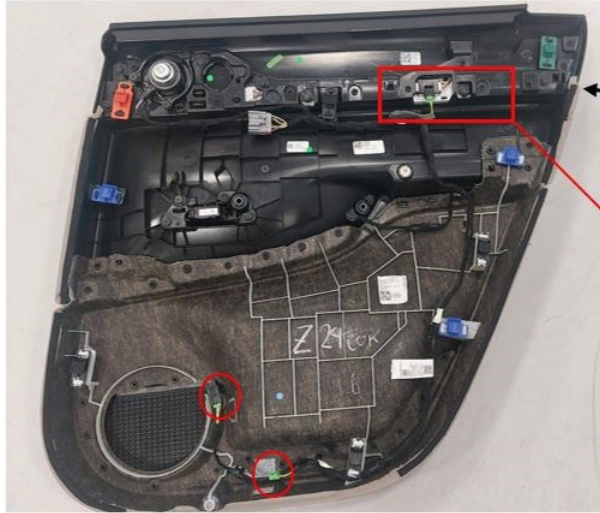
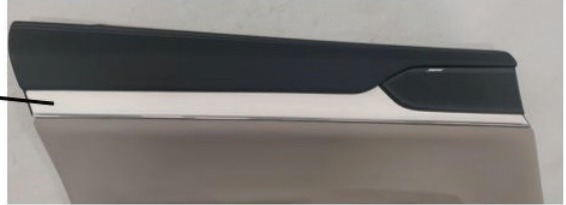
- Examine the connectors of the Deco backlight. Refer to the attached images SE_37035_1.jpeg and SE_37035_2.jpeg for guidance.

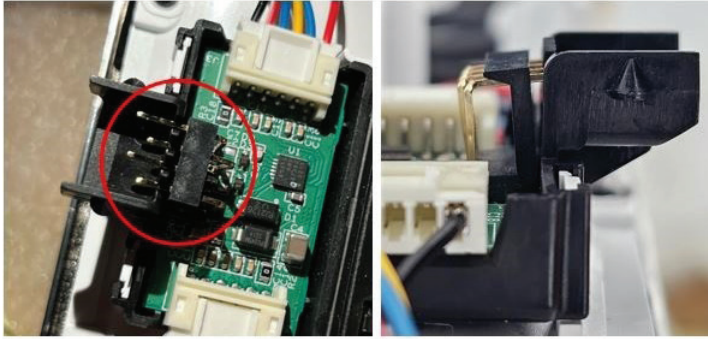
- Check the pins for any damage. Refer to the attached image SE-37035_3.jpeg for an example of damaged pins.
- If the pins are damaged, you will need to replace the Door Deco to rectify the issue.
