**HYUNDAI**
Technical Service Bulletin

GROUP CAMPAIGN	NUMBER 24-01-047H
DATE JULY 2024	MODEL(S) TUCSON (NX4A)

SUBJECT: ICU SOFTWARE UPDATE FOR INCORRECT REAR SEAT BELT WARNING LIGHT AND TURN SIGNAL ERROR MESSAGE (SERVICE CAMPAIGN TBX)

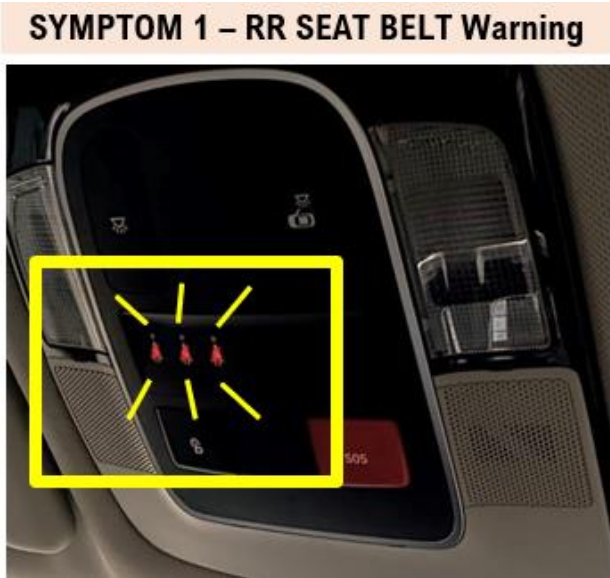
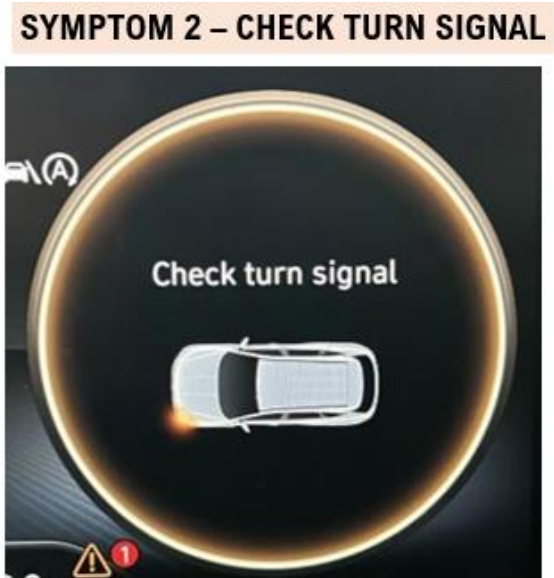
Description: Certain 2024MY Tucson (NX4A) vehicles may exhibit a seat belt warning light for the rear seats illuminating incorrectly and/or a “Check turn signal” error message on the cluster. Follow the procedure in this bulletin to update the software for the Integrated Control Unit (ICU) to correct these conditions.
