# HYUNDAI

## Technical Service Bulletin

GROUP	NUMBER
FUEL SYSTEMS	25-FL-002H
DATE	MODEL(S)
FEBRUARY 2025	SEE BELOW

**SUBJECT:** HIGH PRESSURE FUEL PUMP REPLACEMENT  
(WARRANTY EXTENSION Z04)

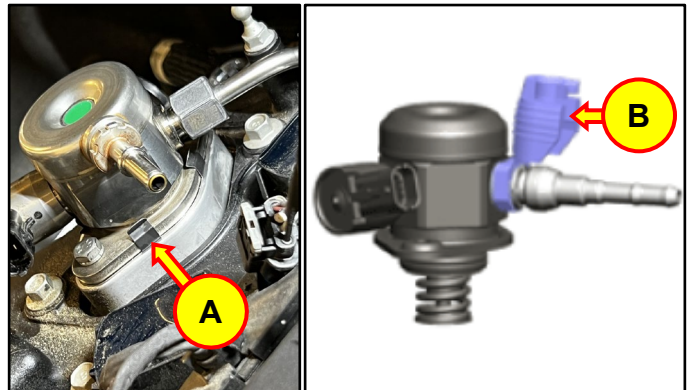
Be sure to transfer the shim-type metal pump gasket (A) and the low pressure fuel hose quick connector clamp (B) (if equipped) over to the new High Pressure Fuel Pump.

7. Tighten the high pressure fuel components to the following specifications:

**High Pressure Fuel Pump Bolt  
Tightening Torque:**

lb-ft	11
N.m	14
