Technical Service Bulletin

GROUP FUEL SYSTEMS	NUMBER 25-FL-002G
DATE FEBRUARY 2025	MODEL(S) G70 (IK)

SUBJECT: HIGH PRESSURE FUEL PUMP REPLACEMENT
(WARRANTY EXTENSION Z05G)

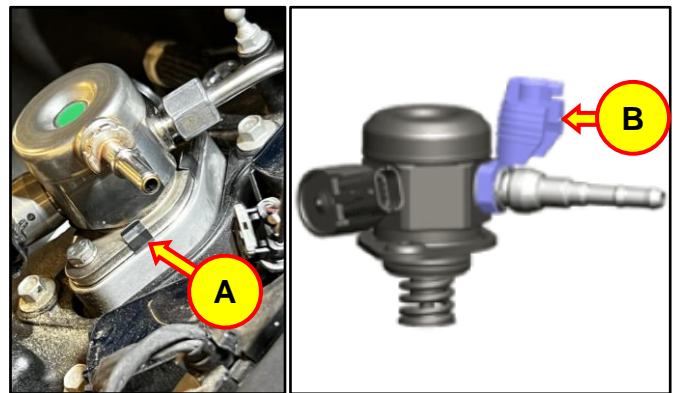
Be sure to transfer the shim-type metal pump gasket (A) and the low pressure fuel hose quick connector clamp (B) (if equipped) over to the new High Pressure Fuel Pump.
