Technical Service Bulletin (TSB)
Daytime Running Light (DRL) Bracket Breakage

REFERENCE:	TSB: 08-032-25 GROUP: 08 - Electrical	Date:	February 5, 2025	REVISION:	—
VEHICLES AFFECTED:	2024 (FG) Fiat 500e This bulletin applies to vehicles built on or after November 20, 2023 (MDH 1120XX) and on or before April 19, 2024 (MDH 0419XX).			MARKET APPLICABILITY:	
				<input checked="" type="checkbox"/> NA	<input checked="" type="checkbox"/> MEA
				<input type="checkbox"/> SA	<input checked="" type="checkbox"/> IAP
				<input checked="" type="checkbox"/> EE	<input type="checkbox"/> CH
CUSTOMER SYMPTOM:	DRL(s) are not aligned with the hood properly.				
CAUSE:	Bracket breakage

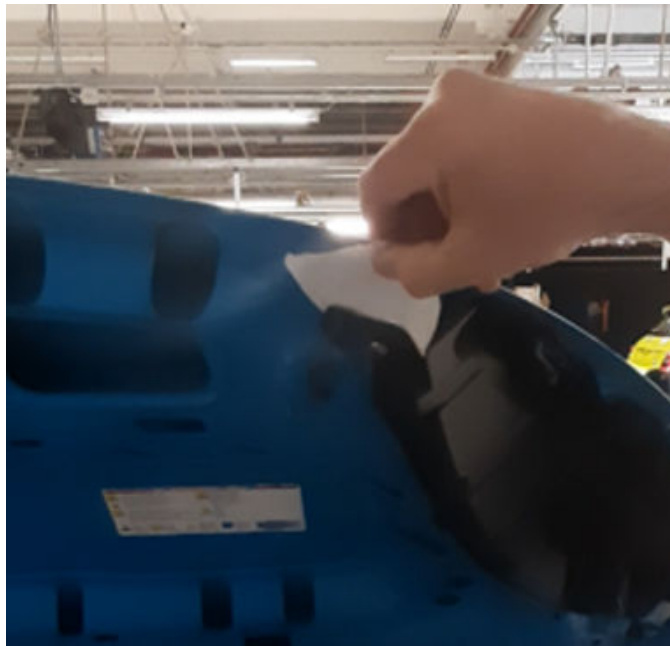
Fig. 1
Checking Gap

1. Open the hood.
2. Check the gap between the DRL brackets and hood with a piece of paper.
3. Is there contact between the piece of paper and the hood at the mounting points [Fig. 1](#)?

- YES>>> Proceed to [Step 4](#).
 - NO>>> This bulletin does not apply. Use Inspection LOP (08-50-65-96). Perform further diagnostics.
4. Remove the DRL. Refer to the detailed service procedures listed in DealerCONNECT>Service Library>Service Info under: 5540B11 - LED Side Lights (DRL) Front Light Cluster One, LH OR RH - R.R.
 5. Using a light, inspect carefully the mounting areas of the DRL.
 6. Are there cracks visible on and near the mounting points?
 - YES>>> Proceed to [Step 8](#).
 - NO>>> Proceed to [Step 7](#).
 7. Re-install the DRL by inserting two 2.5mm (.010 in.) spacers between the DRL mount and the hood. Re-install fasteners and push pins.
