GENERAL MOTORS
DCS7141
URGENT - DISTRIBUTE IMMEDIATELY

Subject: N242485100 - Service Update
Chassis Wiring Harness Retainer

Models: 2025 Cadillac LYRIQ

N242485100 Chassis Wiring Harness Retainer

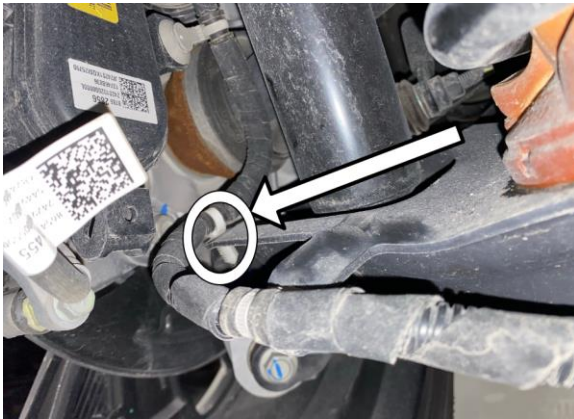
6805565

| Condition | Certain vehicles listed above may have a condition in which the chassis harness branch may contact the rear half shaft boot on LH and RH side. |

2. Remove the wiring harness retainer from the left side rear parking brake actuator harness and the rear of the vehicle.

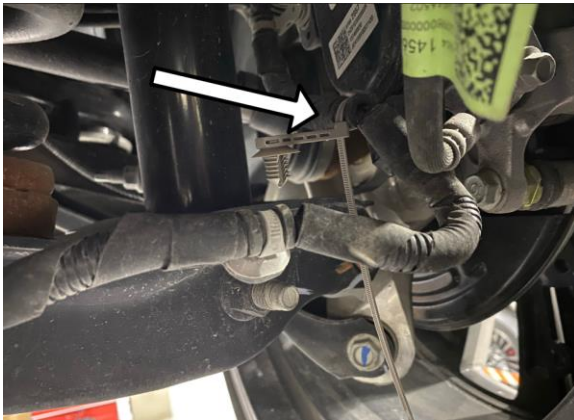
6805566

Note: Right side shown, left side similar.

3. Install the NEW offset wiring harness retainer on the harness. Ensure the offset is facing the rear of the vehicle, pulling the harness away from the rear wheel drive shaft as shown.

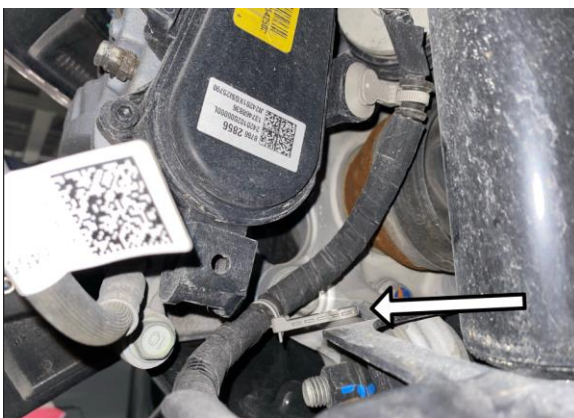
6805568

Note: Ensure the offset is facing the rear of the vehicle, pulling the harness away from the rear wheel drive shaft as shown. Failure to do so may result in damage to the harness and/or the rear wheel drive shaft boot.

4. Push the offset wiring harness retainer back into its housing. Ensure the offset is facing the rear of the vehicle, pulling the harness away from the rear wheel drive shaft as shown. Trim the excess harness tie-down.

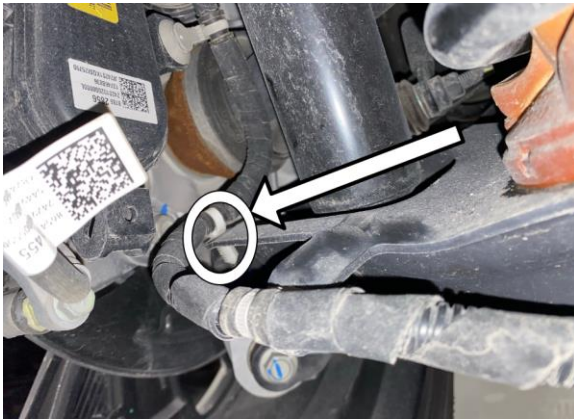
6805565

Note: Left side shown, right side similar.

5. Remove the wiring harness retainer from the right side rear parking brake actuator harness and the rear of the vehicle.

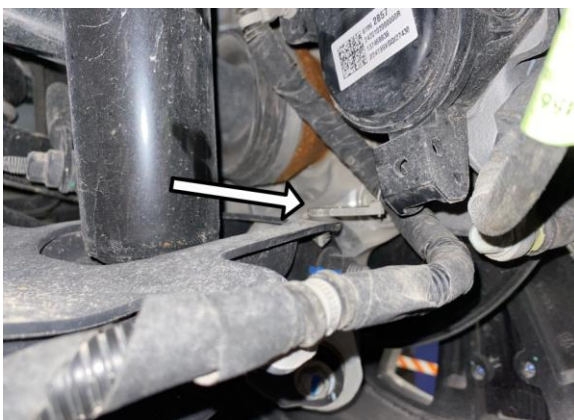
6805570

Note: Ensure the offset is facing the rear of the vehicle, pulling the harness away from the rear wheel drive shaft as shown. Failure to do so may result in damage to the harness and/or the rear wheel drive shaft boot.

7. Push the offset wiring harness retainer back into its housing. Ensure the offset is facing the rear of the vehicle, pulling the harness away from the rear wheel drive shaft as shown. Trim the excess harness tie-down.
8. Inspect the RH rear wheel drive shaft boot for any signs of damage.
