Service Bulletin

Bulletin No.: PIE0815

Subject: Engineering Information – Service Engine Soon (SES) Lamp Illuminated on Driver Information Center (DIC), Suspect Non-OE Catalytic Converters and/or Exhaust Systems, DTCs P013F, P014A, P014B and/or P013E Set

Brand:	Model:	Model Year:		VIN Breakpoint:		Engine:	Transmission:
		from	to	from	to		
Chevrolet	Corvette	2023	2024	—	—	5.5L (RPO LT6)	All

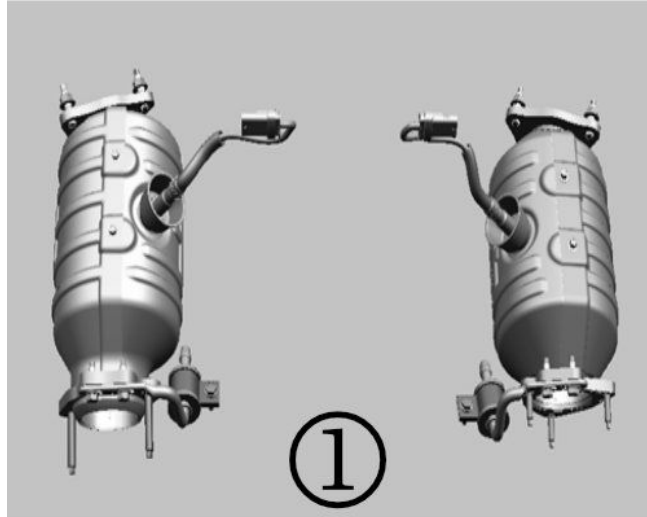
6825871

There are two different conditions in which the above codes may set. One is with the stock OE exhaust components (1) and the other is with an aftermarket non-OE exhaust components (2), as shown in the pictures above.

Note: The different position of the O2 sensors.

Note: If the catalytic converters **DO NOT** look like the ones shown above in the picture (1), the catalytic converter could be considered suspect. Also, please inspect for any aftermarket exhaust systems (2) as well.

DO NOT attempt to repair this concern if non-OE converters are found. Advise the customer that they need to return the vehicle to original OE equipped components. If the converters and/or exhaust system are OE and there are no other issues found, such as aftermarket calibrations per the latest version of Service Bulletin 09-06-04-026 etc., then proceed with applicable SI diagnostic procedures.
