Service Bulletin

Bulletin No.: 22-NA-074

Subject: Information on Gasoline Engine Replacement Guidelines after Connecting Rod or Crankshaft Main Bearing Damage – Replace Oil Cooler, Oil Cooler Lines, Oil Tank and Turbocharger

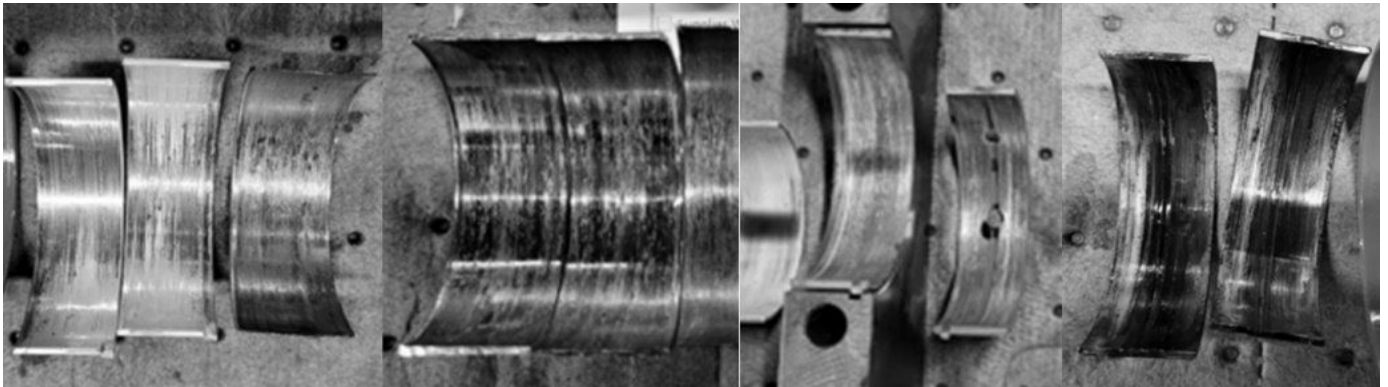
6020407

Below are examples of connecting rod or crankshaft main bearing damage that would require an engine assembly replacement along with the oil cooler, oil cooler lines, oil tank and turbocharger if equipped.
