GROUP	MODEL
Voluntary Emissions Service Campaign	2022-2023MY Multiple Models Listed (HEV, PHEV)
NUMBER	DATE
SC325	February 2025

VOLUNTARY EMISSIONS SERVICE CAMPAIGN

AEWP INSPECTION AND REPLACEMENT (SC325)

This bulletin provides information to inspect and, if necessary, replace the Auxiliary Electric Water Pump (AEWP), control harness wiring, and/or engine room junction box for coolant intrusion and/or corrosion on certain 2022-2023MY Kia Hybrid and Plug-in Hybrid vehicles listed in the table below. The AEWP in the subject vehicles may crack internally and allow coolant to intrude into the AEWP circuitry. If coolant enters the AEWP circuitry, the Check Engine Light (CEL) may be illuminated with one or more DTCs listed on page 2. If the vehicle continues to be driven in this condition, the Active Air Flap (AAF) warning message can also activate, and coolant may eventually migrate through the wiring harness to the engine room junction block. This may result in a reduction of motive power and may cause the vehicle to release air pollutants which exceeds Federal and California standards. These standards were established to protect the public health and welfare from the dangers of air

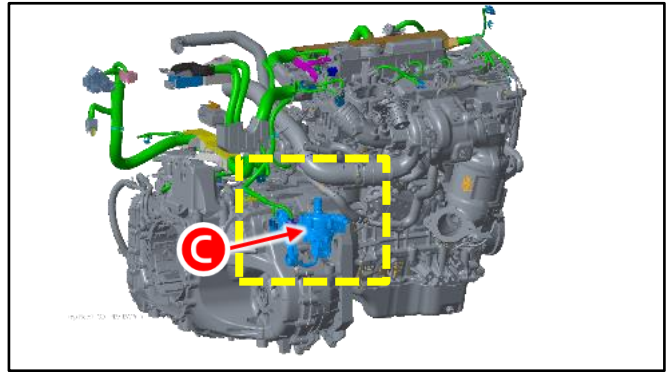
5. Locate AEWP and disconnect the control harness connector (C).
6. Inspect the AEWP connector (C) for moisture and/or coolant residue.

Are moisture and/or coolant residue present in the connector?

- **NO, moisture and coolant residue were NOT found (OK)**, then replace the following parts to close this campaign:
 - 1) AEWP assembly (Page 5)
- **YES, moisture and/or coolant residue WERE found (NG)**, then proceed to step 7.

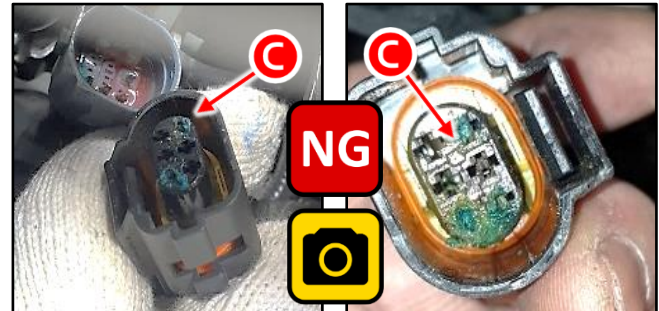
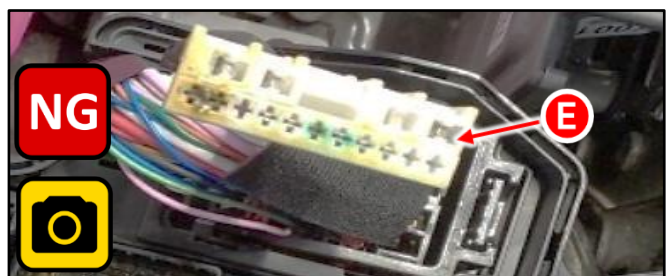
7. Lower the vehicle and locate the Process Control Block (PCB) - Fuse/Junction box (D).
8. Disconnect the control harness connectors (E) and inspect the connector for moisture.

Is coolant residue present in the connector?

- **NO, moisture and coolant residue were NOT found (OK)**, then replace the following parts to close this campaign:
 - 1) AEWP assembly (Page 5)
 - 2) Control Harness wiring (Page 6)
- **YES, moisture and/or coolant residue WERE found (NG)**, take a picture of the inspection area using KDS warranty attachment picture function to secure proper documentation and warranty compliance, then replace the following parts to close this campaign:

- 1) AEWP assembly (Page 5)
- 2) Control Harness wiring (Page 6)
- 3) Engine Room PCB Block (Page 5)
