STAR ONLINE PUBLICATION

Case Number: S2208000154 Rev. A

Symptom/Vehicle Issue: Service Hybrid Electric Vehicle System Message Displayed In The IPC. Vehicle Shakes During A Cold Start And Noise Is Heard Near The P2 Motor. DTC's U0287-00 And B273C-00

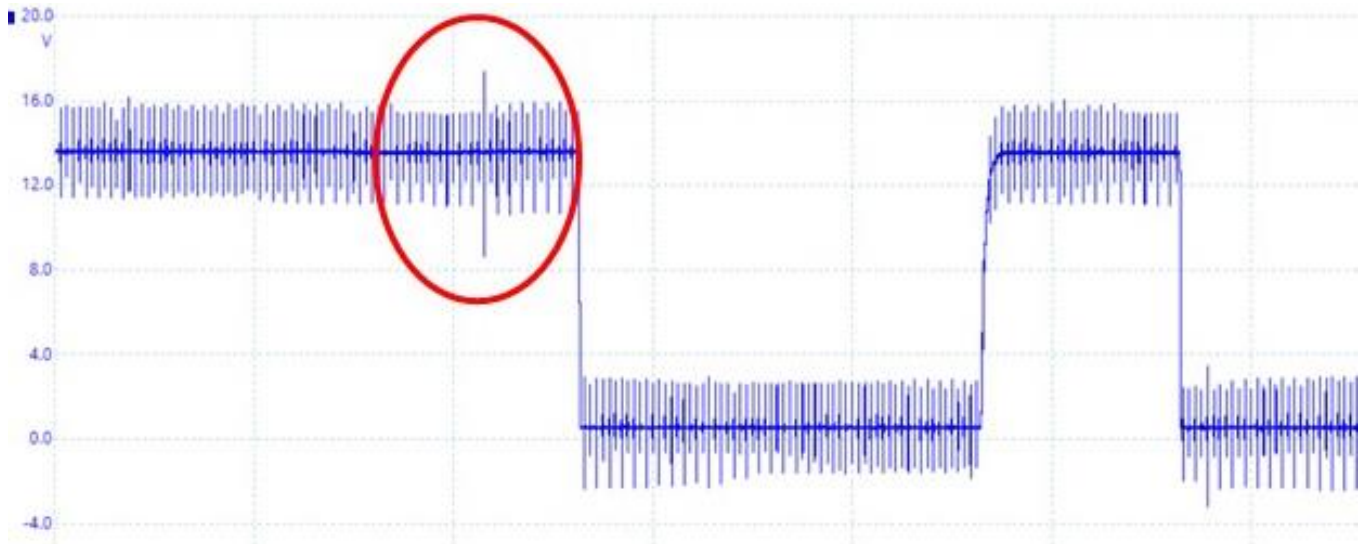
Circuit R414. Electrical noise and voltage spikes caused by HV induction

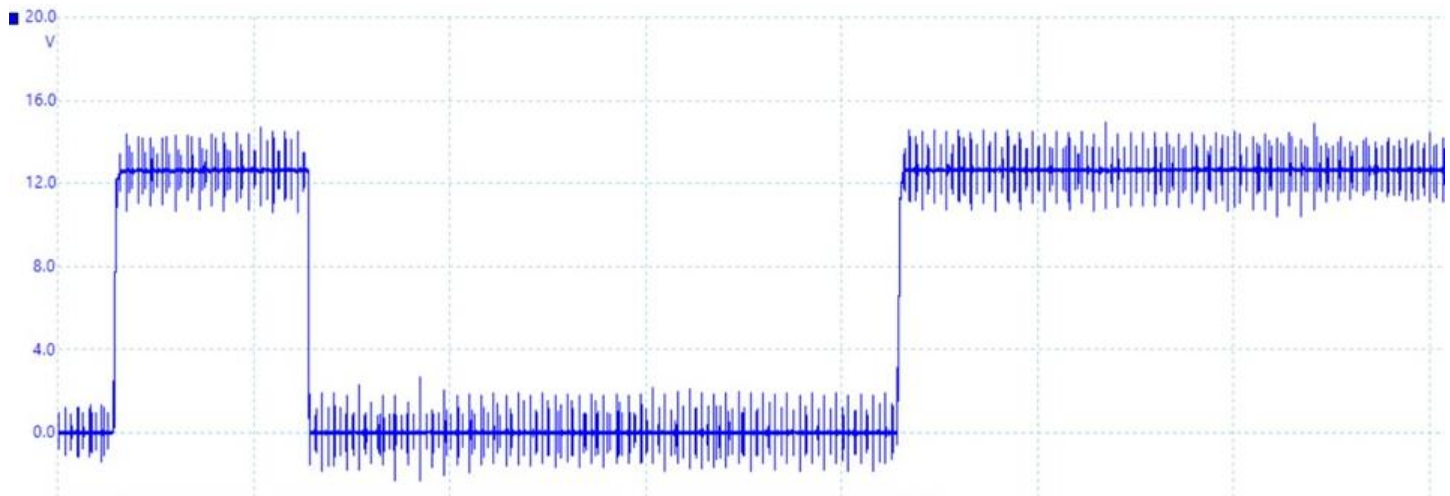
Circuit R414. Known Good Vehicle. Normal scope pattern.

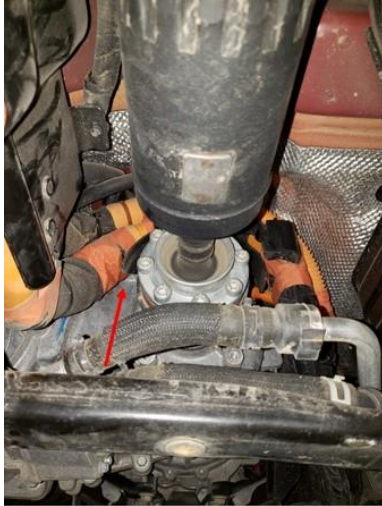
Inspect PIM to P2 wiring harness for rub through or damage near the transmission driveshaft CV joint shield.

PIM to P2 wire
Possible rub point

Repair Procedure: If damage is found, replace the high voltage wiring harness. Follow all safety procedures for powering down and isolating the HV electrical system before removing any HV wiring.

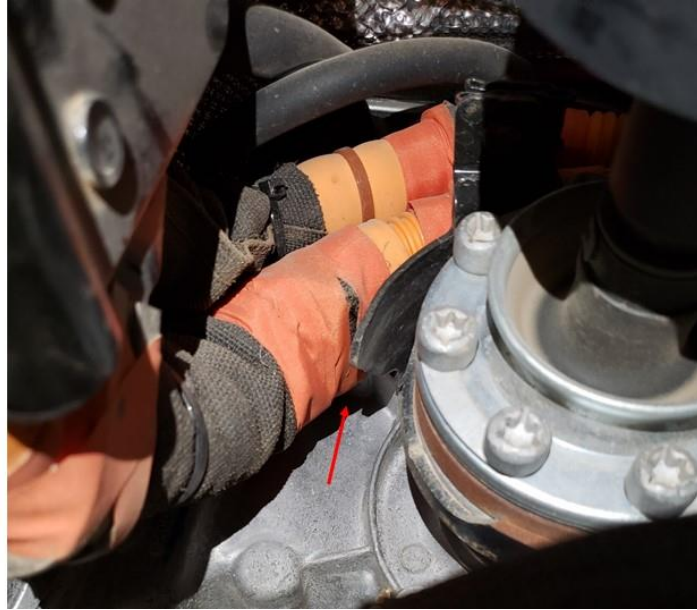
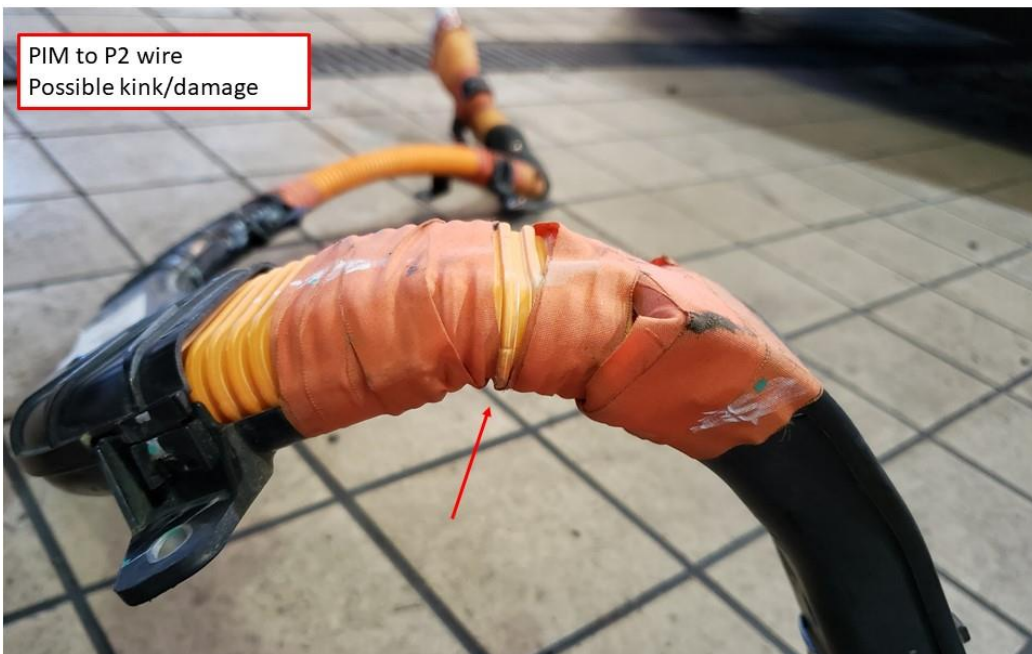
PIM to P2 wire
Possible kink/damage
