TECHNICAL SERVICE BULLETIN

ISSUE DATE:	11/11/2021
SERVICE BULLETIN SUBJECT:	BCT Horn Mux 1.2 Pin Relocation Retrofit
VINs or MODELS AFFECTED:	Service Specified Buses
COMPLETE BY:	Next Service Opportunity
SERVICE BULLETIN #:	SC-21-162
LABOR OPERATION CODE:	EN50Z

BCT HORN MUX 1.2 PIN RELOCATION RETROFIT

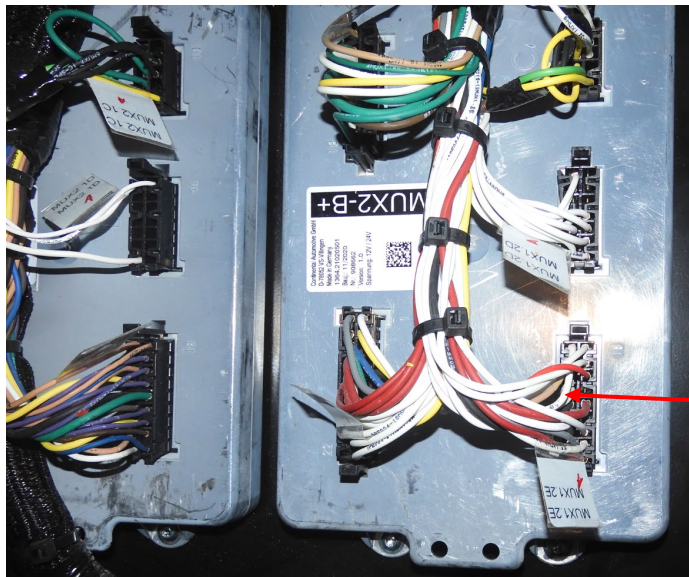
Connector MUX1.2E

The procedure updates the wiring of MUX 1.2 to be compatible with Body Controller Software version 6.10.2.

3. Locate the connector labeled MUX1.2E shown in the following photograph.

4. Disconnect the connector labeled MUX 1.2E.
5. Using a Pin Extractor Tool, remove the Pin in Cavity 6 of the Connector.
6. Install the Pin that was removed from Cavity 6 into Cavity 8 of the Connector.
7. Reconnect the Connector to the MUX.
8. Remove the Lockout/Tagout devices and return the bus to service.
