STAR ONLINE PUBLICATION

Case Number: S2219000005 Rev. C

Symptom/Vehicle Issue: Check Engine Lamp On. Warning Messages In The Cluster. U0131 Lost Communication With Power Steering Control Module Set.

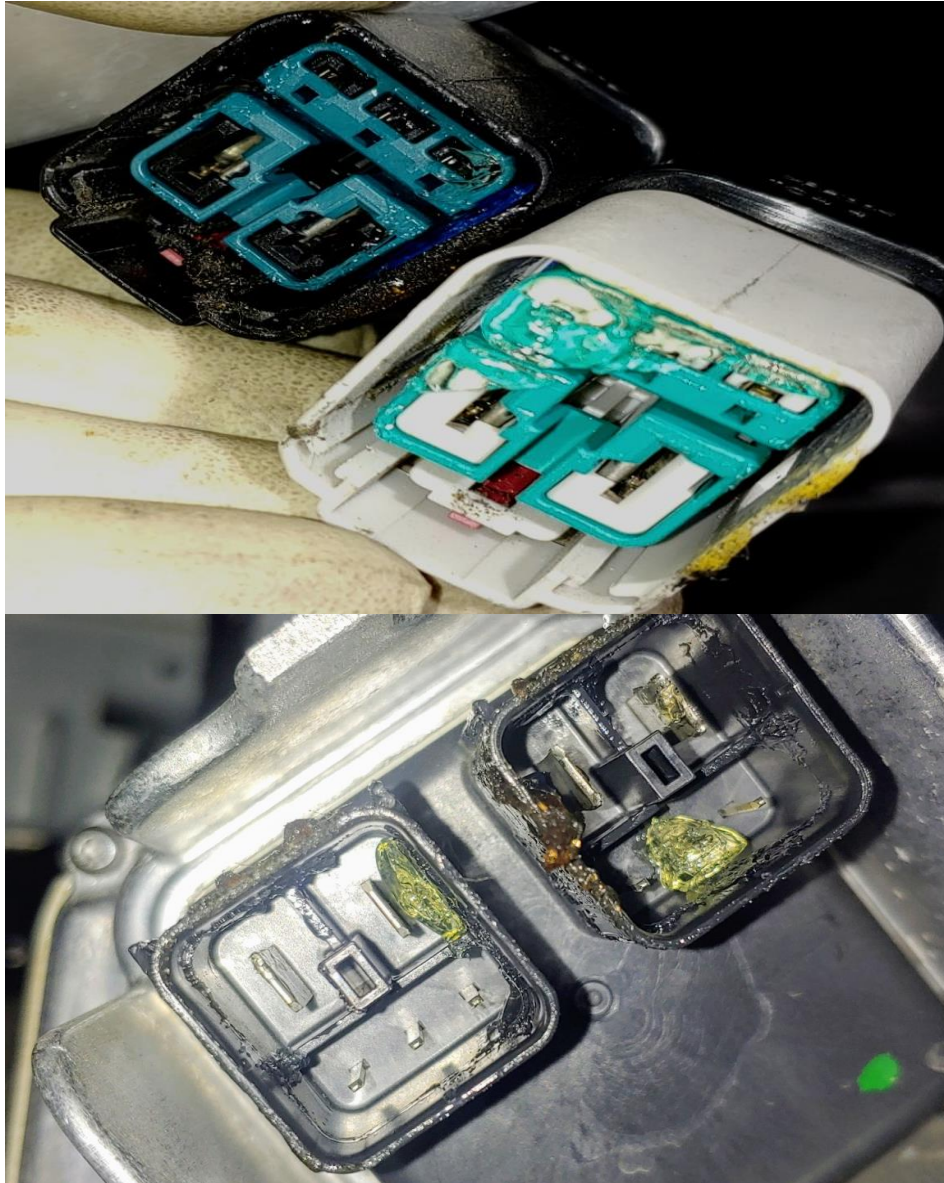
Examples of factory applied dielectric grease. **Do not add to or remove the grease.**
