# Service Bulletin

Bulletin No.: 25-NA-001  
Date: February, 2025

**Subject:** Transmission Fluid Leak Near Torque Converter Housing Area

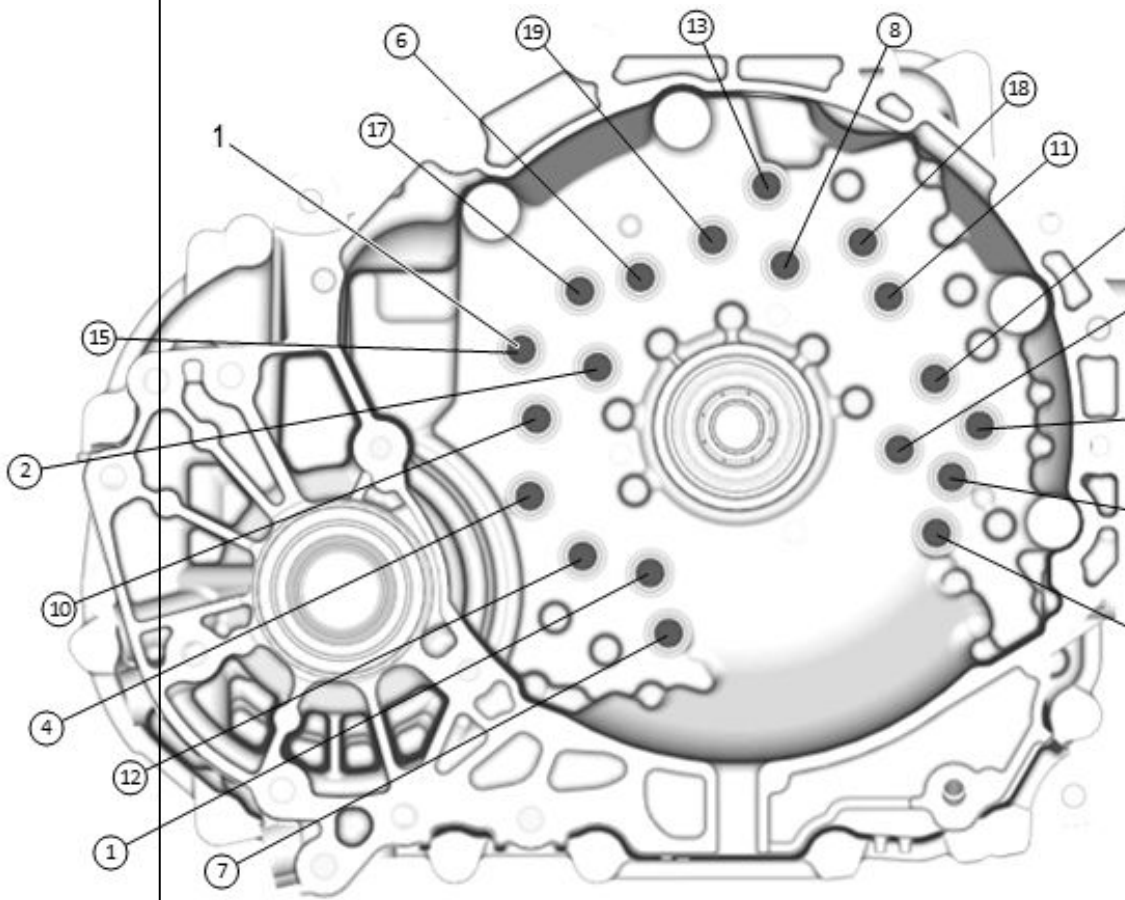
Cause	<p>This condition may be caused by the transmission pump bolts were not fully torqued. <span style="float: right;">6419117</span></p> <p><b>Note:</b> Service replacement transmission assemblies received may be built in the same Julian date range. If that occurs replacement of the pump bolts must be performed before the transmission is installed in the vehicle.</p> <p>For Transmission Julian Date, refer to <i>Transmission Identification Information</i> in SI.</p> <p>Check transmission Julian build date:</p> <ul style="list-style-type: none"> <li>• If the transmission Julian date is between 24 160 and 24 311 and the vehicle comes in with a transmission leak in the torque converter housing area, order the bolt kit as required.</li> </ul> <p><b>Note:</b> Example TUN where Julian date is found: 13241794TKBP0151 (Date Reads 13[24179]4TKBP0151).</p> <ul style="list-style-type: none"> <li>• Once the bolt kit arrives, remove the transmission, and verify that the bolts are loose.</li> <li>• If loose, replace all the bolts and reinstall the transmission.</li> </ul>
