STAR ONLINE PUBLICATION

Case Number: S228A000005 – Rev. E

Symptom/Vehicle Issue: Uconnect Box Error Message, With Active or Stored Cellular Antenna Open or Short Diagnostic Trouble Codes (DTCs)

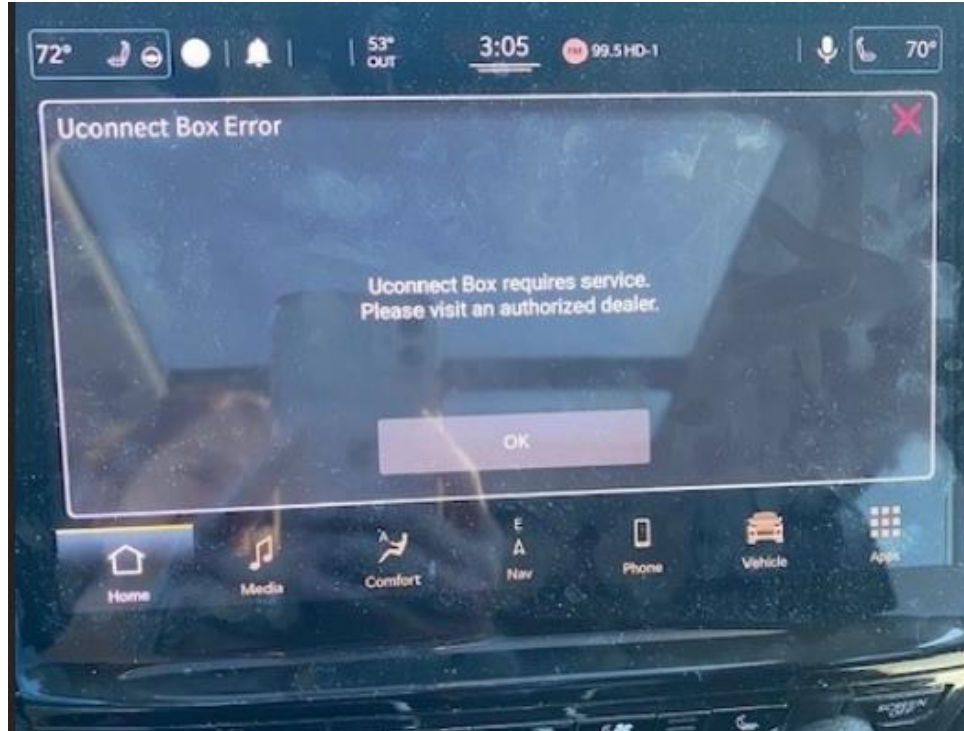
Figure 1: Error Message

Customer Complaint/Technician Observation: The customer may see “Uconnect Box Requires Service” message popup on the radio screen when vehicle starts. wiTECH shows one or more active or stored DTC(s):

Discussion: Every time the antenna open or short DTC(s) was set, the Uconnect box error popup will show on the screen. The message will stay on until next ignition off or customer closes the popup by pressing the cross button at top right corner of the screen.

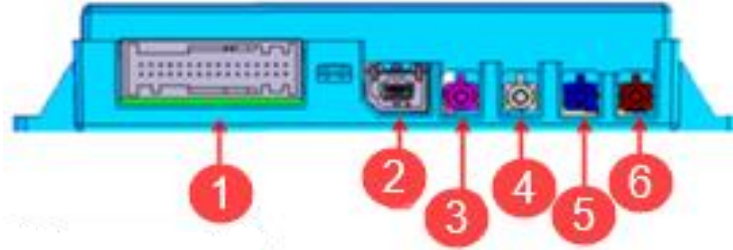
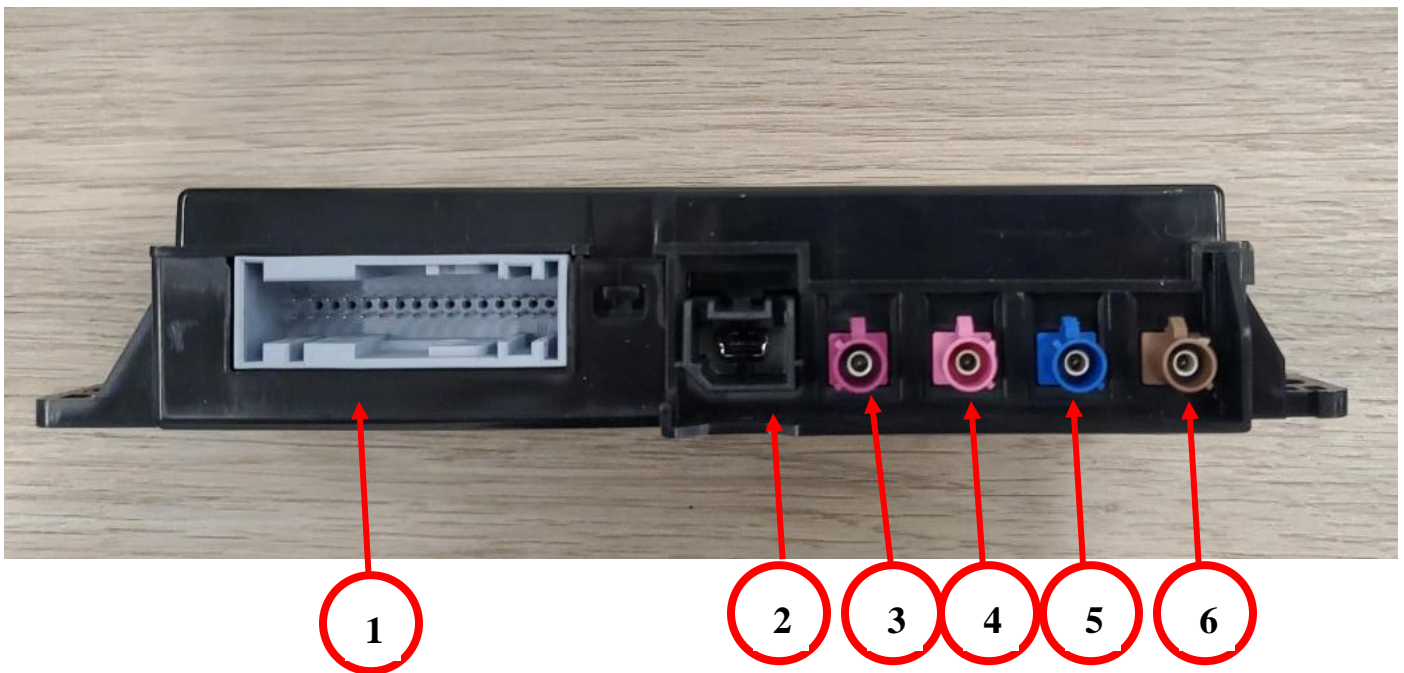
Figure 2: FAKRA Connector Location

TBM Connector	Description	Connector Color	Harness #	Harness Color
1	Main connector			
2	USB / Ethernet		C6	
3	Cellular antenna (CELL 1)	Purple	C2	Claret violet
4	LTE 2 antenna (CELL 2)	Pink / Magenta	C5	Heather violet
5	GNSS IN / Antenna signal	Blue	C3	Blue
6	GNSS OUT / Radio antenna	Brown	C4	Nut Brown

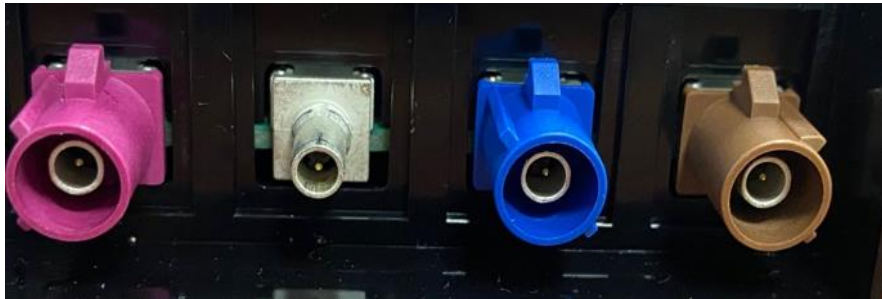
Figure 3: Example of Damaged/Missing Connector Housing

- Check harness continuity and look for any cable pinch or damage.
- Check for proper installation, connector damage, proper coax cable lengths (no tension, center stack approximately 3 in away from IP), bent terminals or a terminal pushed out.
