# Service Bulletin

Bulletin No.: 25-NA-027

**Subject: Windshield Wiper Arm Clearing and Interference Concerns**

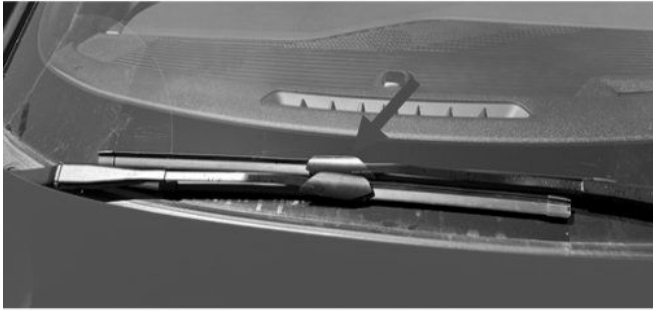
6832673

- Reference image for wipers contact acting in park position.

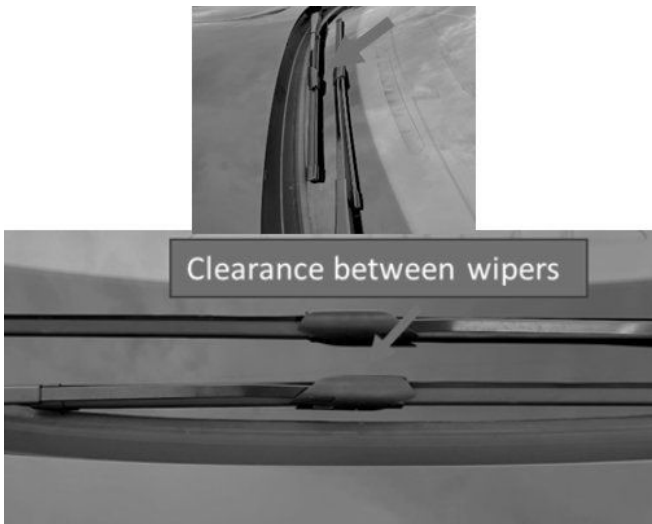
6832674

- Correctly aligned wipers will have a gap between the blades in the park position as shown above.
3. If the wipers are contacting each other in park or any location during cycling, follow *Windshield Wiper Arm Adjustment* procedure in SI.
  4. For issues where the wipers are not fully clearing the windshield: During cycling, the reversal point of the blade is around 40-50 mm (1.6-2.0 in) to the edge of the blackout on the glass as shown below.

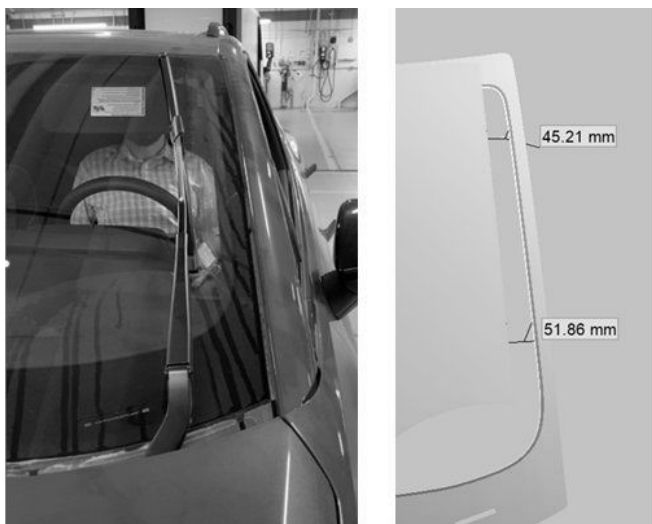
6832676

**Note:** Consistency in measuring this gap can vary depending on where the measurement is taken, tackiness of the glass, and cycle speed of the wipers. It is not recommended to use measurements at the pillar to accurately assess alignment. If it is noted that the un-wiped area appears to be excessive, this measurement can be used as reference. However, correct determination of the alignment should only be performed when the wipers are in the full parked position following the adjustment procedure in the document noted above.
