| REFERENCE: | TSB: 08-022-25 REV. A GROUP: 08 - Electrical | Date: | February 15, 2025 | REVISION: | 08-022-25 |
| VEHICLES AFFECTED: | 2024 (LB) Dodge Charger This bulletin applies to vehicles equipped with 400V G2500 FR/RR Elec Drive Motors (Sales Code ELD). | MARKET APPLICABILITY: | | <input checked="" type="checkbox"/> NA | <input checked="" type="checkbox"/> MEA |
| CAUSE: | BPCM software update | | | | |

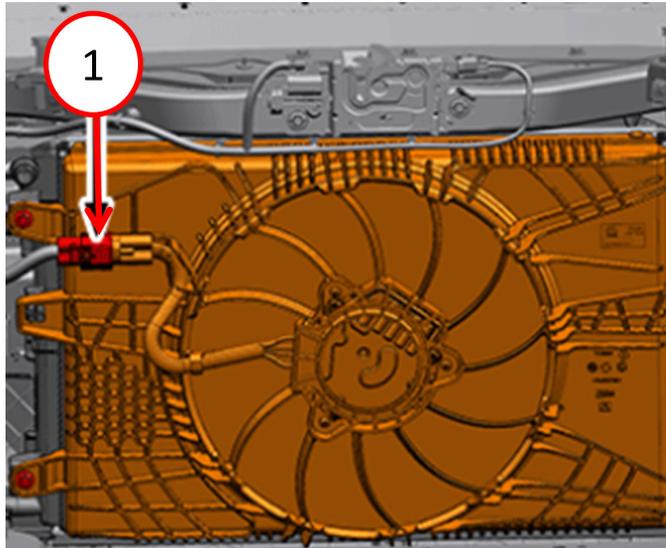
Fig. 1
Cooling Fan Assembly

1 - Wire Harness To Disconnect/Connect

4. Disconnect the cooling fan wire harness connector [Fig 1**](#).

21. **Connect the cooling fan wire harness connector [Fig 1](#).
