# Service Bulletin

Bulletin No.: 21-NA-138  
Date: February, 2025

**Subject:** Squeak, Grind or Clunking Noise from Rear Leaf Springs  
**Attention:** This bulletin applies to Heavy Duty vehicles only. Refer to Bulletin 19-NA-129 for Light Duty vehicles.

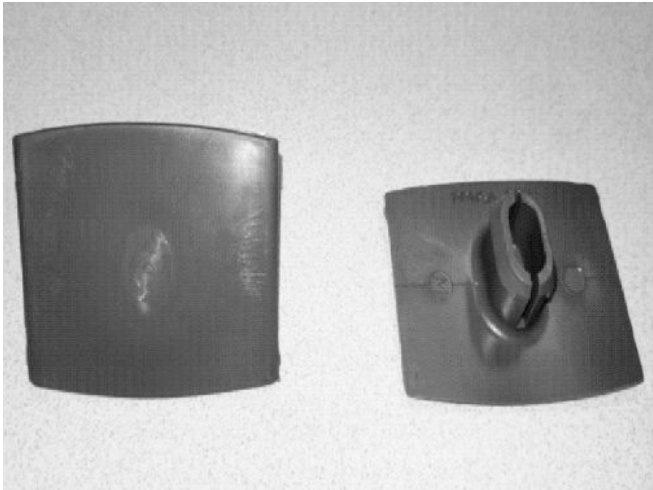
| Condition | Some customers may comment that a squeak, grind, or clunking noise can be heard from the rear leaf springs. |
| Cause | This condition may be caused by the spring insert interacting with the leaf spring.<br><b>Note:</b> Some noise is characteristic with leaf spring suspensions when going over bumps. |

| Correction | <p><b>Important:</b> Do not add any lubricant to the inserts or springs. Lubricant can attract dirt and debris which can lead to noise and premature wear. Some lubricants can also chemically attack the insert material.</p> <div></div> <p>A new insert with a graining pattern will help reduce this noise.<br/>Replace the rear spring inserts utilizing a plastic trim tool or plastic wedge in between the leaf springs.</p> |
