GENERAL MOTORS
DCS7149
URGENT - DISTRIBUTE IMMEDIATELY

Subject: N242480200 - Service Update
Water Leaks Due to Missing Sealer

Models: 2025 Chevrolet Silverado 1500/2500 HD/3500 HD

N242480200 Water Leaks Due to Missing Sealer

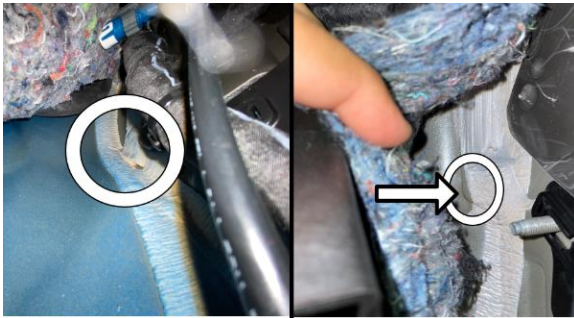
6830775

5. Inspect the sealer bead for complete coverage of the seam as pictured above.

- If the seam is completely covered by the seam sealer, Proceed to Step 12.
- If the seam is NOT completely covered by the seam sealer and is exposed, Proceed to Step 6.
