GENERAL MOTORS  
DCS7148  
URGENT - DISTRIBUTE IMMEDIATELY

Subject: N242489350 - Service Update  
Rear View Camera Display

Models: 2025 Chevrolet Equinox

## N242489350 Rear View Camera Display

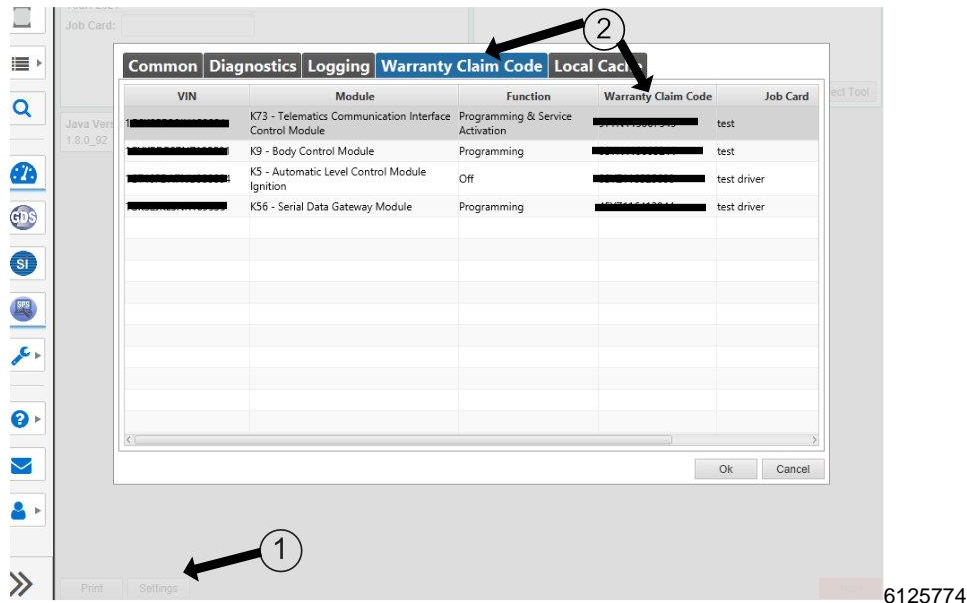
### Warranty Claim Code Information Retrieval

If the Warranty Claim Code was not recorded on the Job Card, the code can be retrieved in the SPS2 system as follows:

1. Open TLC on the computer used to program the vehicle.
2. Select and start SPS2.
3. Select Settings (1).
4. Select the Warranty Claim Code tab (2).

The VIN, Warranty Claim Code and Date/Time will be listed on a roster of recent programming events. If the code is retrievable, dealers should resubmit the transaction making sure to include the code in the SPS Warranty Claim Code field.

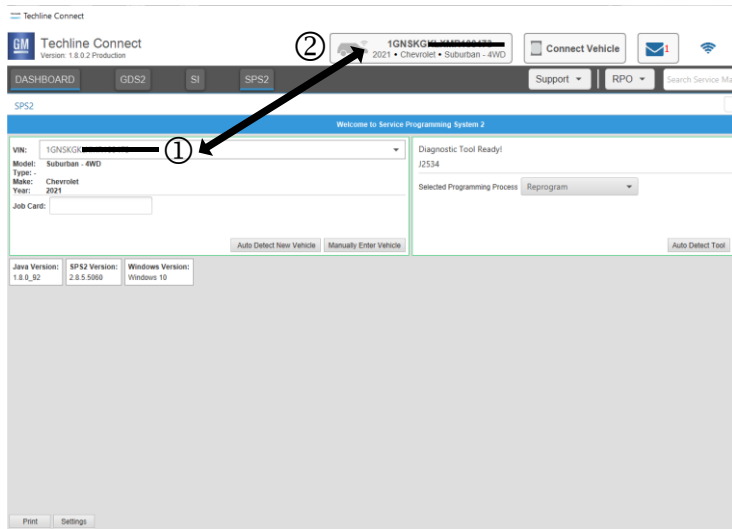
5743643

**Caution:** Be sure the VIN selected in the drop down menu (1) is the same as the vehicle connected (2) before beginning programming.

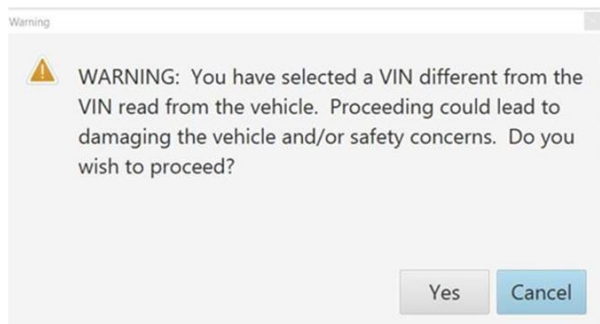
5877000

**Important:** If the vehicle VIN DOES NOT match, the message below will be shown.

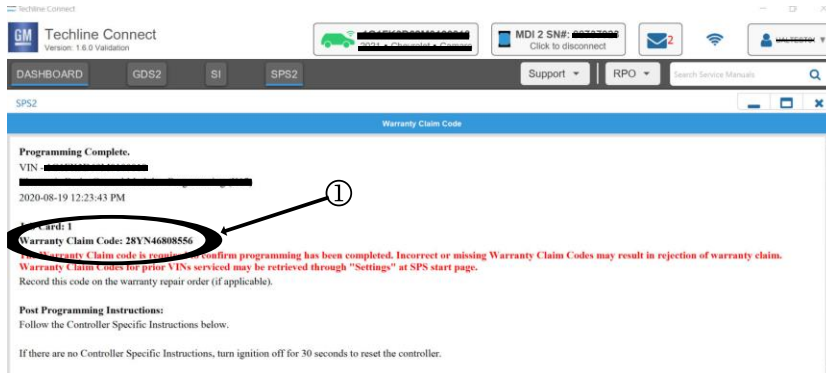
5644478

**Important:** To avoid warranty transaction rejections, you MUST record the warranty claim code provided on the Warranty Claim Code (WCC) screen shown above on the job card. Refer to callout 1 above for the location of the WCC on the screen.

3. Record SPS Warranty Claim Code on job card for warranty transaction submission.
