| REFERENCE: | TSB: 08-028-25 REV. A GROUP: 08 - Electrical | Date: | February 15, 2025 | REVISION: | 08-028-25 | | |
| VEHICLES AFFECTED: | 2025 (LB) Dodge Charger This bulletin applies to vehicles built on or before January 15, 2025 (MDH 0115XX) equipped with 400V G2500 FR/RR Elec Drive Motors (Sales Code ELD). | | | MARKET APPLICABILITY: | | | |
| CAUSE: | EVCU software update | | | | | | |

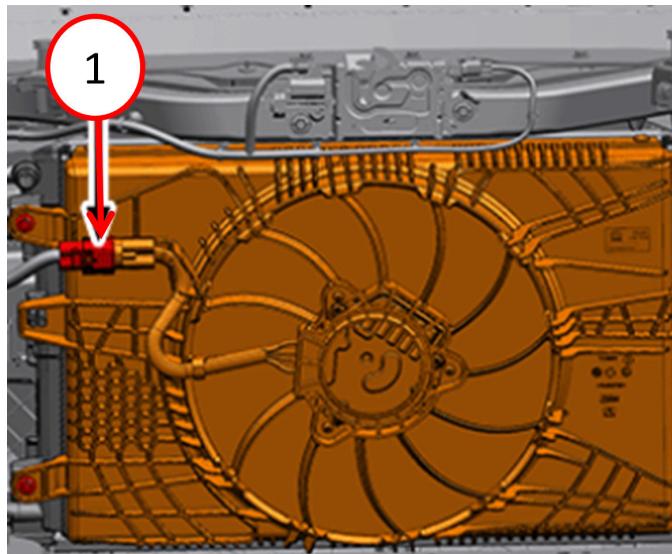
Fig. 1
Cooling Fan Assembly

1 - Wire Harness To Disconnect/Connect

4. Disconnect the cooling fan wire harness connector [Fig. 1**](#).

21. **Connect the cooling fan wire harness connector [Fig. 1](#).
