REFERENCE:	TSB: 08-033-25 GROUP: 08 - Electrical	Date:	February 13, 2025	REVISION:	–
VEHICLES AFFECTED:	2024 (JL) Jeep Wrangler 2024 (JT) Jeep Gladiator This bulletin applies to vehicles built on and before September 25, 2024 (MDH 0924XX) equipped with one of the following radios: <ul style="list-style-type: none">Uconnect 5 Nav W 12.3" Display (USA) (Sales Code UBX).Uconnect 5 Nav W 12.3" Display (MEX) (Sales Code UFX).Uconnect 5 W/ 12.3" Display (USA) (Sales Code UBP).Uconnect 5 W/ 12.3" Display (MEX) (Sales Code UFP).			MARKET APPLICABILITY: <div><input checked="" type="checkbox"/> NA<input type="checkbox"/> MEA</div> <div><input type="checkbox"/> SA<input type="checkbox"/> IAP</div> <div><input type="checkbox"/> EE<input type="checkbox"/> CH</div>	
CUSTOMER SYMPTOM:	Customers may experience one or more of the following: <ul style="list-style-type: none">Unable to select the Turn by Turn Navigation.Blank Performance Pages (Rearview Camera (RVC) Functions Normally).Android Auto® Voice Recognition (VR) inoperative.Media tuner delayed.Charge Schedule not accepting updates via phone (RVC Functions Normally).Ambient light inoperative.Map in Instrument Panel Cluster (IPC) inoperative.

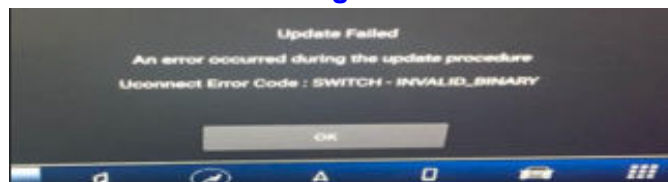
Fig. 7
Switch-Invalid_Binary Error

NOTE: Sometimes the radio throws an error pop up "Switch-Invalid_Binary" after successful radio update. Please ignore this error and click ok [Fig. 7](#).
